Clearwater River Stream Bank Stabilization and Revitalization Project

Report by: Red Lake Watershed Staff Updated: 11/10/05

Red Lake Watershed District Staff
Corey Hanson, Water Quality Coordinator
Stephanie Klamm, Water Quality/Natural Resources Technician

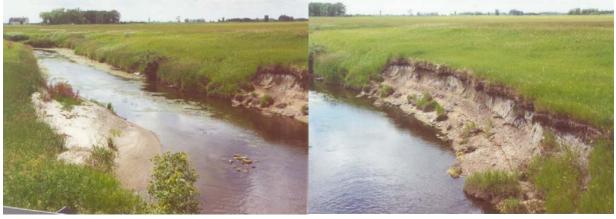
There were several areas of active erosion within the project reach. A scour hole was forming downstream of the CSAH 28 bridge. Severe bank erosion is occurring downstream of the bridge as well, along with the formation of a sand bar on the opposite bank. Flow appeared to be directed into the eroding bank. The scour hole and bank erosion downstream of the bridge may have been aggravated by the erosive forces and velocities generated by a rock pile and beaver dam upstream. Channel bank erosion was also occurring along the outside of a meander within the project reach. Point bars were also forming on the outside of the eroding bend. Toe erosion was apparent along this eroding bend, which appeared to be a cause of the bank stability problems. Head-cutting did not seem to be a problem in this reach.

Alternative solutions to the problem were evaluated including structural techniques, non-structural techniques, and doing nothing. The "do nothing" approach in this case would have resulted in continued erosion. Non-structural techniques to reduce the rate of runoff were out of the scope of the project and were not feasible alternatives for reaching the project goals. Structural alternatives were the most desirable method for stabilizing banks, reducing lateral erosion, and grade stabilization.

The recommended alternatives were discussed with and approved by the RLWD Board of Managers. These originally included removing point bars, installing a cross-vane weir just downstream of the bridge to direct flow away from the bank and toward the center of the channel, install bendway weirs (see example below) along the outside of the river bend to direct flow away from the bank, retain rocks and beaver dam under the bridge, and retaining vegetation on outside meander banks rather than reshaping the banks. During the permitting process, the Minnesota Department of Natural Resources requested that j-hook rock dams be used instead of bendway weirs. The reasoning for this is that they create a scour hole for fish habitat. Since purposefully creating channel erosion wasn't a desired outcome of this project, stream barbs were used as a compromise. A stream barbs may still create a scour hole in the channel, but it will be smaller than one from a j-hook rock dam. Stream barbs are pointed upstream at a sharper angle than bendway weirs, and also increase upstream sedimentation. Stream barbs, j-hook rock dams, and bendway weirs all work to direct the stream of highest velocity away from the stream bank and toward the center of the channel.

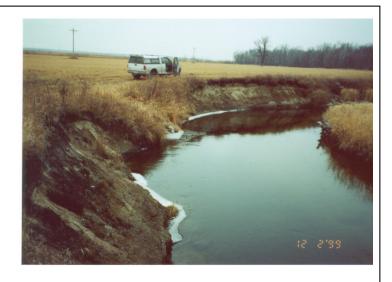
Site A Before Construction, Bank Slumping

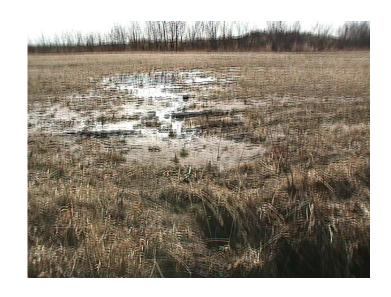
Bank slumping at Bank
Stabilization
Site C
1 year after construction
Malfunctioning Drain Tile?

Bank Slumping at Bank
Stabilization
Site C
Pooling of water that is the Apparent
Cause of the Slumping

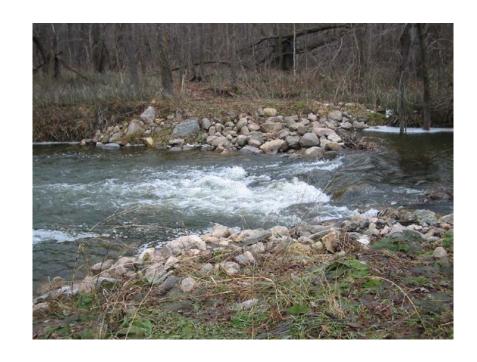
Additional Cross-Vane Weirs Site P Newly Constructed, Fall 2003

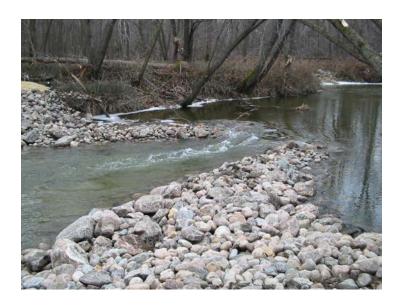
Additional Cross-Vane Weirs Site O Newly Constructed Fall 2003

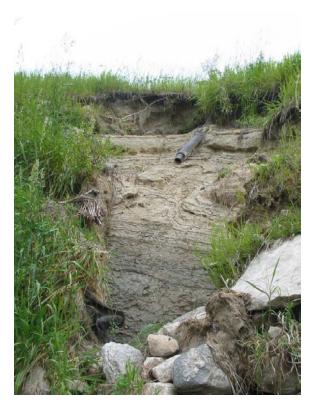
Erosion at Site C.

This was apparently caused by a drainage tile, the end of which was buried during the construction. Drainage from the tile caused the sloughing and erosion of the bank. This site was repaired in the summer of 2004.
