By Corey Hanson, Red Lake Watershed District Water Quality Coordinator. 4/3/2017.

### **Clearwater River Watershed Restoration and Protection Strategy (WRAPS) Project**

RED LAKE WATERSHED DISTRICT  
MONTHLY WATER QUALITY REPORT

February 2017

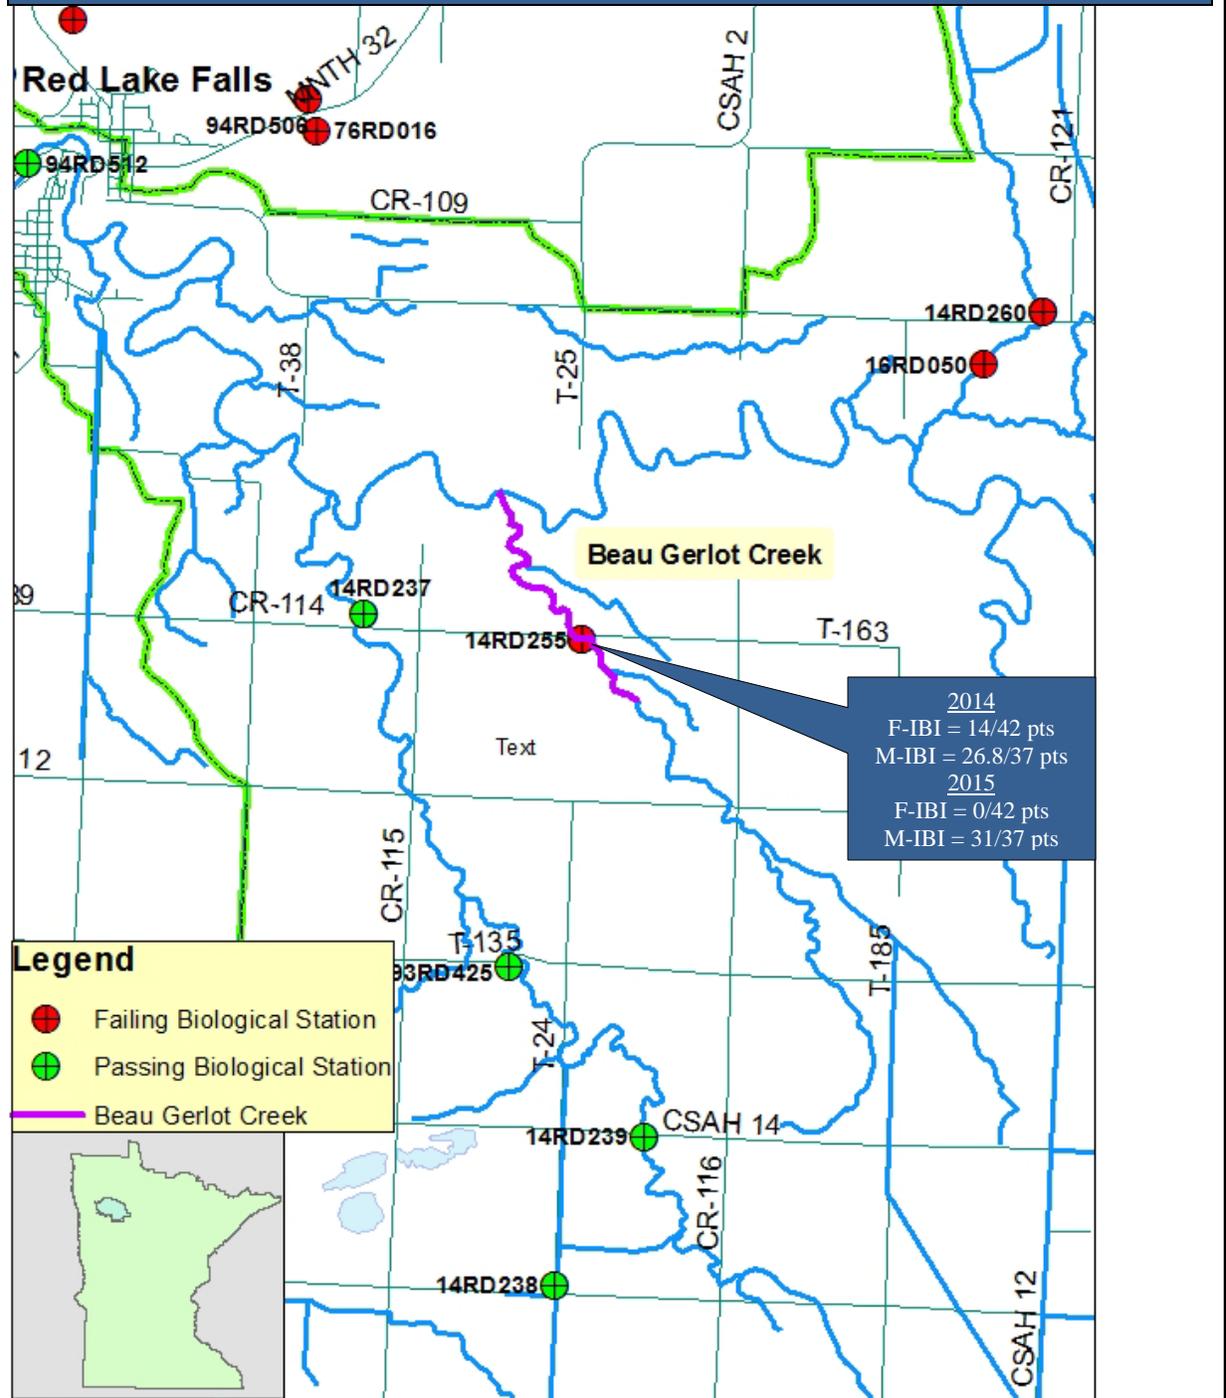
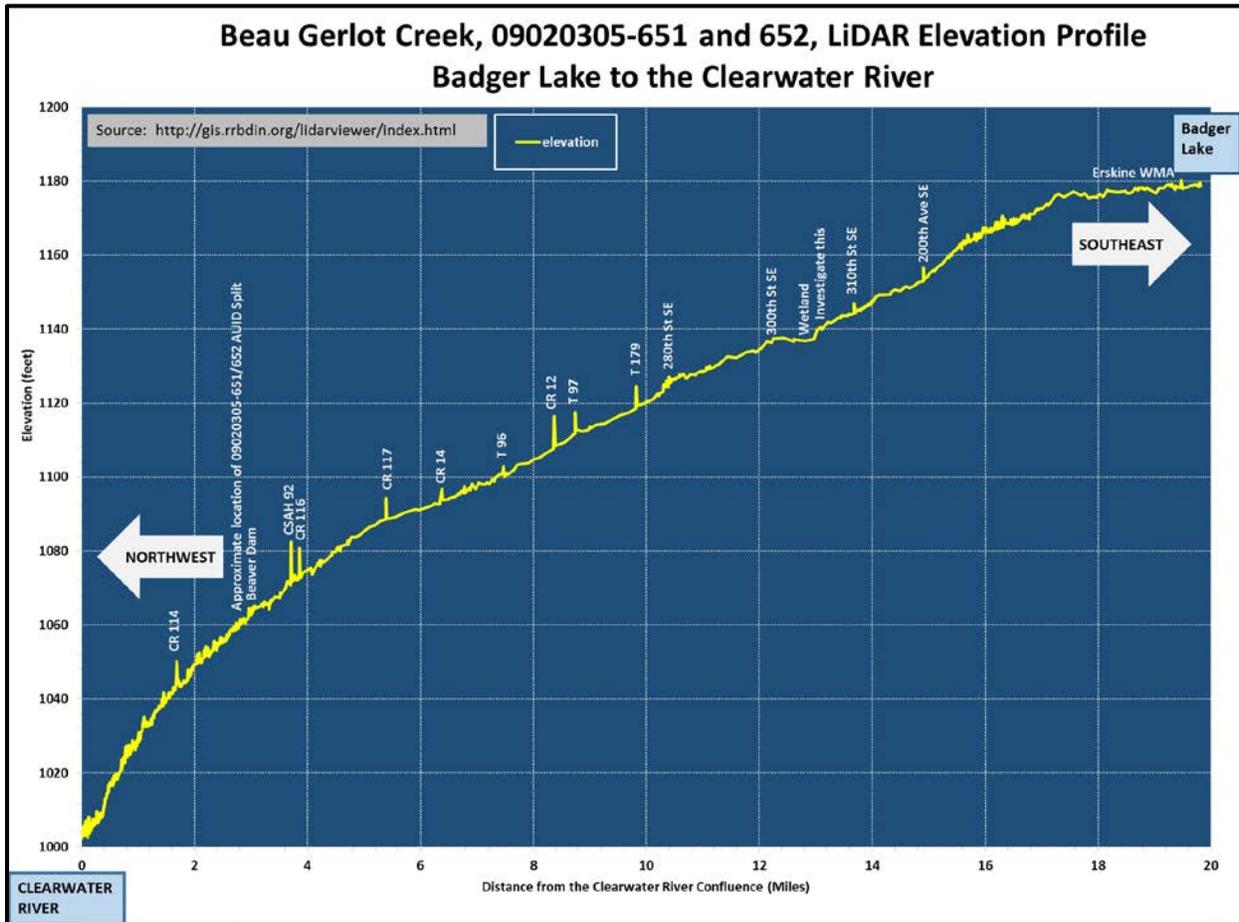
### Beau Gerlot Creek Fish and Macroinvertebrate Index of Biotic Integrity Impairments

**Beau Gerlot Creek** (AUID 09020305-652) is impaired by low fish and macroinvertebrate IBI scores. Beau Gerlot Creek meets water quality standards for the water chemistry parameters that affect aquatic life (dissolved oxygen, nutrients, and total suspended solids), so physical characteristics of the stream were examined. Flow alterations (upstream channelization, flashy flows, and extended periods of no flow), lack of connectivity, and lack of habitat were the primary candidate causes of the impairments. There is strong evidence that suggests that the combination of a steep gradient and crude private crossings may contribute to fish passage barriers, especially during lower flows. The LiDAR Elevation profile shows a significant increase in gradient downstream of County Road 114.

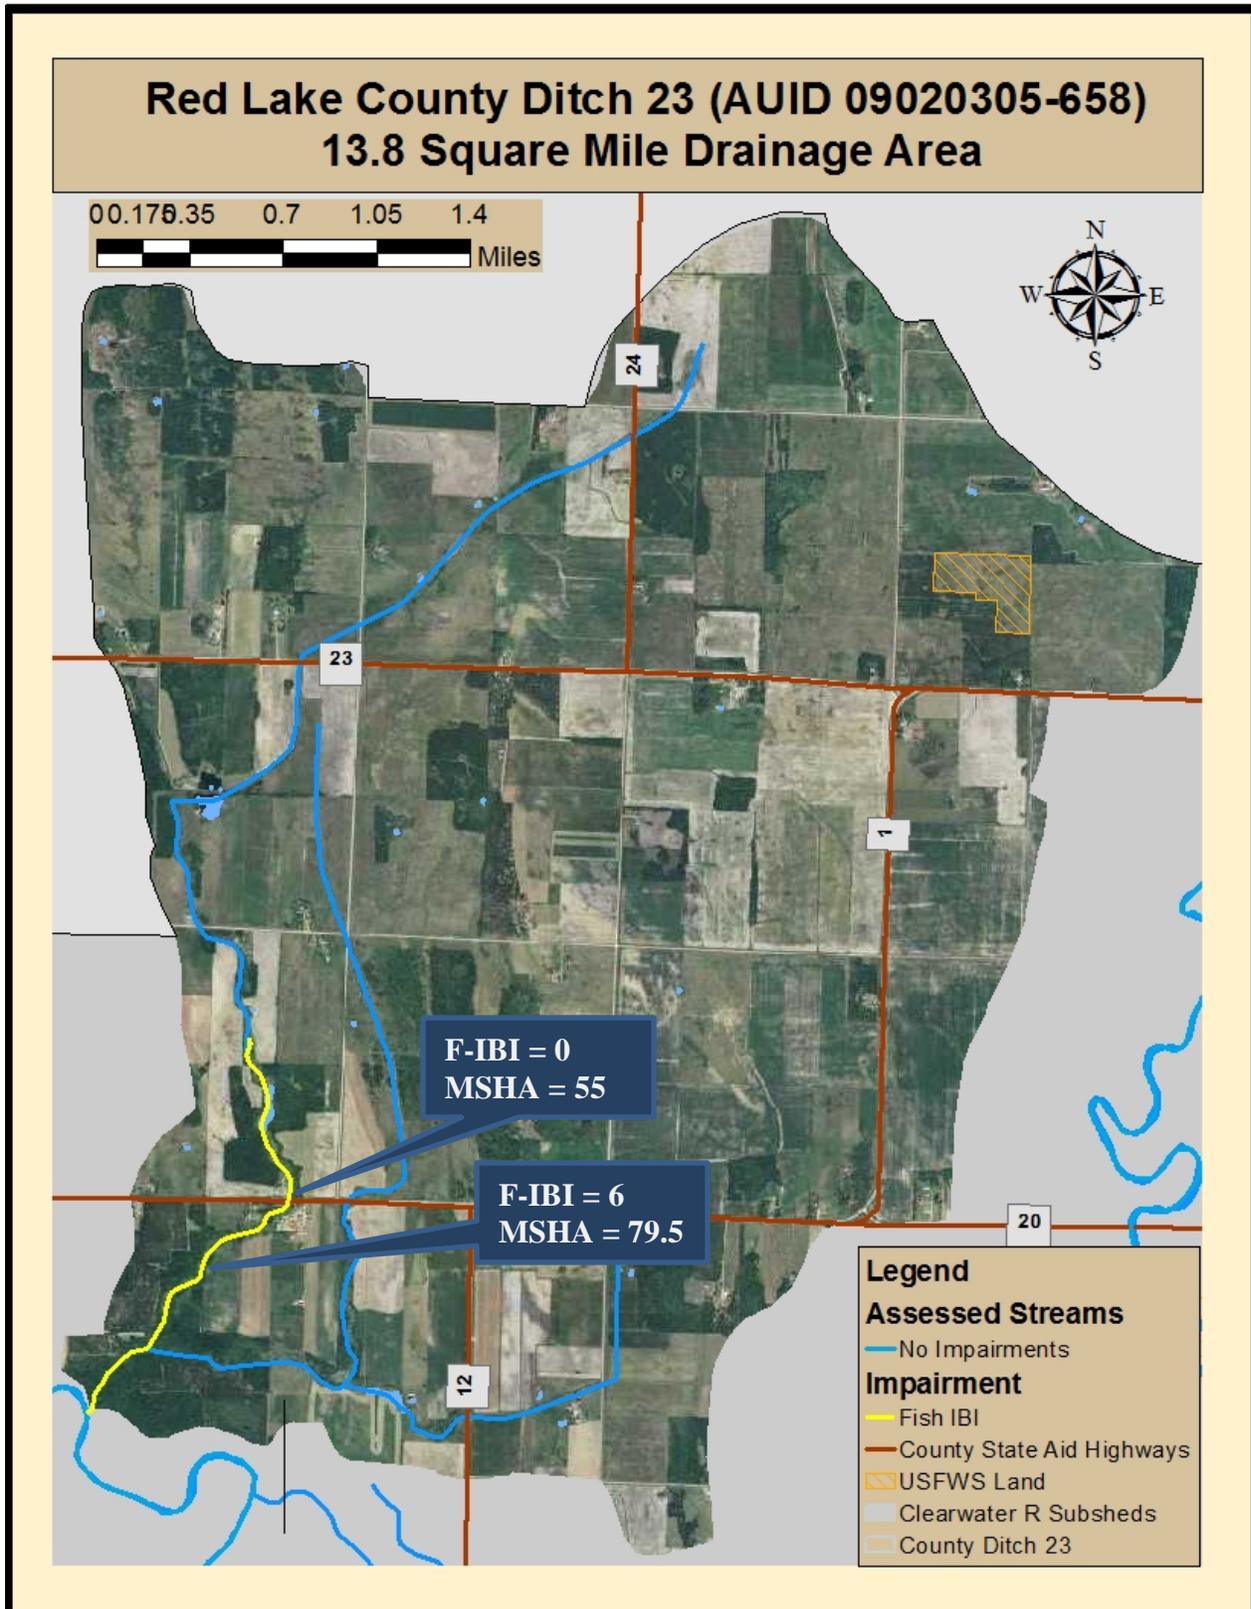
The natural outlet of the **Red Lake County Ditch 23** drainage system (AUID 09020305-658) was found to be impaired by low fish IBI scores. Flows were too low for the stream to be sampled for macroinvertebrates. The outlet of Red Lake County Ditch 23 is a natural channel that has a high gradient between CSAH 1 and the Clearwater River. It also receives drainage from the Red Lake County Ditch 17 drainage area. Dissolved oxygen barely failed (11% of daily minimums were <5 mg/L) to meet standards. Habitat scores were less than desired. DO and habitat values are not as poor, however, as the zero-point fish index of biotic integrity score would suggest. Fish passage and a lack of base flow are more likely to be the primary stressors of aquatic life in the stream. The culvert at CSAH 1 was a concern for MPCA stressor identification staff. They felt that the culvert could be negatively affecting fish passage during low flows and high flows. During lower flows, there is insufficient depth within the culvert to allow fish passage. During high flows, the velocities within the culvert could be too fast to allow fish passage.

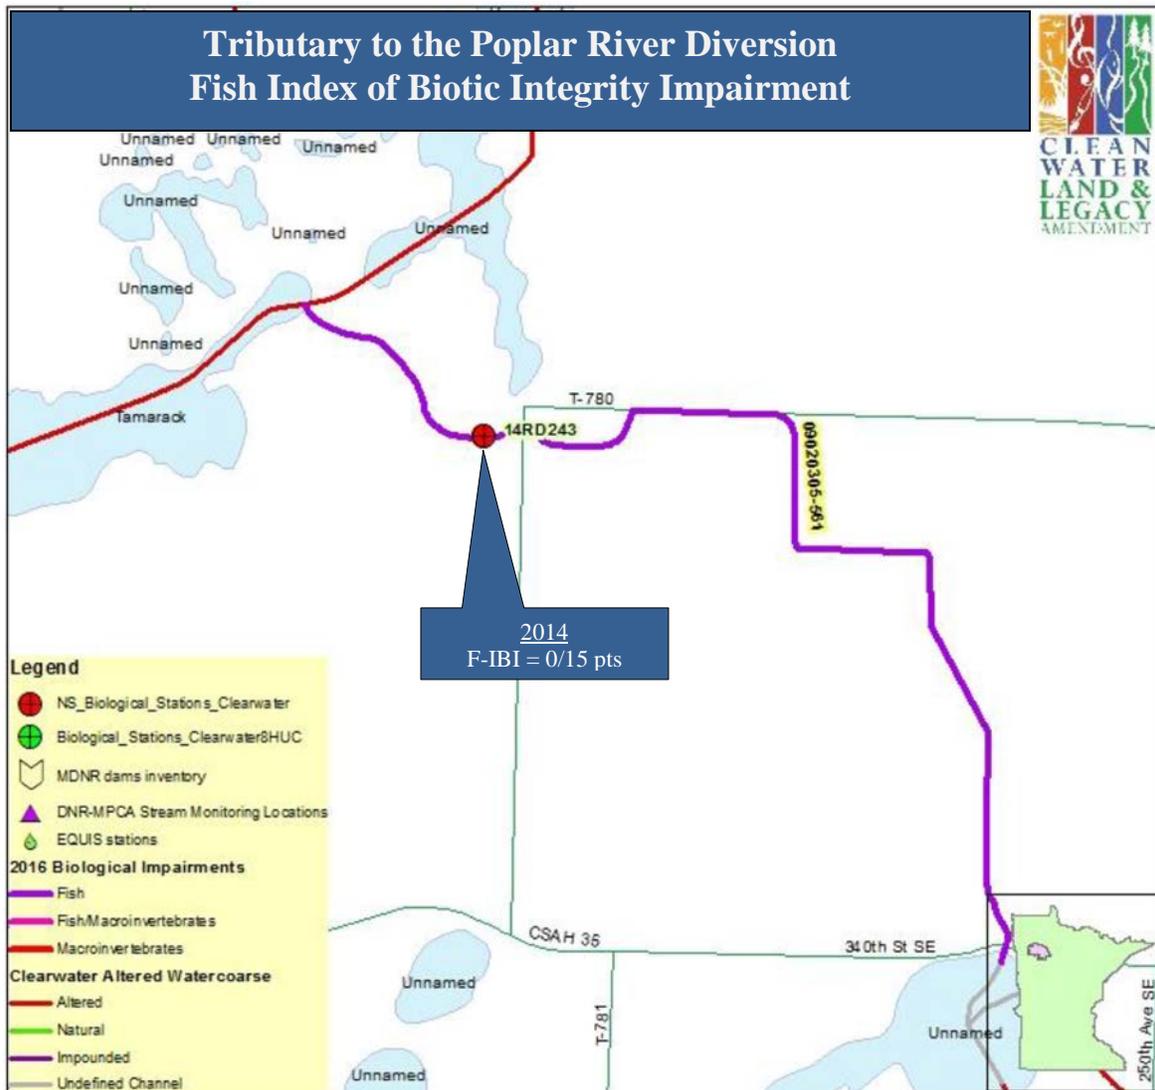
A tributary (AUID 09020305-561) to the Poplar River Diversion that flows from Gerdin Lake to the Poplar River Diversion was a site at which the MPCA sampled fish and found that the reach is impaired by a low fish IBI score (zero points). Stagnant conditions in the stream led to extremely low dissolved oxygen concentrations when water quality was monitored at the site in 2016. The sampling of this ditch for fish is highly questionable. According to the information presented for the review of tiered aquatic life use (TALU) standards, this ditch should be considered a limited resource value watercourse. It does not meet the IBI expectations for general use or modified use streams. It is a man-made channel. Restoration of this channel would not mean restoration of a meandering stream channel. Rather, it would mean abandonment/plugging of the channel and restoration of the wetlands that it appears to be draining. The area has been considered for a large storage (flood damage reduction) project in the past. Aerial photos show that beaver dams are a frequent occurrence along the reach and downstream of the final road crossing. The Poplar River Diversion, into which this channel drains, was not sampled or assessed.

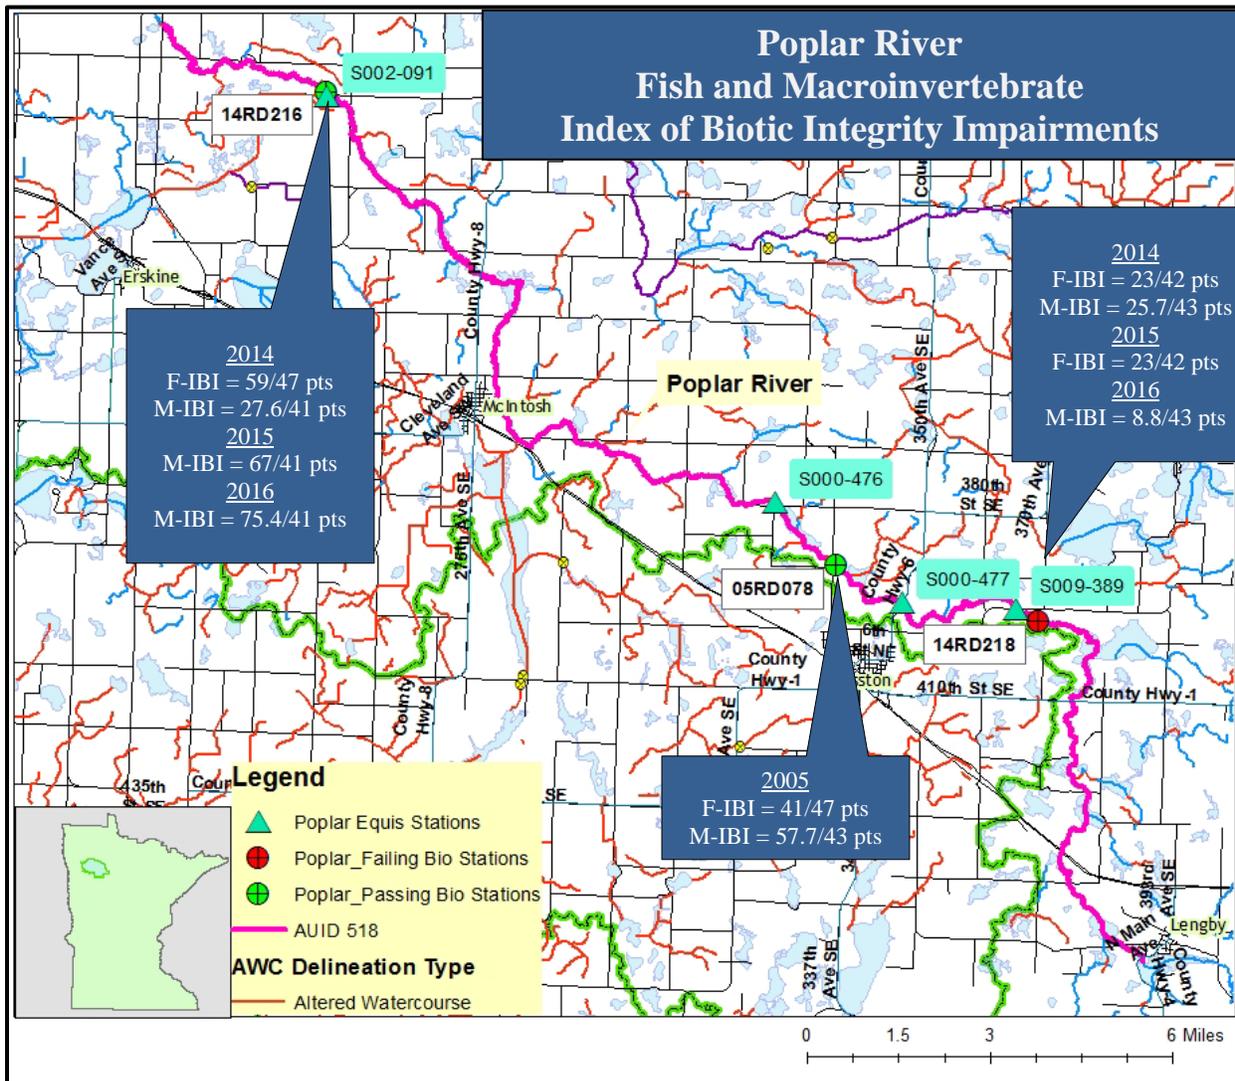
The **Poplar River** (AUID 09020305-518) upstream of Highway 59 is impaired by low fish and macroinvertebrate IBI scores. The poorest DO levels and IBI scores were found near the CSAH 27 crossing of the Poplar River, NE of Fosston at stations 14RD218 and S009-389. Both stations are located downstream of a large wetland complex near the outlet of Whitefish Lake. The Poplar River channel nearly disappears within the wetland complex between the CSAH 1 and CSAH 27 crossings as it flows past Whitefish Lake. Aerial photos show that the channel has been gradually filled-in with vegetation between 1991 and the present. The land use surrounding this wetland complex is primarily row crop agriculture. During periods of medium to high flow, it is likely that these wetland complexes flush out nutrients that can affect downstream DO concentrations. Nutrient samples collected during the 2016 deployment did not show elevated TP or nitrogen concentrations. DO levels recover downstream of CSAH 27, but drop significantly after passing through a riparian wetland downstream of CSAH 30. Some beaver dams have been found along the reach that may temporarily affect fish passage.

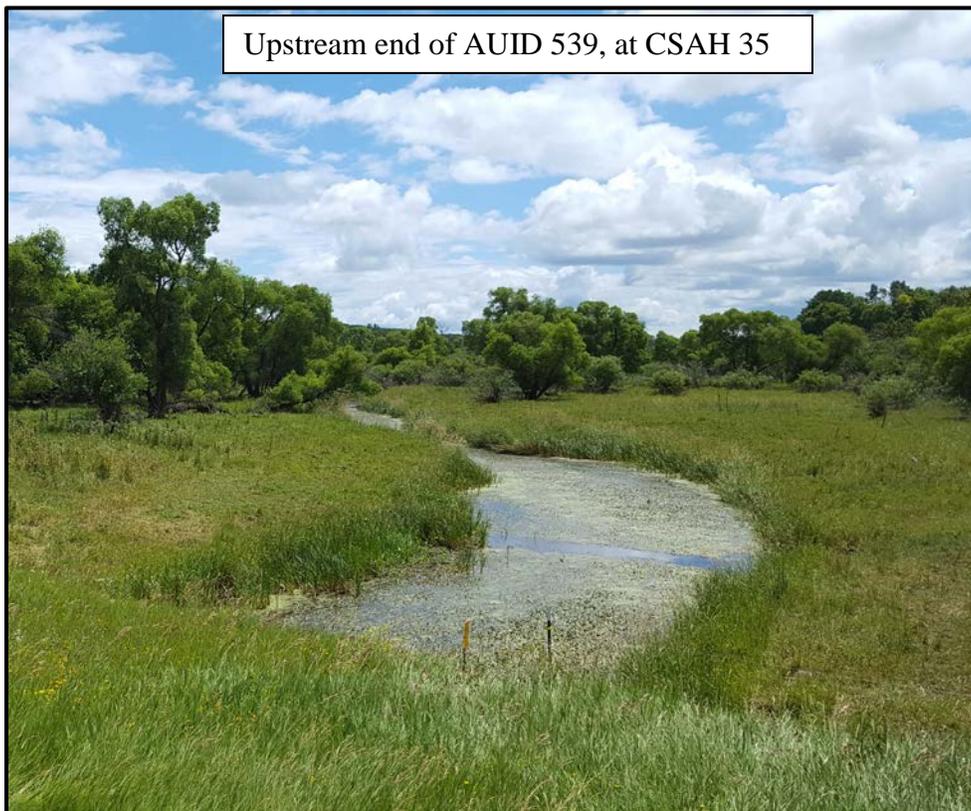
Upstream end of AUID 539, at CSAH 35

The **Hill River** (AUID 09020305-539) between Hill River Lake and the Lost River is impaired by low fish and macroinvertebrate IBI scores. Scores were very good at the downstream end of the reach near Brooks, but were poor near the upstream end of the reach near Hill River Lake. The river looks significantly different at either end of this reach. The upstream end has consistently low dissolved oxygen concentrations, a lower gradient, a mucky bottom, stagnant water, and a lot of in-channel vegetation. The downstream end of the Hill River has consistently good dissolved oxygen concentrations, gradient, consistent flow, and a sand/gravel bottom. A LiDAR profile of the reach revealed that there is a change in gradient where the channel begins flowing west toward Brooks (near the 14RD263 site on the following map). Additional continuous dissolved oxygen monitoring is recommended for the summer of 2017 within the portion of the river that changes from a northerly direction to a westerly direction (somewhere between 310<sup>th</sup> Ave SE and CSAH 8). The primary stressors to aquatic life suspected in AUID 539 on the Hill River are most evident at (and upstream of) site 05RD026. Those stressors are lack of connectivity, low DO/daily DO flux, and lack of habitat. Low dissolved oxygen seems to be the primary stressor for aquatic life. DO concentrations are being more greatly affected by physical characteristic of the stream rather than by pollutant concentrations. There is evidence that, despite not being a direct cause of the IBI impairments, there is also room for improvement of the in-stream habitat of this portion of the Hill River.

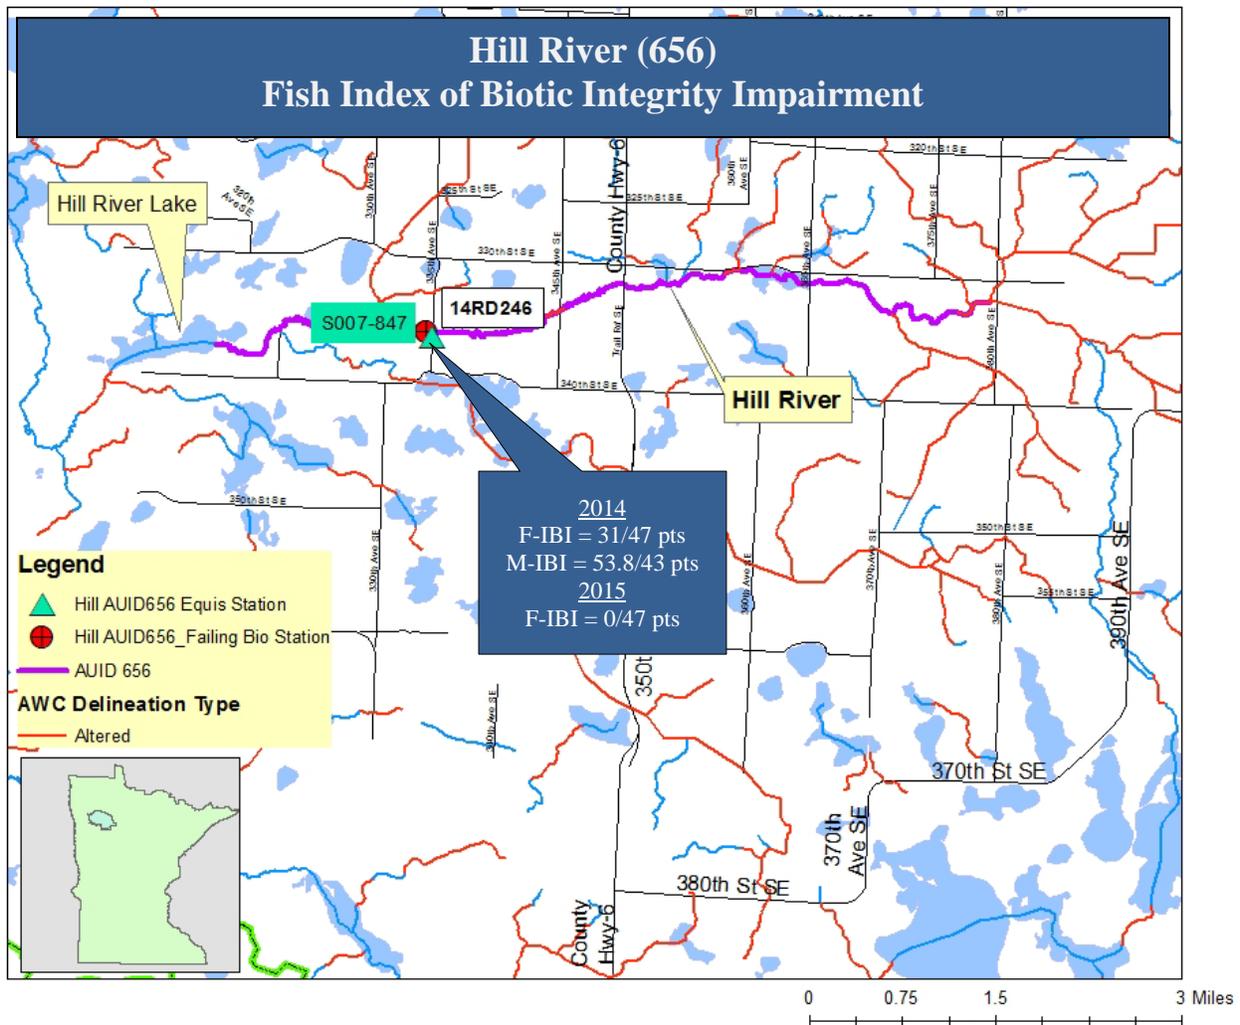
The **Hill River** (AUID 09020305-656) upstream of Hill River Lake is impaired by low fish IBI scores. The dam at the outlet of Hill River Lake prevents a barrier to fish passage to upstream reaches of the Hill River. Low dissolved oxygen is another significant stressor to aquatic life along this reach. Although dissolved oxygen levels are not as bad upstream of Hill River Lake as they are downstream of Hill River Lake, the river failed to meet dissolved oxygen and dissolved oxygen fluctuation standards at the 335<sup>th</sup> Ave SE crossing. Portions of the Hill River have been channelized upstream of this reach. Wetlands, including some large basins, have been drained with ditches. The channelization and wetland drainage would increase flashiness of flow and reduce base flow. Flow can become stagnant in the late summer and the channel becomes filled with dense macrophyte growth. Habitat scores were “fair” but the quality of the substrate was a concern. Further evidence of channel instability is provided by pictures of severe bank erosion and frequent channel damage from the many livestock access points throughout the river.

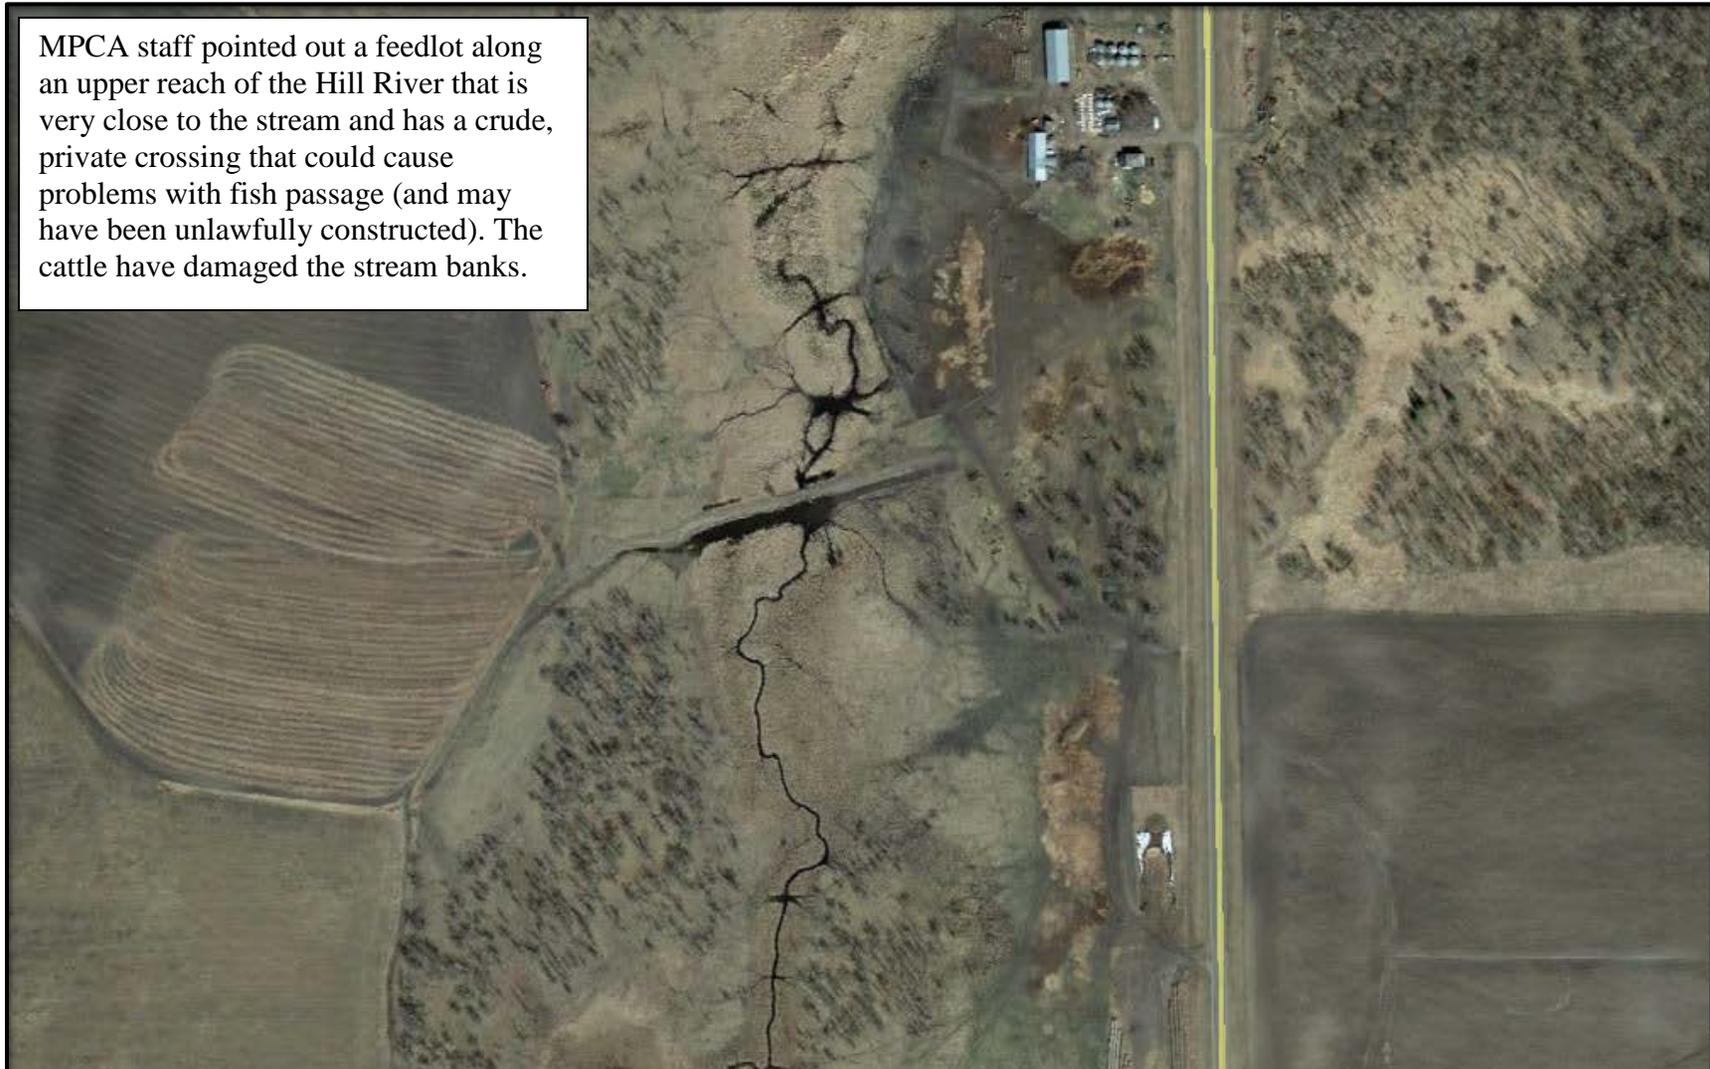
MPCA staff pointed out a feedlot along an upper reach of the Hill River that is very close to the stream and has a crude, private crossing that could cause problems with fish passage (and may have been unlawfully constructed). The cattle have damaged the stream banks.

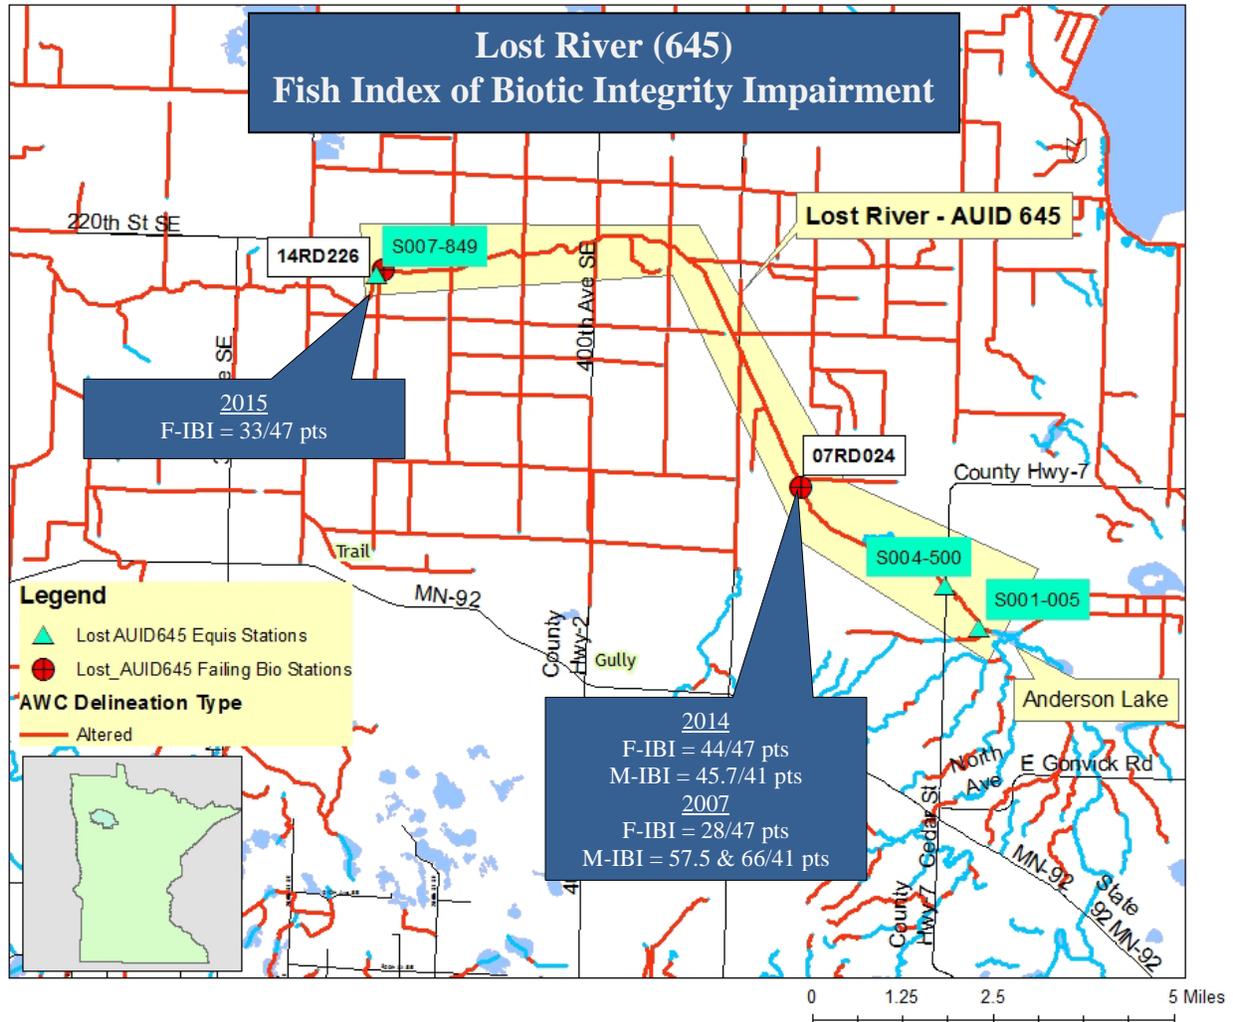
The channelized portion of the **Lost River (645)** (09020305-645) between Anderson Lake and a ditch along CSAH 28 is impaired by low fish IBI scores. Dissolved oxygen concentrations at the downstream end of the reach failed to meet state standards (frequently lower than 5 mg/L). Along with the low dissolved oxygen concentrations, the daily dissolved oxygen fluctuation was also high. Poor habitat quality is a stressor of aquatic life along this reach, particularly near the upstream, 07RD024 sampling station near 550<sup>th</sup> St. There are beaver dams along the reach that can act as temporary fish passage barriers.

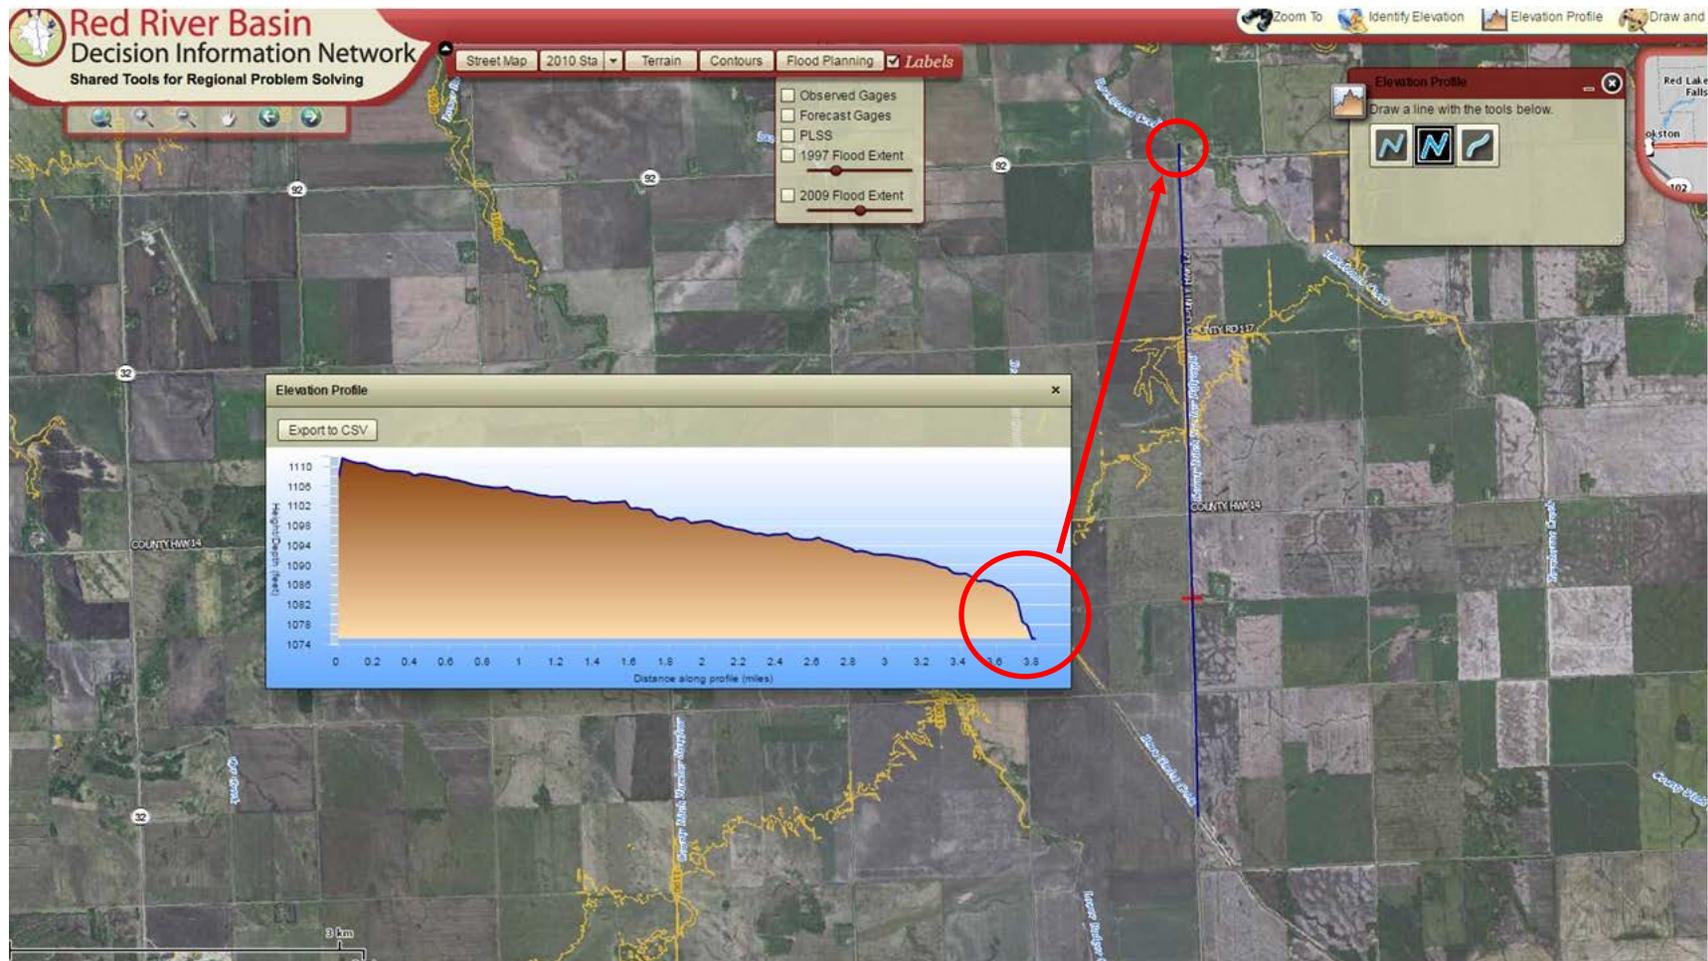
- While looking at LiDAR data for neighboring streams, RLWD staff noticed a potential need for a grade stabilization along Red Lake County Ditch 58 (a tributary of Terrebonne Creek).
