# Red Lake River Erosion Site and Assessment Catalog

## Threatening Infrastructure or homes

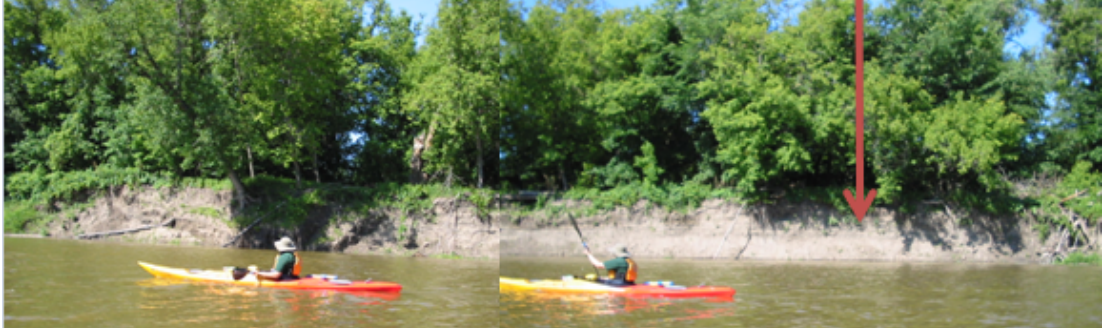
<b>Condition of bank</b>		<b>5</b>					
Toe and upper bank eroding	5	x					
Toe undercutting	3						
Toe stable, upper bank eroding	1						
<b>Problem Trend</b>		<b>1</b>					
Increasing	5						
Decreasing or stable	1	x					
<b>Side-slope of bank</b>		<b>5</b>					
Vertical, 1:1	5	x

2:1, 3:1	2						
4:1 or flatter	1						
<b>Length of eroded bank</b>		<b>5</b>					
More than 50 ft.	5	x					
20 to 50 ft.	3						
Less than 20 ft.	1						
<b>Depth of river</b>		<b>2</b>					
More than 3 ft.	2	x					
Less than 3 ft.	1						
<b>Soil type or texture</b>		<b>1</b>					
Sand	3						
Gravel	2						
Stratified	2						
Clay, loam	1	x					
<b>Vegetative Cover on bank slope</b>		<b>5</b>					
0-10%	5	x					
10-50%	3						
50-100%	1						
<b>Apparent cause of erosion</b>		<b>2</b>					
Light access traffic	1						
Obstruction in river	1						
Bank seepage	1						
Gully by side channels	1						
Bend in river	2	x					
Wave action (impoundments)	2						
Road-stream crossing;	3						
Moderate access traffic	3						
Heavy access (foot, horse, etc.)	5						
<b>Mean height of eroded bank</b>		<b>5</b>					
More than 20 ft.	7						
10 to 20 ft.	5	x					
5 to 10 ft.	3						
Less than 5 ft.	1						
<b>Current</b>		<b>1</b>

Fast	2						
Slow	1	x					
<b>Total Points for site</b>		<b>32</b>	<b>Moderate</b>

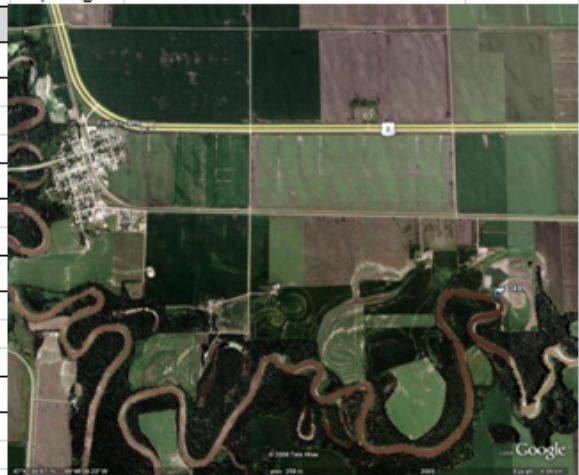
Streambank Erosion Severity Index			Site 49	
Site Description	Eroding cutbank 1.7 miles east of Fisher			
Site visits on	6/8/2007 10:28		lat/long:	N47 47.487 W96 45.400
OBSERVATION			SCORE	
<b>Condition of bank</b>			<b>3</b>	
Toe and upper bank eroding	5			
Toe undercutting	3	x		
Toe stable, upper bank eroding	1			
<b>Problem Trend</b>			<b>5</b>	
Increasing	5	x		
Decreasing or stable	1			
<b>Side-slope of bank</b>			<b>5</b>	
Vertical, 1:1	5	x

2:1, 3:1	2			
4:1 or flatter	1			
<b>Length of eroded bank</b>			<b>5</b>	
More than 50 ft.	5	x		
20 to 50 ft.	3			
Less than 20 ft.	1			
<b>Depth of river</b>			<b>2</b>	
More than 3 ft.	2	x		
Less than 3 ft.	1			
<b>Soil type or texture</b>			<b>1</b>	
Sand	3			
Gravel	2			
Stratified	2			
Clay, loam	1	x		
<b>Vegetative Cover on bank slope</b>			<b>3</b>	
0-10%	5			
10-50%	3	x		
50-100%	1			
<b>Apparent cause of erosion</b>			<b>3</b>	
Light access traffic	1			
Obstruction in river	1			
Bank seepage	1			
Gully by side channels	1			
Bend in river	2	x		
Wave action (impoundments)	2			
Road-stream crossing; grade/shoulder	3			
Moderate access traffic	3	x		
Heavy access (foot, horse, etc.) traffic	5			
<b>Mean height of eroded bank</b>			<b>3</b>	
More than 20 ft.	7			
10 to 20 ft.	5			
5 to 10 ft.	3	x		
Less than 5 ft.	1			
<b>Current</b>			<b>2</b>	
Fast	2			
Slow	1	x		
<b>Total Points for site</b>			<b>32</b>	
			<b>Moderate</b>

0-30	Minor	30-36	Moderate	>36 Severe
There is a road built along the streambank.

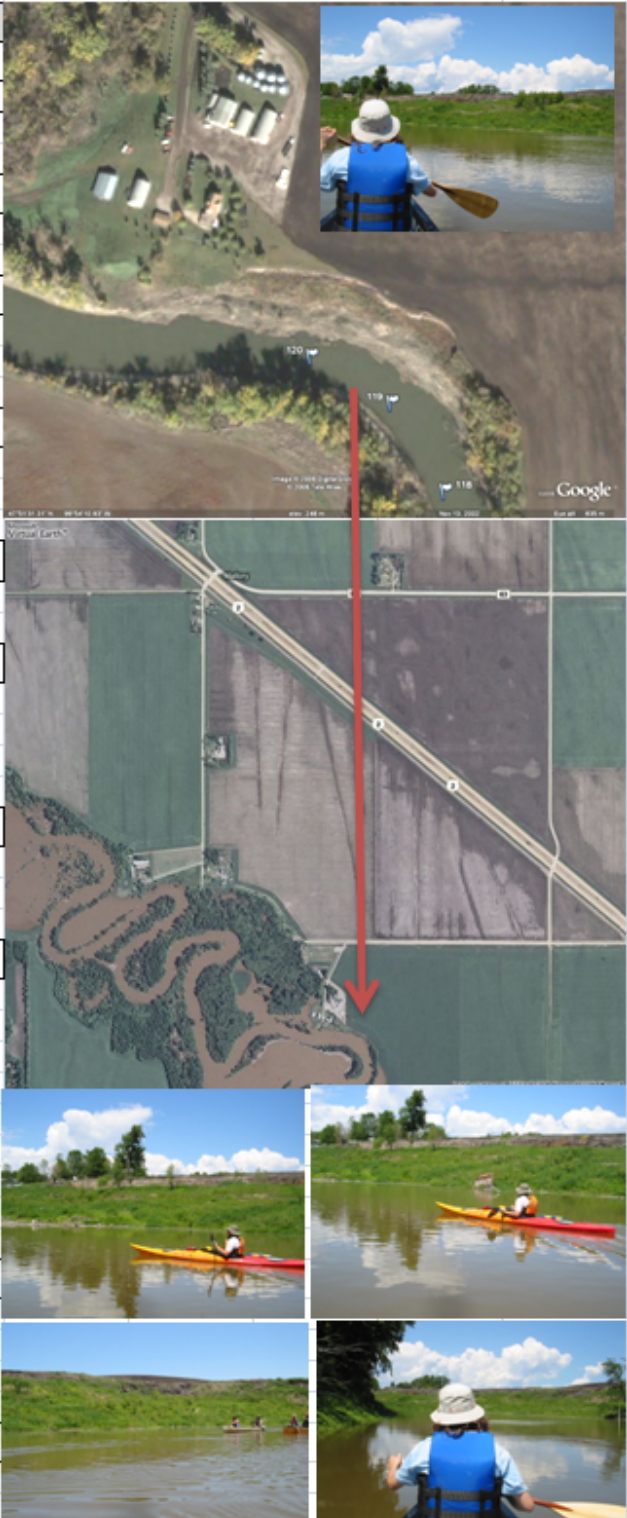
Streambank Erosion Severity Index					
Site Description	Washout along a field, outside of a bend, south of Mallory				
Site visits on	6/9/2007 13:40	lat/long:	N47 51.419 W96 54.672		
OBSERVATION		SCORE			
<b>Condition of bank</b>		<b>3</b>			
Toe and upper bank eroding	5	x			
Toe undercutting	3				
Toe stable, upper bank eroding	1				
<b>Problem Trend</b>		<b>1</b>			
Increasing	5	x			
Decreasing or stable	1				
<b>Side-slope of bank</b>		<b>5</b>			
Vertical, 1:1	5	x

2:1, 3:1	2				
4:1 or flatter	1				
<b>Length of eroded bank</b>		<b>5</b>			
More than 50 ft.	5	x			
20 to 50 ft.	3				
Less than 20 ft.	1				
<b>Depth of river</b>		<b>2</b>			
More than 3 ft.	2	x			
Less than 3 ft.	1				
<b>Soil type or texture</b>		<b>1</b>			
Sand	3	x			
Gravel	2				
Stratified	2				
Clay, loam	1				
<b>Vegetative Cover on bank slope</b>		<b>1</b>			
0-10%	5	x			
10-50%	3				
50-100%	1				
<b>Apparent cause of erosion</b>		<b>2</b>			
Light access traffic	1	x			
Obstruction in river	1				
Bank seepage	1				
Gully by side channels	1				
Bend in river	2				
Wave action (impoundments)	2				
Road-stream crossing;	3				
Moderate access traffic	3				
Heavy access (foot, horse, etc.)	5				
<b>Mean height of eroded bank</b>				<b>7</b>	
More than 20 ft.	7			x	
10 to 20 ft.	5				
5 to 10 ft.	3				
Less than 5 ft.	1				
<b>Current</b>		<b>1</b>			
Fast	2	x			
Slow	1				
<b>Total Points for site</b>		<b>28</b>

<b>Minor</b>			
0-30	Minor	30-36	Moderate		
		>36	Severe

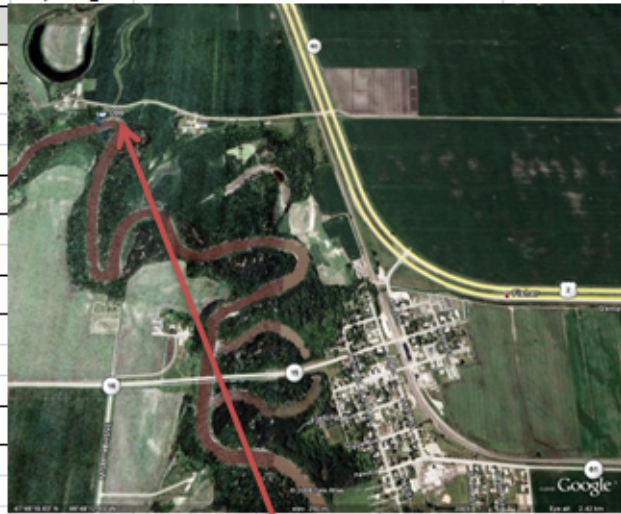
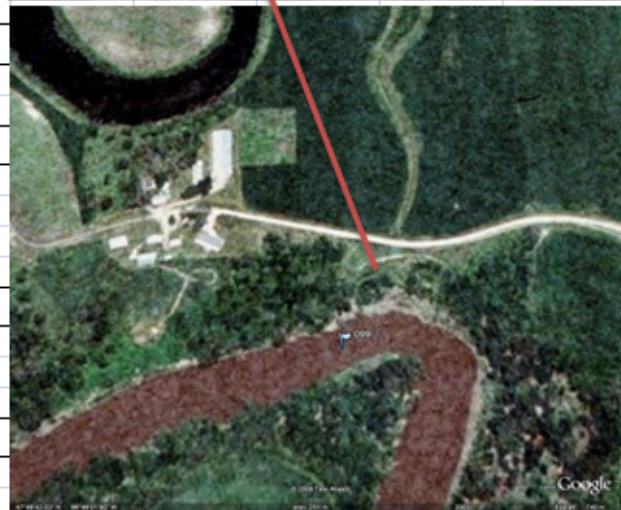
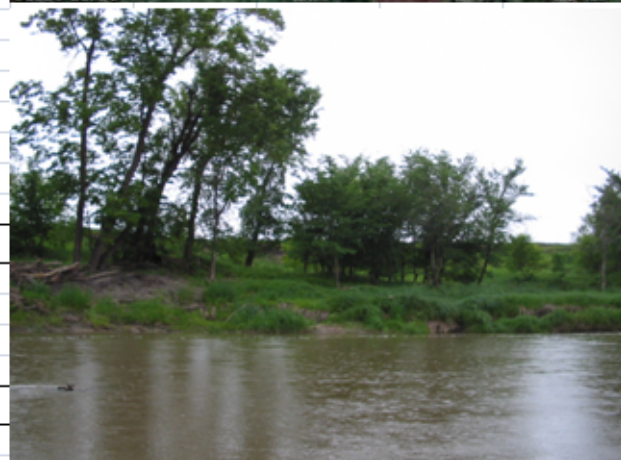
Streambank Erosion Severity Index		Site 99				
Site Description	Tall slumping bank near farm, west of Fisher					
Site visits on	6/9/2007 9:39	lat/long:	N47 48.653 W96 49.012			
OBSERVATION		SCORE				
<b>Condition of bank</b>		<b>1</b>				
Toe and upper bank eroding	5					
Toe undercutting	3					
Toe stable, upper bank eroding	1	x				
<b>Problem Trend</b>		<b>1</b>				
Increasing	5					
Decreasing or stable	1	x				
<b>Side-slope of bank</b>		<b>5</b>				
Vertical, 1:1	5	x

2:1, 3:1	2					
4:1 or flatter	1					
<b>Length of eroded bank</b>		<b>5</b>				
More than 50 ft.	5	x				
20 to 50 ft.	3					
Less than 20 ft.	1					
<b>Depth of river</b>		<b>2</b>				
More than 3 ft.	2	x				
Less than 3 ft.	1					
<b>Soil type or texture</b>		<b>1</b>				
Sand	3					
Gravel	2					
Stratified	2					
Clay, loam	1	x				
<b>Vegetative Cover on bank slope</b>		<b>1</b>				
0-10%	5					
10-50%	3					
50-100%	1	x				
<b>Apparent cause of erosion</b>		<b>2</b>				
Light access traffic	1					
Obstruction in river	1					
Bank seepage	1					
Gully by side channels	1					
Bend in river	2	x				
Wave action (impoundments)	2					
Road-stream crossing;	3					
Moderate access traffic	3					
Heavy access (foot, horse, etc.)	5					
<b>Mean height of eroded bank</b>		<b>7</b>				
More than 20 ft.	7	x				
10 to 20 ft.	5					
5 to 10 ft.	3					
Less than 5 ft.	1					
<b>Current</b>		<b>2</b>				
Fast	2					
Slow	1	x				
<b>Total Points for site</b>		<b>27</b>	<b>Minor</b>

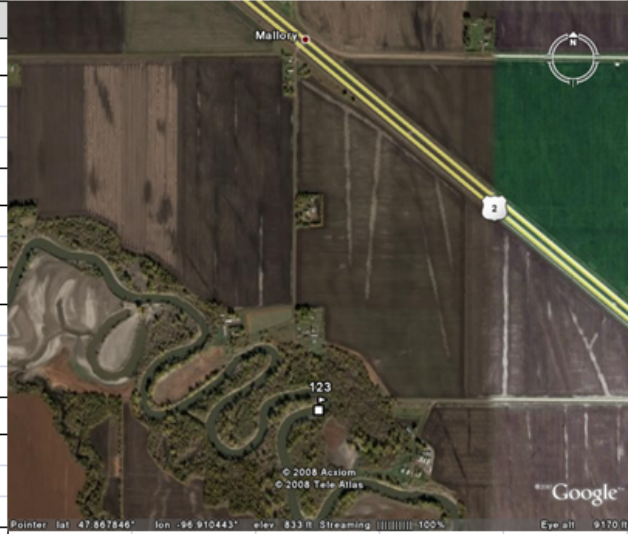
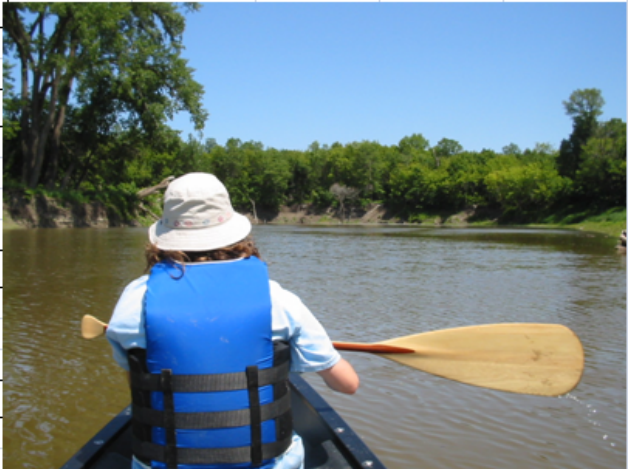
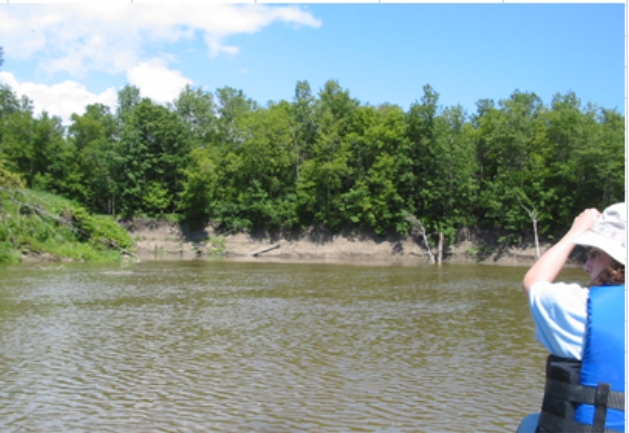
Streambank Erosion Severity Index		
Site Description	Tall eroding bank on an outside bend of the river, south of Mallory	
Site visits on	6/9/2007 13:46	lat/long: N47 51.717 W96 54.621
OBSERVATION	SCORE	
<b>Condition of bank</b>	<b>5</b>	
Toe and upper bank eroding	5	x
Toe undercutting	3	
Toe stable, upper bank eroding	1	
<b>Problem Trend</b>	<b>5</b>	
Increasing	5	x
Decreasing or stable	1	
<b>Side-slope of bank</b>	<b>5</b>	
Vertical, 1:1	5	x

2:1, 3:1	2	
4:1 or flatter	1	
<b>Length of eroded bank</b>	<b>5</b>	
More than 50 ft.	5	x
20 to 50 ft.	3	
Less than 20 ft.	1	
<b>Depth of river</b>	<b>2</b>	
More than 3 ft.	2	x
Less than 3 ft.	1	
<b>Soil type or texture</b>	<b>2</b>	
Sand	3	
Gravel	2	
Stratified	2	
Clay, loam	1	x
<b>Vegetative Cover on bank slope</b>	<b>5</b>	
0-10%	5	x
10-50%	3	
50-100%	1	
<b>Apparent cause of erosion</b>	<b>2</b>	
Light access traffic	1	
Obstruction in river	1	
Bank seepage	1	
Gullying by side channels	1	
Bend in river	2	x
Wave action (impoundments)	2	
Road-stream crossing;	3	
Moderate access traffic	3	
Heavy access (foot, horse, etc.)	5	
<b>Mean height of eroded bank</b>	<b>7</b>	
More than 20 ft.	7	x
10 to 20 ft.	5	
5 to 10 ft.	3	
Less than 5 ft.	1	
<b>Current</b>	<b>1</b>	
Fast	2	
Slow	1	x
<b>Total Points for site</b>	<b>39</b>	<b>Severe</b>
0-30	Minor	
30-36	Moderate	
>36	Severe

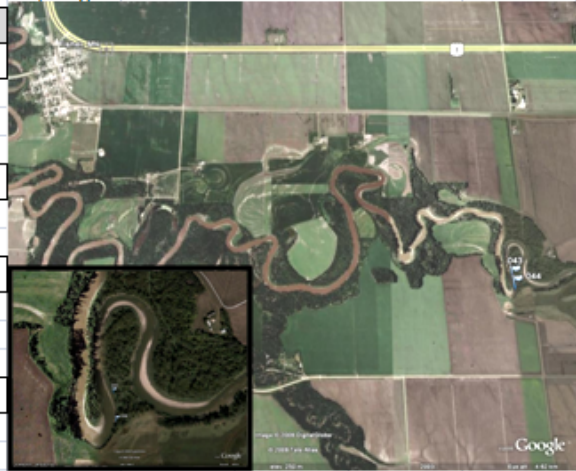
Streambank Erosion Severity Index			Site 43-44	
Site Description		Eroding cutbank 2.6 miles east of Fisher		
Site visits on		6/8/2007 10:02		
		lat/long: N47 46.895 W96 44.469		
OBSERVATION		SCORE		
<b>Condition of bank</b>		<b>5</b>		
Toe and upper bank eroding		5	x	
Toe undercutting		3		
Toe stable, upper bank eroding		1		
<b>Problem Trend</b>		<b>5</b>		
Increasing		5	x	
Decreasing or stable		1		
<b>Side-slope of bank</b>		<b>5</b>		
Vertical, 1:1		5	x

2:1, 3:1		2		
4:1 or flatter		1		
<b>Length of eroded bank</b>		<b>5</b>		
More than 50 ft.		5	x	
20 to 50 ft.		3		
Less than 20 ft.		1		
<b>Depth of river</b>		<b>2</b>		
More than 3 ft.		2	x	
Less than 3 ft.		1		
<b>Soil type or texture</b>		<b>1</b>		
Sand		3		
Gravel		2		
Stratified		2		
Clay, loam		1	x	
<b>Vegetative Cover on bank slope</b>		<b>5</b>		
0-10%		5	x	
10-50%		3		
50-100%		1		
<b>Apparent cause of erosion</b>		<b>2</b>		
Light access traffic		1		
Obstruction in river		1		
Bank seepage		1		
Gully by side channels		1		
Bend in river		2	x	
Wave action (impoundments)		2		
Road-stream crossing; grade/shoulder		3		
Moderate access traffic		3		
Heavy access (foot, horse, etc.) traffic		5		
<b>Mean height of eroded bank</b>		<b>5</b>		
More than 20 ft.		7		
10 to 20 ft.		5	x	
5 to 10 ft.		3		
Less than 5 ft.		1		
<b>Current</b>		<b>2</b>		
Fast		2		
Slow		1	x	
<b>Total Points for site</b>		<b>37</b>		
0-30 Minor		30-36 Moderate		Severe

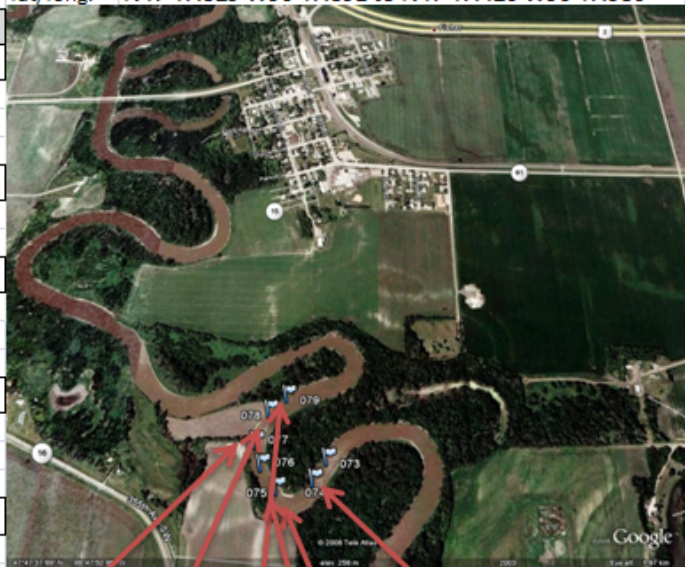
Streambank Erosion Severity Index		Sites 73-79	
Site Description	Cutbank on the Red lake River south of Fisher		
Site visits on	6/8/2007 12:36 - 12:41	lat/long:	N47 47.329 W96 47.891 to N47 47.426 W96 47.986
OBSERVATION		SCORE	
<b>Condition of bank</b>		<b>5</b>	
Toe and upper bank eroding	5	x	
Toe undercutting	3		
Toe stable, upper bank eroding	1		
<b>Problem Trend</b>		<b>5</b>	
Increasing	5	x	
Decreasing or stable	1		
<b>Side-slope of bank</b>		<b>5</b>	
Vertical, 1:1	5	x

2:1, 3:1	2		
4:1 or flatter	1		
<b>Length of eroded bank</b>		<b>5</b>	
More than 50 ft.	5	x	
20 to 50 ft.	3		
Less than 20 ft.	1		
<b>Depth of river</b>		<b>2</b>	
More than 3 ft.	2	x	
Less than 3 ft.	1		
<b>Soil type or texture</b>		<b>1</b>	
Sand	3		
Gravel	2		
Stratified	2		
Clay, loam	1	x	
<b>Vegetative Cover on bank slope</b>		<b>5</b>	
0-10%	5	x	
10-50%	3		
50-100%	1		
<b>Apparent cause of erosion</b>		<b>2</b>	
Light access traffic	1		
Obstruction in river	1		
Bank seepage	1		
Gullyng by side channels	1		
Bend in river	2	x	
Wave action (impoundments)	2		
Road-stream crossing;	3		
Moderate access traffic	3		
Heavy access (foot, horse, etc.)	5		
<b>Mean height of eroded bank</b>		<b>5</b>	
More than 20 ft.	7		
10 to 20 ft.	5	x	
5 to 10 ft.	3		
Less than 5 ft.	1		
<b>Current</b>		<b>2</b>	
Fast	2		
Slow	1	x	
<b>Total Points for site</b>		<b>37</b>	
		<b>Severe</b>	
0-30	Minor	30-36	Moderate
		>36	Severe
<p>Together, these photos show about 1/3 mile of eroding cutbank around the bend of the river</p>

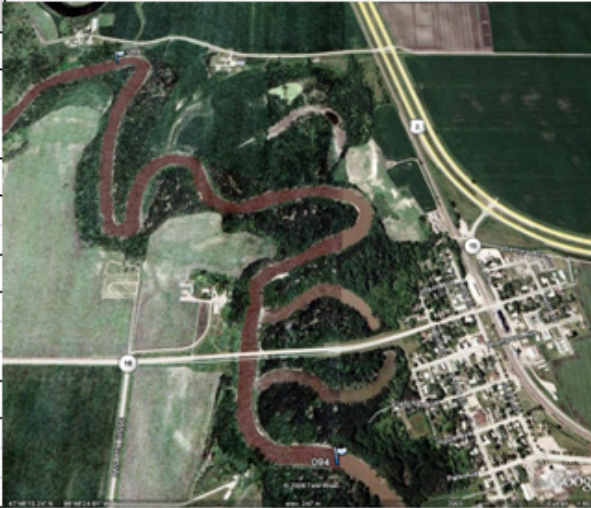
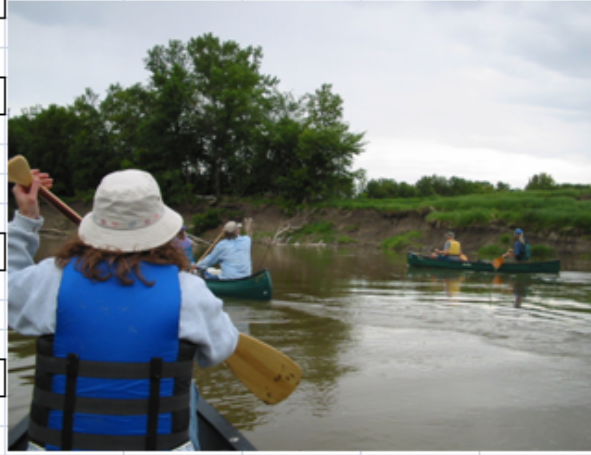
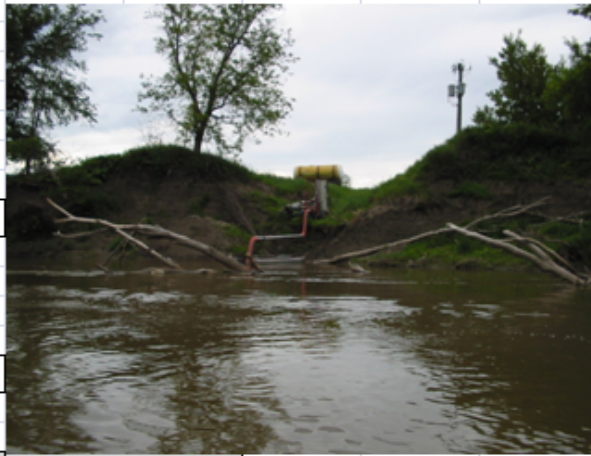
Streambank Erosion Severity Index		Site 95					
Site Description	eroding bank along a field near Fisher						
Site visits on	6/9/2007 9:23		lat/long:				
OBSERVATION		SCORE

<b>Condition of bank</b>		<b>5</b>					
Toe and upper bank eroding	5		x				
Toe undercutting	3						
Toe stable, upper bank eroding	1						
<b>Problem Trend</b>		<b>5</b>					
Increasing	5		x				
Decreasing or stable	1						
<b>Side-slope of bank</b>		<b>5</b>					
Vertical, 1:1	5		x

2:1, 3:1	2						
4:1 or flatter	1						
<b>Length of eroded bank</b>		<b>5</b>					
More than 50 ft.	5		x				
20 to 50 ft.	3						
Less than 20 ft.	1						
<b>Depth of river</b>		<b>2</b>					
More than 3 ft.	2		x				
Less than 3 ft.	1						
<b>Soil type or texture</b>		<b>1</b>					
Sand	3						
Gravel	2						
Stratified	2						
Clay, loam	1		x				
<b>Vegetative Cover on bank slope</b>		<b>5</b>					
0-10%	5		x				
10-50%	3						
50-100%	1						
<b>Apparent cause of erosion</b>		<b>2</b>					
Light access traffic	1						
Obstruction in river	1						
Bank seepage	1						
Gullying by side channels	1						
Bend in river	2		x				
Wave action (impoundments)	2						
Road-stream crossing;	3						
Moderate access traffic	3						
Heavy access (foot, horse, etc.)	5						
<b>Mean height of eroded bank</b>		<b>5</b>					
More than 20 ft.	7						
10 to 20 ft.	5		x				
5 to 10 ft.	3						
Less than 5 ft.	1						
<b>Current</b>		<b>2</b>

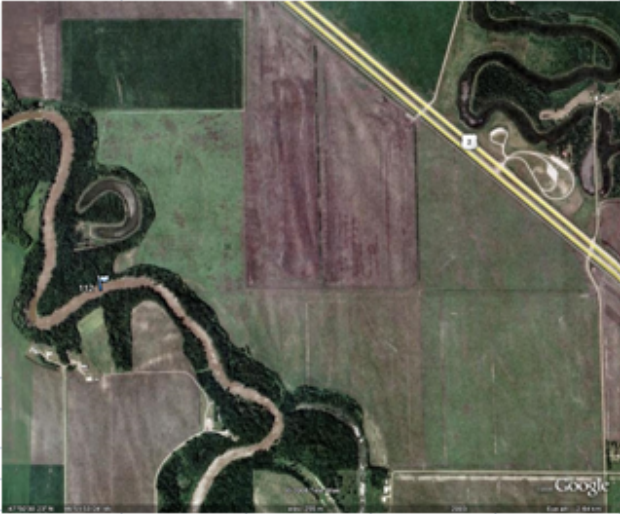
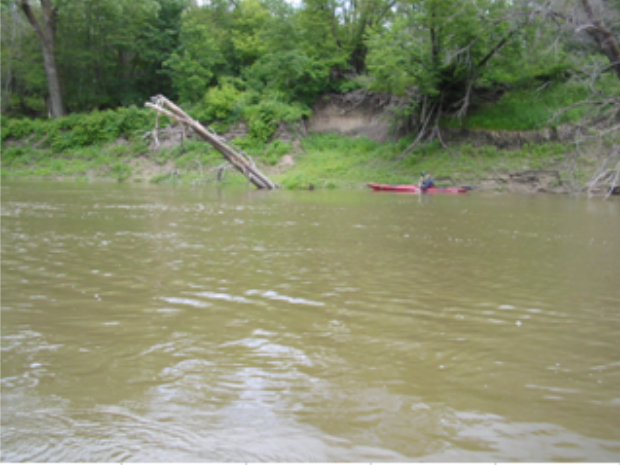
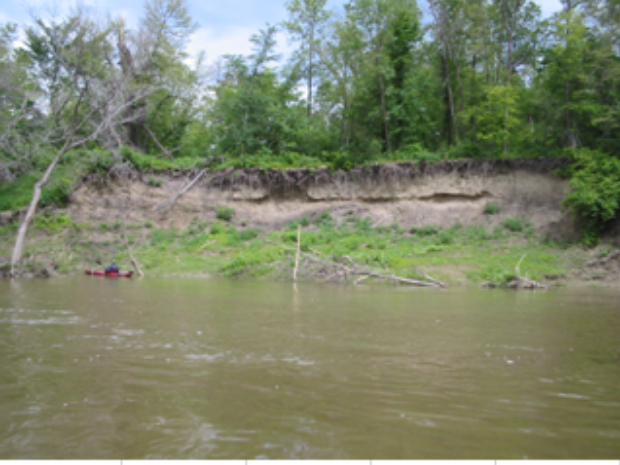
Streambank Erosion Severity Index		Site 112					
Site Description		Tall cutbank, SW of Fisher Rest Area					
Site visits on		6/9/2007 11:28		lat/long:	N47 50.419 W96 52.637		
OBSERVATION		SCORE

<b>Condition of bank</b>		<b>5</b>					
Toe and upper bank eroding	5	x					
Toe undercutting	3						
Toe stable, upper bank eroding	1						
<b>Problem Trend</b>		<b>5</b>					
Increasing	5	x					
Decreasing or stable	1						
<b>Side-slope of bank</b>		<b>5</b>					
Vertical, 1:1	5	x

2:1, 3:1	2						
4:1 or flatter	1						
<b>Length of eroded bank</b>		<b>5</b>					
More than 50 ft.	5	x					
20 to 50 ft.	3						
Less than 20 ft.	1						
<b>Depth of river</b>		<b>2</b>					
More than 3 ft.	2	x					
Less than 3 ft.	1						
<b>Soil type or texture</b>		<b>2</b>					
Sand	3						
Gravel	2						
Stratified	2	x					
Clay, loam	1						
<b>Vegetative Cover on bank slope</b>		<b>3</b>					
0-10%	5						
10-50%	3	x					
50-100%	1						
<b>Apparent cause of erosion</b>		<b>2</b>					
Light access traffic	1						
Obstruction in river	1						
Bank seepage	1						
Gullying by side channels	1						
Bend in river	2	x					
Wave action (impoundments)	2						
Road-stream crossing;	3						
Moderate access traffic	3						
Heavy access (foot, horse, etc.)	5						
<b>Mean height of eroded bank</b>		<b>7</b>					
More than 20 ft.	7	x					
10 to 20 ft.	5						
5 to 10 ft.	3						
Less than 5 ft.	1						
<b>Current</b>		<b>1</b>

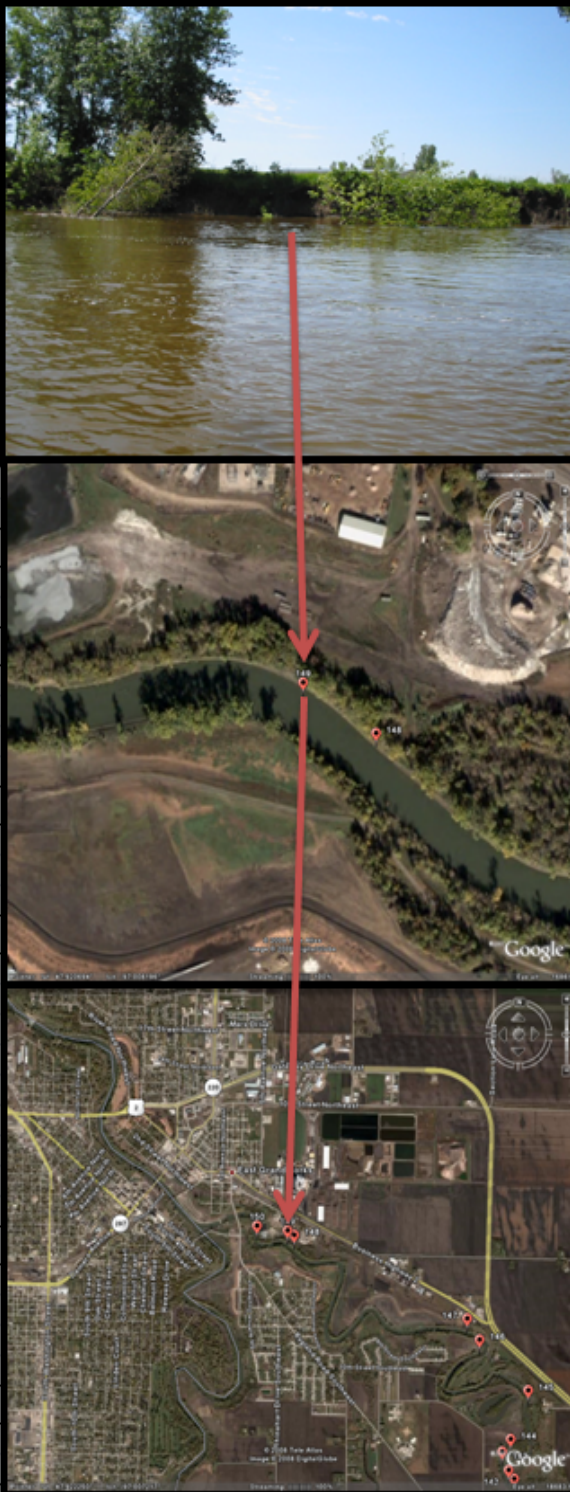
Streambank Erosion Severity Index		
Site Description	Eroding cutbank in East Grand Forks	
Site visits on	6/10/2007	lat/long: N47 55.256 W97 00.483
OBSERVATION	SCORE	
<b>Condition of bank</b>	<b>5</b>	
Toe and upper bank eroding	5	x
Toe undercutting	3	
Toe stable, upper bank erodin	1	
<b>Problem Trend</b>	<b>5</b>	
Increasing	5	x
Decreasing or stable	1	
<b>Side-slope of bank</b>	<b>5</b>	
Vertical, 1:1	5	1:1

2:1, 3:1	2	
4:1 or flatter	1	
<b>Length of eroded bank</b>	<b>5</b>	
More than 50 ft.	5	
20 to 50 ft.	3	x
Less than 20 ft.	1	
<b>Depth of river</b>	<b>2</b>	
More than 3 ft.	2	
Less than 3 ft.	1	x
<b>Soil type or texture</b>	<b>1</b>	
Sand	3	?
Gravel	2	
Stratified	2	
Clay, loam	1	
<b>Vegetative Cover on bank slope</b>	<b>5</b>	
0-10%	5	
10-50%	3	x
50-100%	1	
<b>Apparent cause of erosion</b>	<b>2</b>	
Light access traffic	1	x
Obstruction in river	1	
Bank seepage	1	
Gullyng by side channels	1	
Bend in river	2	x
Wave action (impoundments)	2	
Road-stream crossing;	3	
Moderate access traffic	3	
Heavy access (foot, horse,	5	
<b>Mean height of eroded bank</b>	<b>5</b>	
More than 20 ft.	7	
10 to 20 ft.	5	
5 to 10 ft.	3	x
Less than 5 ft.	1	
<b>Current</b>	<b>1</b>	
Fast	2	x
Slow	1	
<b>Total Points for site</b>	<b>36</b>	
<b>Moderate</b>		
0-30	Minor	30-36
		Moderate
		>36
		Severe

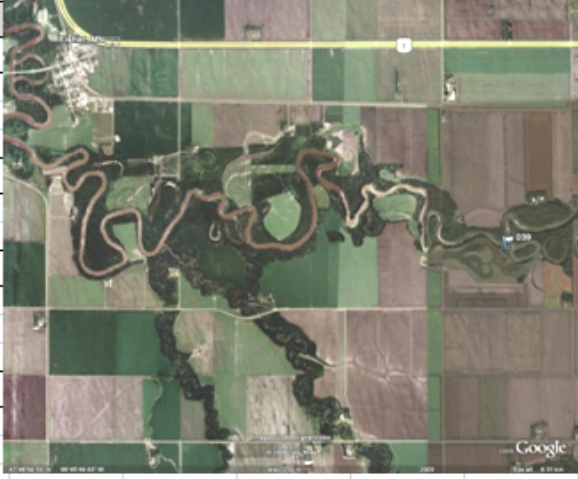
Streambank Erosion Severity Index		Site 39					
Site Description		Eroding streambank 3.3 miles SE of Fisher					
Site visits on		6/8/2007 9:47		lat/long:		N47 46.872 W96 43.725	
OBSERVATION		SCORE

<b>Condition of bank</b>		<b>5</b>					
Toe and upper bank eroding		5	x				
Toe undercutting		3					
Toe stable, upper bank eroding		1					
<b>Problem Trend</b>		<b>5</b>					
Increasing		5	x				
Decreasing or stable		1					
<b>Side-slope of bank</b>		<b>5</b>					
Vertical, 1:1		5	x

2:1, 3:1		2					
4:1 or flatter		1					
<b>Length of eroded bank</b>		<b>5</b>					
More than 50 ft.		5	x				
20 to 50 ft.		3					
Less than 20 ft.		1					
<b>Depth of river</b>		<b>2</b>					
More than 3 ft.		2	x				
Less than 3 ft.		1					
<b>Soil type or texture</b>		<b>1</b>					
Sand		3					
Gravel		2					
Stratified		2					
Clay, loam		1	x				
<b>Vegetative Cover on bank slope</b>		<b>5</b>					
0-10%		5	x				
10-50%		3					
50-100%		1					
<b>Apparent cause of erosion</b>		<b>2</b>					
Light access traffic		1					
Obstruction in river		1					
Bank seepage		1					
Gullying by side channels		1					
Bend in river		2	x				
Wave action (impoundments)		2					
Road-stream crossing; grade/shoulder		3					
Moderate access traffic		3					
Heavy access (foot, horse, etc.) traffic		5					
<b>Mean height of eroded bank</b>		<b>3</b>					
More than 20 ft.		7					
10 to 20 ft.		5					
5 to 10 ft.		3	x				
Less than 5 ft.		1

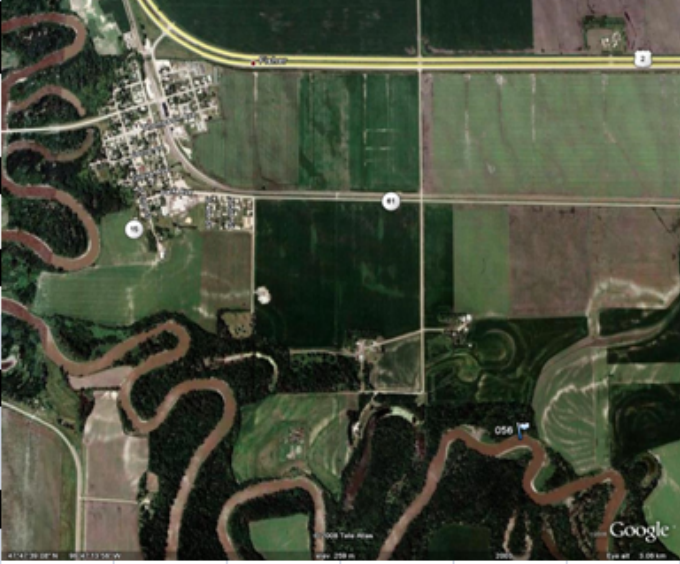
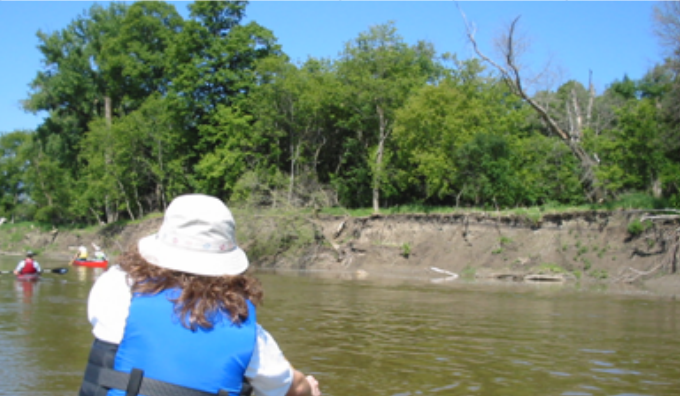
Streambank Erosion Severity Index		Site 56					
Site Description	Cutbank along bend in Red Lake River SE of Fisher						
Site visits on	6/8/2007 10:59		lat/long:	N47 47.241 W96 46.552			
OBSERVATION		SCORE

<b>Condition of bank</b>		<b>5</b>					
Toe and upper bank eroding	5	x					
Toe undercutting	3						
Toe stable, upper bank eroding	1						
<b>Problem Trend</b>		<b>5</b>					
Increasing	5	x					
Decreasing or stable	1						
<b>Side-slope of bank</b>		<b>5</b>					
Vertical, 1:1	5	x

2:1, 3:1	2						
4:1 or flatter	1						
<b>Length of eroded bank</b>		<b>5</b>					
More than 50 ft.	5	x					
20 to 50 ft.	3						
Less than 20 ft.	1						
<b>Depth of river</b>		<b>2</b>					
More than 3 ft.	2	x					
Less than 3 ft.	1						
<b>Soil type or texture</b>		<b>1</b>					
Sand	3						
Gravel	2						
Stratified	2						
Clay, loam	1	x					
<b>Vegetative Cover on bank slope</b>		<b>5</b>					
0-10%	5	x					
10-50%	3						
50-100%	1						
<b>Apparent cause of erosion</b>		<b>2</b>					
Light access traffic	1						
Obstruction in river	1						
Bank seepage	1						
Gullying by side channels	1						
Bend in river	2	x					
Wave action (impoundments)	2						
Road-stream crossing;	3						
Moderate access traffic	3						
Heavy access (foot, horse, etc.)	5						
<b>Mean height of eroded bank</b>		<b>3</b>					
More than 20 ft.	7						
10 to 20 ft.	5						
5 to 10 ft.	3	x					
Less than 5 ft.	1						
<b>Current</b>		<b>2</b>

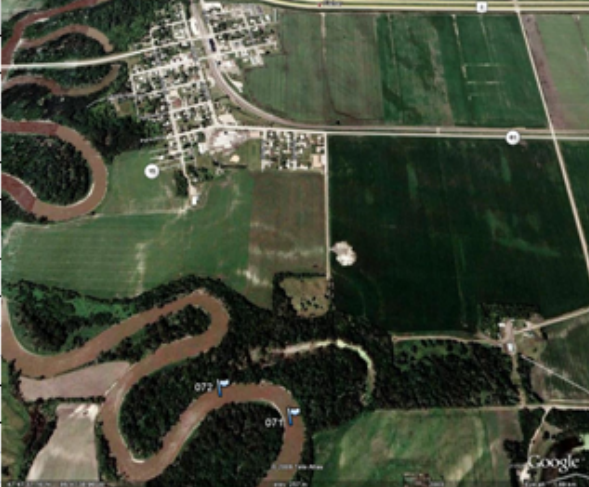
Streambank Erosion Severity Index		Sites 71-72					
Site Description	Cutbank on the Red Lake River south of Fisher						
Site visits on	6/8/2007 12:35		lat/long:	N47 47.376 W96 47.813			
OBSERVATION		SCORE

<b>Condition of bank</b>		<b>5</b>					
Toe and upper bank eroding	5	x					
Toe undercutting	3						
Toe stable, upper bank eroding	1						
<b>Problem Trend</b>		<b>5</b>					
Increasing	5	x					
Decreasing or stable	1						
<b>Side-slope of bank</b>		<b>5</b>					
Vertical, 1:1	5	x

2:1, 3:1	2						
4:1 or flatter	1						
<b>Length of eroded bank</b>		<b>5</b>					
More than 50 ft.	5	x					
20 to 50 ft.	3						
Less than 20 ft.	1						
<b>Depth of river</b>		<b>2</b>					
More than 3 ft.	2	x					
Less than 3 ft.	1						
<b>Soil type or texture</b>		<b>1</b>					
Sand	3						
Gravel	2						
Stratified	2						
Clay, loam	1	x					
<b>Vegetative Cover on bank slope</b>		<b>5</b>					
0-10%	5	x					
10-50%	3						
50-100%	1						
<b>Apparent cause of erosion</b>		<b>2</b>					
Light access traffic	1						
Obstruction in river	1						
Bank seepage	1						
Gullying by side channels	1						
Bend in river	2	x					
Wave action (impoundments)	2						
Road-stream crossing;	3						
Moderate access traffic	3						
Heavy access (foot, horse, etc.)	5						
<b>Mean height of eroded bank</b>		<b>3</b>					
More than 20 ft.	7						
10 to 20 ft.	5						
5 to 10 ft.	3	x					
Less than 5 ft.	1						
<b>Current</b>		<b>2</b>

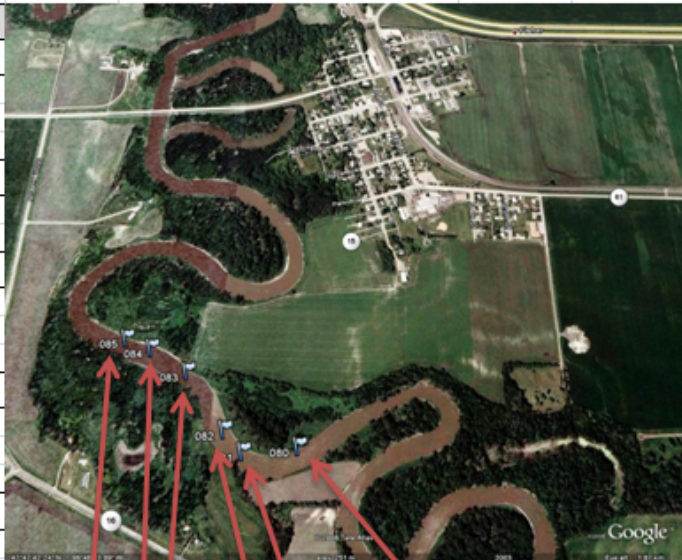
Streambank Erosion Severity Index		Sites 80-85	
Site Description	Very long stretch of eroding river bank south of Fisher		
Site visits on	6/8/2007 12:56	lat/long:	N47 47.769 W96 48.510
OBSERVATION		SCORE	
<b>Condition of bank</b>		<b>5</b>	
Toe and upper bank eroding	5	x	
Toe undercutting	3		
Toe stable, upper bank eroding	1		
<b>Problem Trend</b>		<b>5</b>	
Increasing	5	x	
Decreasing or stable	1		
<b>Side-slope of bank</b>		<b>5</b>	
Vertical, 1:1	5	x

2:1, 3:1	2		
4:1 or flatter	1		
<b>Length of eroded bank</b>		<b>5</b>	
More than 50 ft.	5	x	
20 to 50 ft.	3		
Less than 20 ft.	1		
<b>Depth of river</b>		<b>2</b>	
More than 3 ft.	2	x	
Less than 3 ft.	1		
<b>Soil type or texture</b>		<b>1</b>	
Sand	3		
Gravel	2		
Stratified	2		
Clay, loam	1	x	
<b>Vegetative Cover on bank slope</b>		<b>3</b>	
0-10%	5		
10-50%	3	x	
50-100%	1		
<b>Apparent cause of erosion</b>		<b>2</b>	
Light access traffic	1		
Obstruction in river	1		
Bank seepage	1		
Gullying by side channels	1		
Bend in river	2	x	
Wave action (impoundments)	2		
Road-stream crossing;	3		
Moderate access traffic	3		
Heavy access (foot, horse, etc.)	5		
<b>Mean height of eroded bank</b>		<b>5</b>	
More than 20 ft.	7		
10 to 20 ft.	5	x	
5 to 10 ft.	3		
Less than 5 ft.	1		
<b>Current</b>		<b>2</b>	
Fast	2		
Slow	1	x	
<b>Total Points for site</b>		<b>35</b>	<b>Moderate</b>
0-30	Minor	30-36	Moderate
		>36	Severe
The eroded areas in this group alone occur across a .5 mile length of stream. These sites combine with sites 86 through 94 to form a nearly continuous 1.3 mile stretch of river with eroding banks.

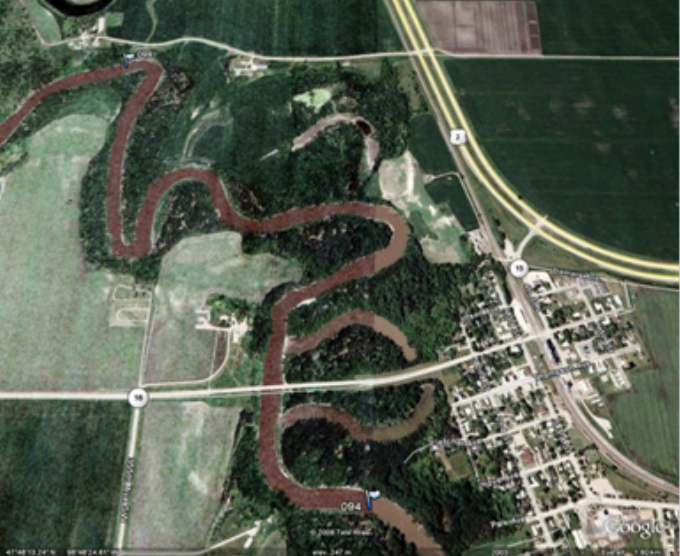
Streambank Erosion Severity Index		Site 97							
Site Description		Eroding bank on outside of bend in river near Fisher and CSAH 15 crossing							
Site visits on		6/9/2007 9:26		lat/long:					
OBSERVATION		SCORE

<b>Condition of bank</b>		<b>5</b>							
Toe and upper bank eroding		5	x						
Toe undercutting		3							
Toe stable, upper bank eroding		1							
<b>Problem Trend</b>		<b>5</b>							
Increasing		5	x						
Decreasing or stable		1							
<b>Side-slope of bank</b>		<b>5</b>							
Vertical, 1:1		5	x

2:1, 3:1		2							
4:1 or flatter		1							
<b>Length of eroded bank</b>		<b>5</b>							
More than 50 ft.		5	x						
20 to 50 ft.		3							
Less than 20 ft.		1							
<b>Depth of river</b>		<b>2</b>							
More than 3 ft.		2	x						
Less than 3 ft.		1							
<b>Soil type or texture</b>		<b>1</b>							
Sand		3							
Gravel		2							
Stratified		2							
Clay, loam		1	x						
<b>Vegetative Cover on bank slope</b>		<b>3</b>							
0-10%		5							
10-50%		3	x						
50-100%		1							
<b>Apparent cause of erosion</b>		<b>2</b>							
Light access traffic		1							
Obstruction in river		1							
Bank seepage		1							
Gullyng by side channels		1							
Bend in river		2	x						
Wave action (impoundments)		2							
Road-stream crossing;		3							
Moderate access traffic		3							
Heavy access (foot, horse, etc.)		5							
<b>Mean height of eroded bank</b>		<b>5</b>							
More than 20 ft.		7							
10 to 20 ft.		5	x						
5 to 10 ft.		3

Less than 5 ft.		1							
<b>Current</b>		<b>2</b>							
Fast		2							
Slow		1	x						
<b>Total Points for site</b>		<b>35</b>		<b>Moderate</b>					
0-30	Minor	30-36	Moderate	>36	Severe				
GPS wasn't getting correct readings for sites 95-98

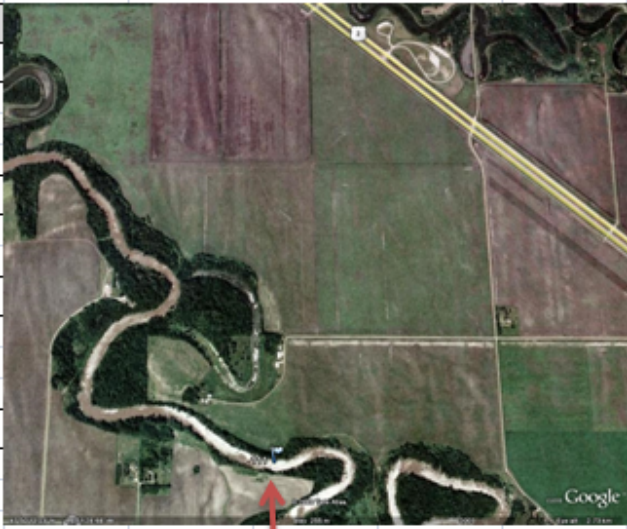
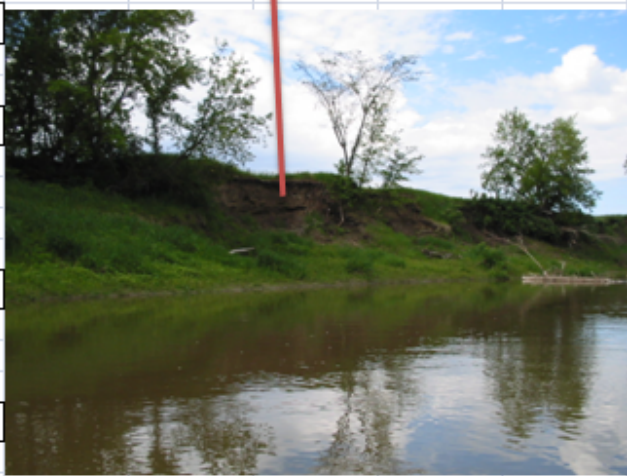
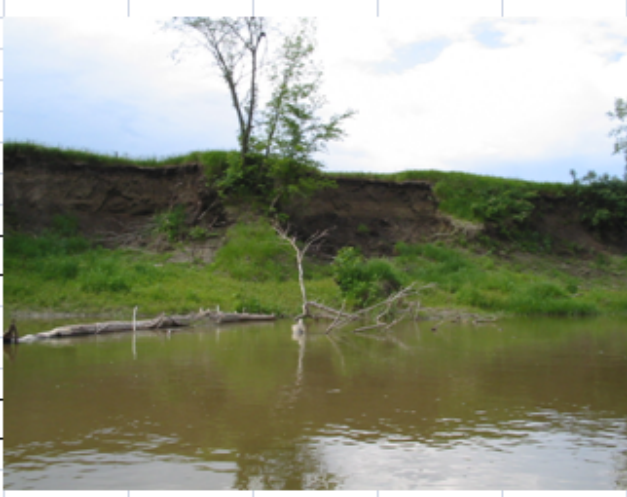
Streambank Erosion Severity Index		Site 111	
Site Description	Eroding bank along field S of Fisher Rest Stop		
Site visits on	6/9/2007 11:03	lat/long:	N47 49.693 W96 51.624
OBSERVATION		SCORE	
<b>Condition of bank</b>		<b>5</b>	
Toe and upper bank eroding	5	x	
Toe undercutting	3		
Toe stable, upper bank eroding	1		
<b>Problem Trend</b>		<b>5</b>	
Increasing	5	x	
Decreasing or stable	1		
<b>Side-slope of bank</b>		<b>5</b>	
Vertical, 1:1	5	x

2:1, 3:1	2		
4:1 or flatter	1		
<b>Length of eroded bank</b>		<b>5</b>	
More than 50 ft.	5	x	
20 to 50 ft.	3		
Less than 20 ft.	1		
<b>Depth of river</b>		<b>2</b>	
More than 3 ft.	2	x	
Less than 3 ft.	1		
<b>Soil type or texture</b>		<b>2</b>	
Sand	3		
Gravel	2		
Stratified	2	x	
Clay, loam	1		
<b>Vegetative Cover on bank slope</b>		<b>3</b>	
0-10%	5		
10-50%	3	x	
50-100%	1		
<b>Apparent cause of erosion</b>		<b>2</b>	
Light access traffic	1		
Obstruction in river	1		
Bank seepage	1		
Gully by side channels	1		
Bend in river	2	x	
Wave action (impoundments)	2		
Road-stream crossing;	3		
Moderate access traffic	3		
Heavy access (foot, horse, etc.)	5		
<b>Mean height of eroded bank</b>		<b>5</b>	
More than 20 ft.	7		
10 to 20 ft.	5	x	
5 to 10 ft.	3		
Less than 5 ft.	1		
<b>Current</b>		<b>1</b>	
Fast	2		
Slow	1	x	
<b>Total Points for site</b>		<b>35</b>	<b>Moderate</b>
0-30	Minor	30-36	Moderate
		>36	Severe
This spot is eroding the most where the plowed field is nearer to the river

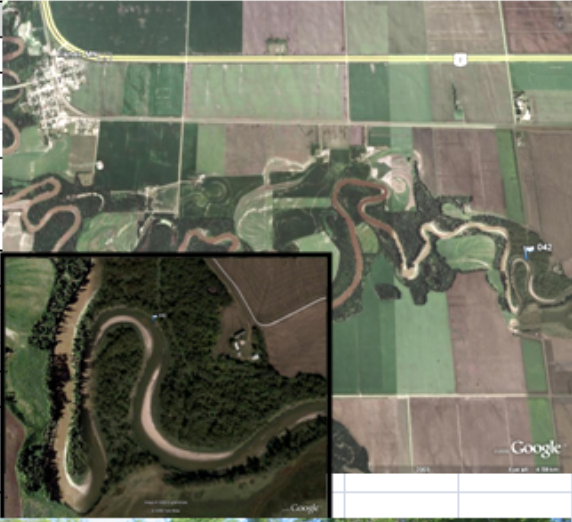
Streambank Erosion Severity Index		Site 42					
Site Description		Eroding streambank 2.8 miles east of Fisher					
Site visits on		6/8/2007 9:57		lat/long:		N47 47.114 W96 44.386	
OBSERVATION		SCORE

<b>Condition of bank</b>		<b>5</b>					
Toe and upper bank eroding		5	x

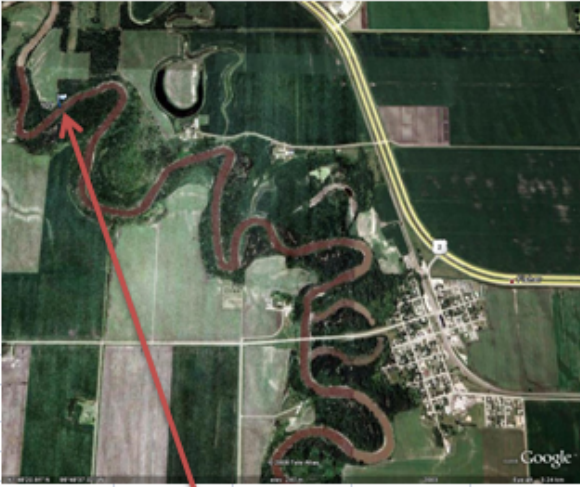
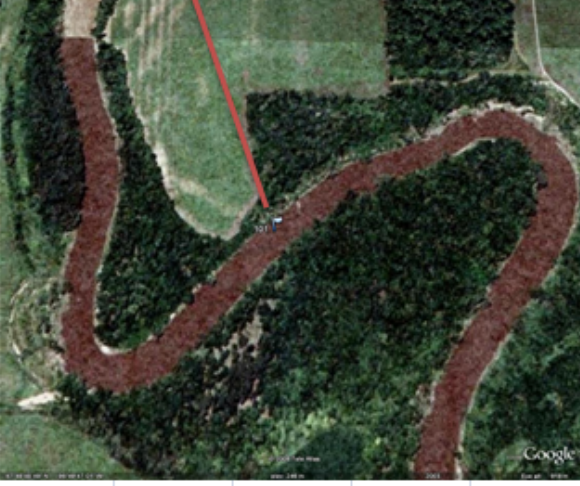
Streambank Erosion Severity Index		Site 101							
Site Description		Eroding bank NW of Fisher		lat/long:		N47 48.813 W96 49.803			
Site visits on		6/9/2007 9:56							
OBSERVATION		SCORE

<b>Condition of bank</b>		<b>5</b>							
Toe and upper bank eroding		5	x						
Toe undercutting		3							
Toe stable, upper bank eroding		1							
<b>Problem Trend</b>		<b>5</b>							
Increasing		5	x						
Decreasing or stable		1							
<b>Side-slope of bank</b>		<b>5</b>							
Vertical, 1:1		5	x

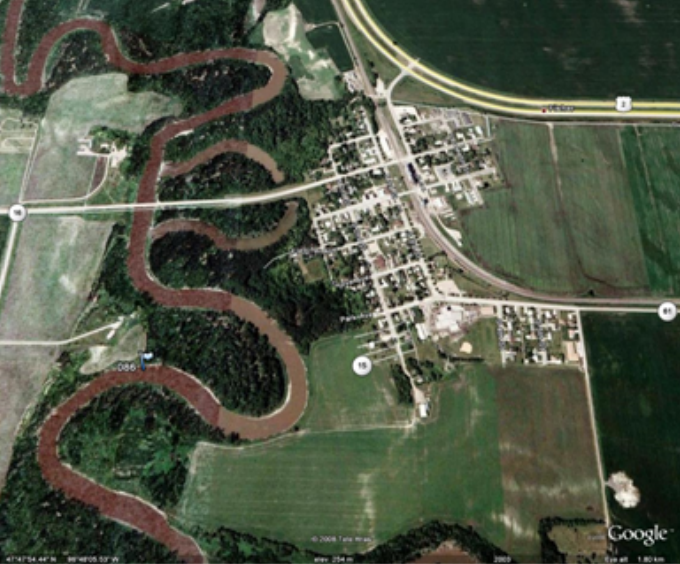
Streambank Erosion Severity Index		Site 86					
Site Description	Cutbank along bend in Red Lake Rier near Fisher						
Site visits on	6/8/2007 12:56	lat/long:	N47 47.769 W96 48.510				
OBSERVATION		SCORE

<b>Condition of bank</b>		<b>3</b>					
Toe and upper bank eroding	5						
Toe undercutting	3	x					
Toe stable, upper bank eroding	1						
<b>Problem Trend</b>		<b>1</b>					
Increasing	5						
Decreasing or stable	1	x					
<b>Side-slope of bank</b>		<b>5</b>					
Vertical, 1:1	5	x

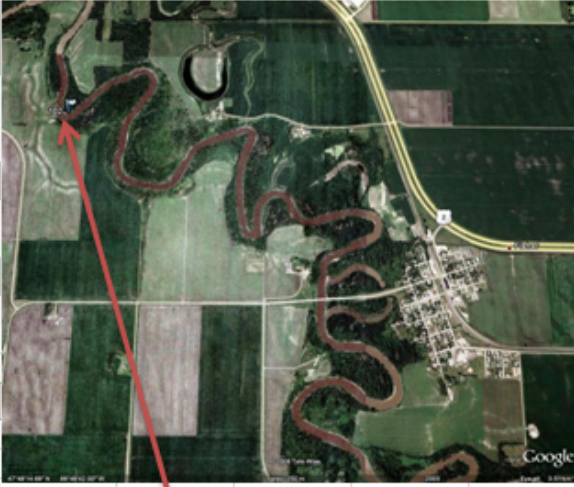
Streambank Erosion Severity Index		Site 102									
Site Description		Slumping streambank along a bend in the river NW of Fisher									
Site visits on		6/9/2007 9:58		lat/long:		N47 48.726 W96 49.943					
OBSERVATION		SCORE

<b>Condition of bank</b>		<b>1</b>									
Toe and upper bank eroding		5									
Toe undercutting		3									
Toe stable, upper bank eroding		1								x	
<b>Problem Trend</b>		<b>1</b>									
Increasing		5									
Decreasing or stable		1								x	
<b>Side-slope of bank</b>		<b>5</b>									
Vertical, 1:1		5								x
