## Geomorphic and Hydrologic Influences on TMDL Impairments in the Grand Marais Creek Watershed (AUID 09020306)

May 30, 2014

Emmons & Olivier Resources, Inc. Chris Lenhart, PhD. Ecological Engineering Group, BBE Department - University of Minnesota

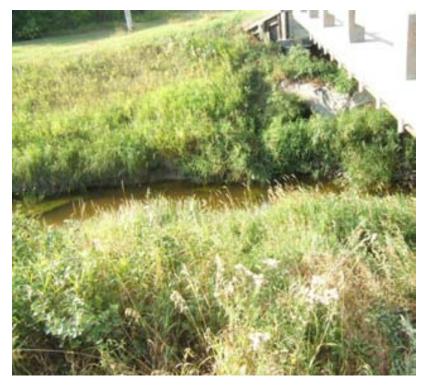
Channel Type	Ditched (E6)
Est. Bankfull El.	809'
Channel Slope	0.015%
Sinuosity	1.0
Bankfull Width	27.6′
W/D Ratio	10.7
Material (D50)	0.06 mm
BEHI Rating	Moderate
NBS Rating	Moderate
MADRAS Score	15
Pfankuch Score	118 (Poor)

**NOTES & OBSERVATIONS:** As with many ditched systems, low instream habitat was observed throughout the study reach. This particular site was near dry during the assessment. A few stream features indicate that a small "E" channel is beginning to develop between the ditch banks.

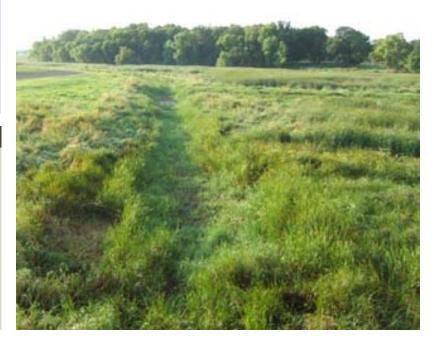
Channel Type	E6
Est. Bankfull El.	805.1'
Channel Slope	0.056%
Sinuosity	1.5
Bankfull Width	17.0′
W/D Ratio	17.2
Material (D50)	0.06 mm
BEHI Rating	Low
NBS Rating	Low
MADRAS Score	10
Pfankuch Score	61 (Good)

**NOTES & OBSERVATIONS:** This reach contains an "E" channel winding through a wide, low gradient historic channel. An accessible floodplain and well-vegetated stream banks limit bank erosion potential. This site was dry during the assessment.

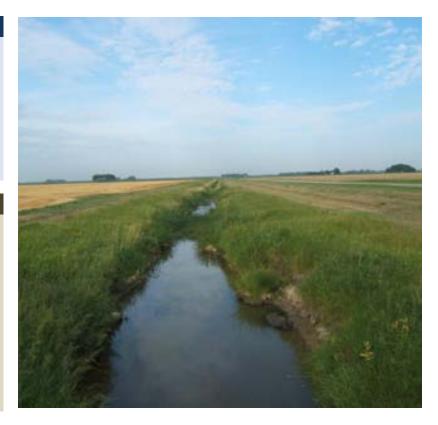
AUID	09020306-515
Stream/River	CD2
County	Polk
Drainage Area	90.8 sq. mi.
Date	8/26/13
Field/Site ID	3
<b>Bio Monitoring</b>	12RD100
MSHA Score	31

Channel Type	Ditched (Bc)
Est. Bankfull El.	827.0'
Channel Slope	0.009%
Sinuosity	1.0
Bankfull Width	19.9'
W/D Ratio	5.5
Material (D50)	0.06 mm
<b>BEHI Rating</b>	Moderate
NBS Rating	Low
MADRAS Score	15
Pfankuch Score	125 (Poor)

**NOTES & OBSERVATIONS:** Similar to Site 1, this ditch contains dense vegetation that protects the channel and banks during flood events. Very little instream habitat exists in this ditch (i.e. lack of defined riffles, pools, no instream woody debris).

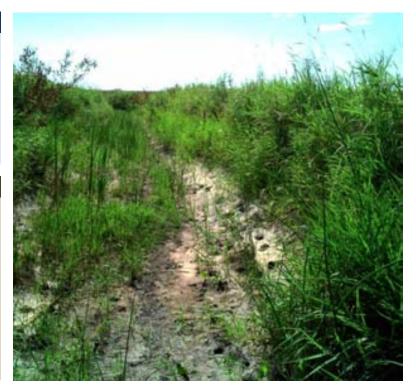
REACH INFORMATION	
AUID	09020306-509
Stream/River	Brandt Creek
County	Polk
Drainage Area	23.3 sq. mi.
Date	8/27/13
Field/Site ID	5
<b>Bio Monitoring</b>	No
MSHA Score	N/A

Channel Type	E5
Est. Bankfull El.	886.6'
Channel Slope	0.07%
Sinuosity	1.3
Bankfull Width	21.1′
W/D Ratio	11.3
Material (D50)	0.08 mm
BEHI Rating	Low/Moderate
NBS Rating	Moderate
MADRAS Score	N/A
Pfankuch Score	81 (Fair)

**NOTES & OBSERVATIONS:** This study site occurs within the restored reach of Brandt Creek. Two beaver dams were documented within the reach, but the site was dry during the assessment. Limited pool and riffle structure was observed at this site.

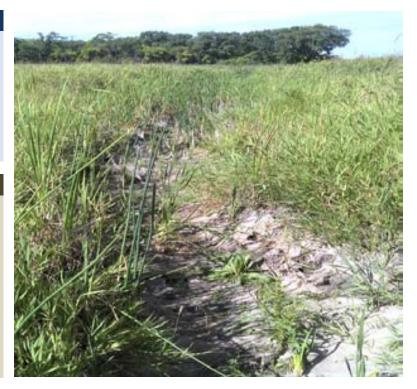
AUID	09020306-509
Stream/River	Brandt Creek
County	Polk
Drainage Area	19.4 sq. mi.
Date	8/27/13
Field/Site ID	6
<b>Bio Monitoring</b>	No
MSHA Score	34

Channel Type	E5
Est. Bankfull El.	895.0′
Channel Slope	0.13%
Sinuosity	1.55
Bankfull Width	14.6'
W/D Ratio	8.4
Material (D50)	0.08 mm
BEHI Rating	Low/Moderate
NBS Rating	Low/Very Low
MADRAS Score	13
Pfankuch Score	75 (Good)

**NOTES & OBSERVATIONS:** This reach is located immediately downstream of the impoundment in the restored segment of Brandt Creek. Similar to Site 5, the lack of water greatly affects available instream habitat for aquatic organisms.

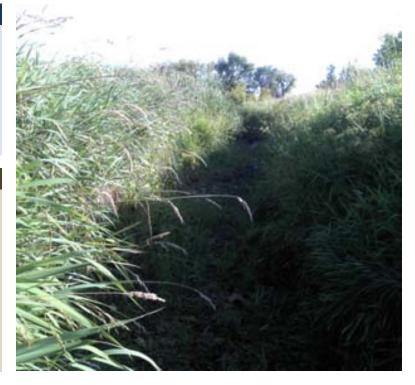
REACH INFORMATION	
AUID	09020306-509
Stream/River	Brandt Creek
County	Polk
Drainage Area	16.5 sq. mi.
Date	8/28/13
Field/Site ID	7
<b>Bio Monitoring</b>	No
MSHA Score	N/A

С
918.0′
0.22%
1.38
25.9′
28.8
0.06 mm
Very Low
Very Low
N/A
62 (Good)

**NOTES & OBSERVATIONS:** This reach is located immediately upstream of the impoundment. The dense vegetation in this reach protects the banks from channel and bank erosion.

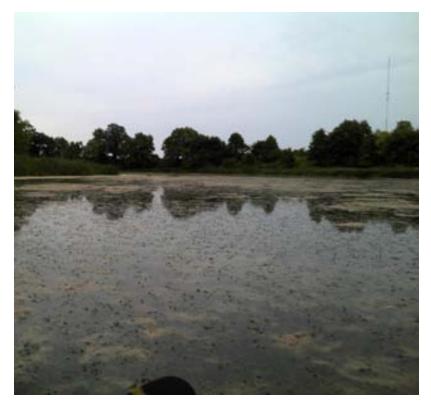
REACH INFORMATION	
AUID	09020306-507
Stream/River	Grand Marais
	Creek
County	Polk
Drainage Area	27.2 sq. mi.
Date	8/26/13
Field/Site ID	9
<b>Bio Monitoring</b>	No
MSHA Score	30

Channel Type	N/A
Est. Bankfull El.	831.0'
Channel Slope	N/A
Sinuosity	3.02
Bankfull Width	N/A
W/D Ratio	N/A
Material (D50)	0.06 mm
BEHI Rating	Very Low
NBS Rating	Very Low
MADRAS Score	19
Pfankuch Score	N/A

**NOTES & OBSERVATIONS:** This reach is located near the headwaters of Grand Marais Creek. The study reach consisted of a sinuous, shallow, flow-through cattail marsh with no identifiable bankfull indicators; therefore, classification could not be completed for this site.

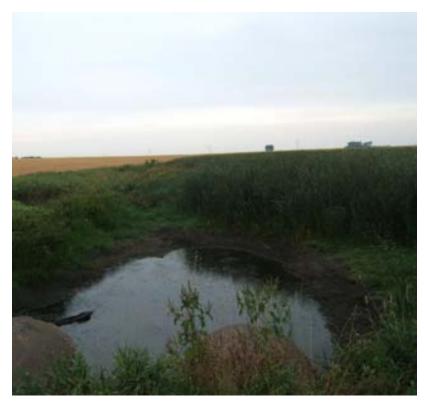
REACH INFORMATION	
AUID	09020306-507
Stream/River	Grand Marais Crk
County	Polk
Drainage Area	51.5 sq. mi.
Date	8/26/13
Field/Site ID	10
Bio Monitoring MSHA Score	No 21

N/A
N/A
N/A
1.8
N/A
N/A
0.06 mm
Very Low
Very Low
1
94 (Fair)

**NOTES & OBSERVATIONS:** Similar to Site 9, this reach consisted of a shallow, flow-through cattail marsh with no identifiable bankfull indicators; therefore, classification could not be completed for this site. The shallow-sloped, well-vegetated banks limit the erosion potential in this reach.

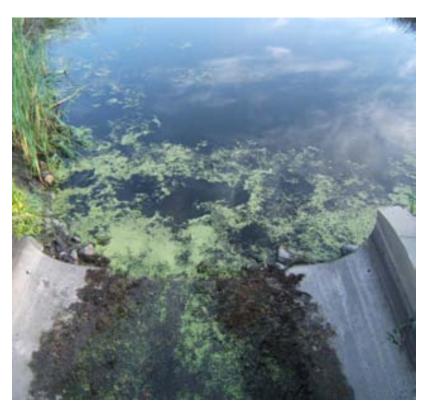
09020306-507
Grand Marais
Creek
Polk
61.4 sq. mi.
8/26/13
11
No
17

Channel Type	E6
Est. Bankfull El.	821.6′
Channel Slope	0.031%
Sinuosity	1.2
Bankfull Width	11.5′
W/D Ratio	18.8
Material (D50)	0.06 mm
BEHI Rating	Low
NBS Rating	Low
MADRAS Score	1
Pfankuch Score	79 (Fair)

**NOTES & OBSERVATIONS:** Similar to Site 2, a small "E" channel is developing within the wide, low-gradient historic channel. An accessible floodplain and dense vegetation protect the stream banks during flood events. This site was dry during the assessment and little instream habitat was observed.

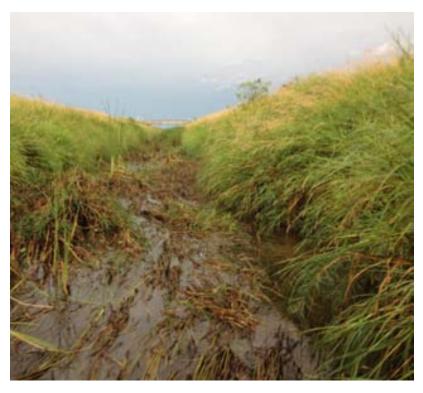
Channel Type	Ditched (B6c)
Est. Bankfull El.	806.9'
Channel Slope	0.073%
Sinuosity	1.0
Bankfull Width	30.1'
W/D Ratio	9.5
Material (D50)	0.06 mm
BEHI Rating	Moderate
NBS Rating	Low
MADRAS Score	15
Pfankuch Score	69 (Good)

**NOTES & OBSERVATIONS:** A small "E" channel is beginning to develop between the ditch banks. Similar to other ditched systems, low instream habitat was observed throughout the study reach. Separate BEHI analyses were completed for two eroded banks measuring 71-feet long & 115-feet long and scored Moderate & High respectively.

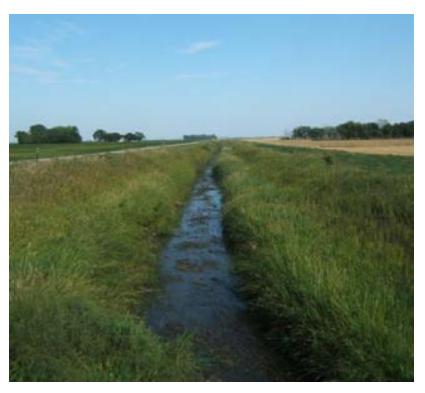
09020306-517
JD 75
Polk
64.5 sq. mi.
8/28/13
16
12RD087
27

Channel Type	Ditched (E6)
Est. Bankfull El.	834.3'
Channel Slope	0.12%
Sinuosity	1.0
Bankfull Width	17.6′
W/D Ratio	10
Material (D50)	0.06 mm
BEHI Rating	Low
NBS Rating	Moderate
MADRAS Score	15
Pfankuch Score	62 (Good)

**NOTES & OBSERVATIONS**: A small "E" channel is beginning to develop within the ditch banks. A separate BEHI analysis was completed for a 156-foot long disturbed bank and scored Moderate. Very little instream habitat was observed in this ditch system.

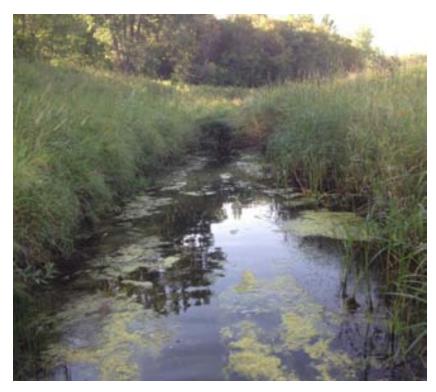
#### **REACH INFORMATION** AUID 09020306-517 Stream/River JD 75 County Pennington **Drainage Area** 12.8 sq. mi. Date 8/27/13 Field/Site ID 19 **Bio Monitoring** 07RD023 **MSHA Score** N/A

Channel Type	Ditched (E6)
Est. Bankfull El.	992.6′
Channel Slope	0.26%
Sinuosity	1.0
Bankfull Width	11.7′
W/D Ratio	10.4
Material (D50)	20.0 mm
BEHI Rating	Moderate
NBS Rating	Low
MADRAS Score	N/A
Pfankuch Score	58 (Good)

**NOTES & OBSERVATIONS**: Unlike most sites assessed in the watershed, this reach contains a well-defined riffle/ pool sequence with a coarse substrate. An "E4" channel is developing between the ditch banks and contains a small bankfull bench. This stream occurs within the beach ridge.

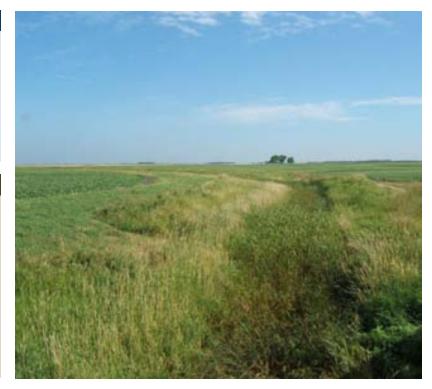
REACH INFORMATION	
AUID	09020306-518
Stream/River	CD7
County	Polk
Drainage Area	18.2 sq. mi.
Date	8/28/13
Field/Site ID	20
<b>Bio Monitoring</b>	No
MSHA Score	18

Channel Type	Ditched (B6c)
Est. Bankfull El.	829.6′
Channel Slope	0.13%
Sinuosity	1.0
Bankfull Width	18.4′
W/D Ratio	10.1
Material (D50)	0.06 mm
BEHI Rating	Low
NBS Rating	Low
MADRAS Score	15
Pfankuch Score	57 (Good)

**NOTES & OBSERVATIONS:** This site was dry during the assessment and very little instream habitat was observed. A separate BEHI analysis was completed for a 40-foot long disturbed bank and was scored Moderate.

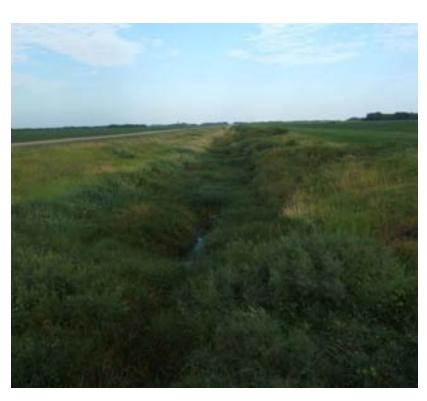
REACH INFORMATION	
AUID	09020306-519
Stream/River	JD 1
County	Polk
Drainage Area	57.7 sq. mi.
Date	8/29/13
Field/Site ID	21
<b>Bio Monitoring</b>	No
MSHA Score	18

Channel Type	Ditched (B6c)
Est. Bankfull El.	803.4′
Channel Slope	0.086%
Sinuosity	1.0
Bankfull Width	44.4'
W/D Ratio	20.0
Material (D50)	0.06 mm
BEHI Rating	Low
NBS Rating	Moderate
MADRAS Score	15
Pfankuch Score	53 (Good)

**NOTES & OBSERVATIONS:** As with of most ditched systems, typical stream features (i.e. riffles, pools, point bars, bankfull bench) were not observed in this ditch. The site was dry during the assessment.

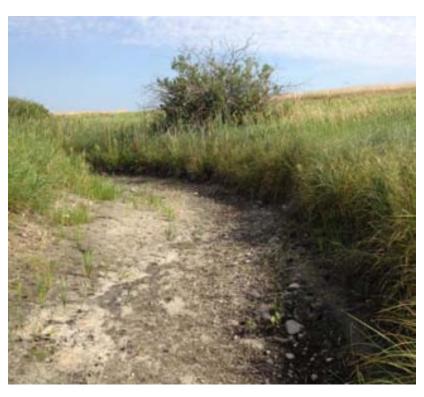
Channel Type	C4
Est. Bankfull El.	938.0'
Channel Slope	0.11%
Sinuosity	1.3
Bankfull Width	16.2'
W/D Ratio	16.3
Material (D50)	23.0 mm
BEHI Rating	Low
NBS Rating	Moderate
MADRAS Score	11
Pfankuch Score	56 (Good)

**NOTES & OBSERVATIONS**: This reach occurs below a control structure for an impoundment. The stream channel appears to have been recently modified as indicated by excavator marks on the banks. This stream is located within the beach ridge and contains a gravel substrate. Separate BEHI analyses were completed for two eroded banks measuring 100-feet long and 30-feet long and scored Moderate and High respectively.
