# Red Lake Watershed District Annual Report

**2004**

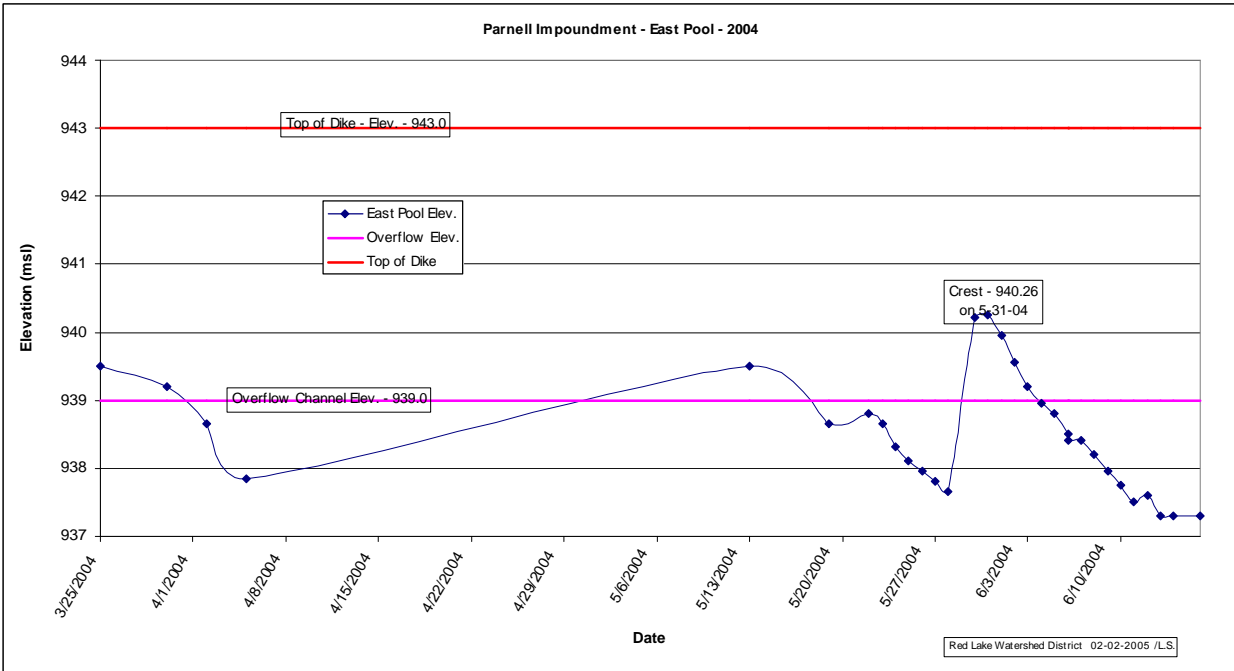
In mid-May, 2.53 inches of rain fell but this did not cause enough runoff to perform any gate operation. On May 29, 2.20 inches of rain fell near the site and reports of 4+ inches upstream of the impoundment. This precipitation occurred when soil conditions were still saturated and generated significant runoff. The control gates were closed and flood waters were stored in the impoundment and released slowly when downstream water levels receded. The stored water for each pool can easily be seen on the graphs below.

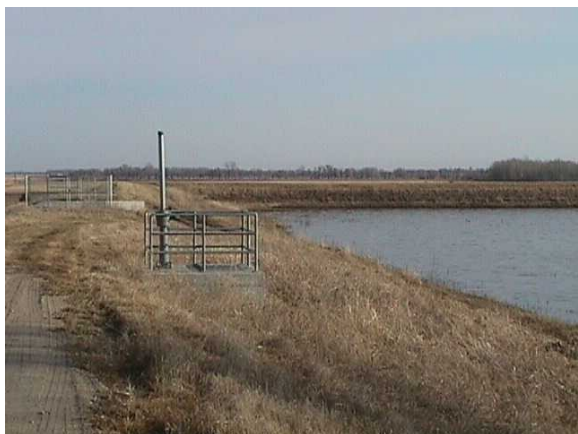
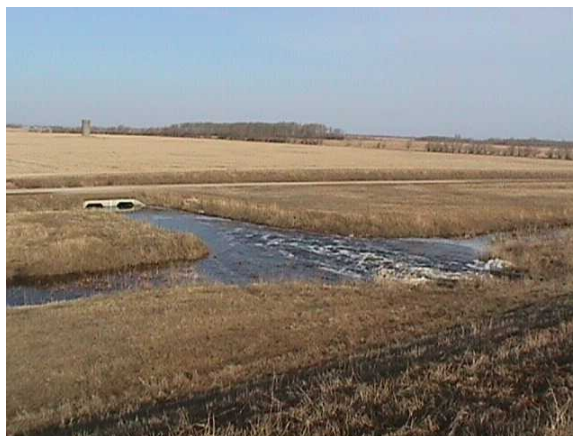
Parnell Impoundment - West Pool Control Structure  
Outlet into Polk County Ditch #126

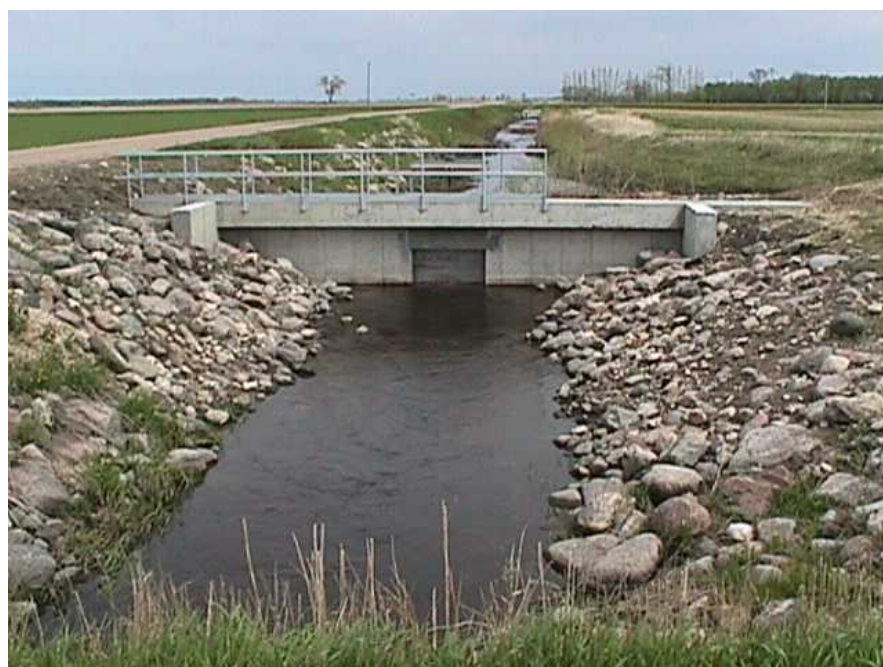
Parnell Impoundment South Outlet Control Structure  
Judicial Ditch #60 Weir Operable Gate

2004 was the first year to implement the project’s revised Operating Plan for controlling runoff events. The impoundment is now better utilized to store flood waters by operating control gates. Releases from both the east and west pools are made when downstream conditions are acceptable. Stream gage monitoring sites are located in strategic locations in both JD #60 and Polk CD #126 which are the outlet channels for the East and West Pools, respectfully. A local (neutral party) person was contracted to record stream gage data, record water elevations for the pools, and operate the control gates. Gate operation is directed by the Red Lake Watershed District.

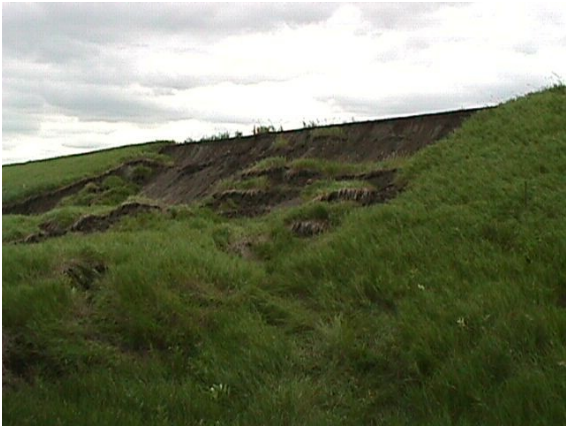
Slope Failure

2004 – In the fall of 2004 this dam encountered another failure at approximately the same location as the one in 2000. The Board of Managers determined that until a plan can be developed to accomplish a long term repair, the pool should be lowered from its normal level to help reduce the risks of damages should the dam fail completely.

In November, Davidson Construction of Holt, MN was hired to perform excavation, re-sloping, and modify the existing outlet structure to draw-down the permanent pool. The original structure was constructed with a fixed crest weir with no screw gate for draw-down purposes. Two holes at different elevations were made in the structure for the draw-down and excavations were performed on the downstream embankment slope to inspect for seepage. No seepage/saturated soils were found during this inspection.

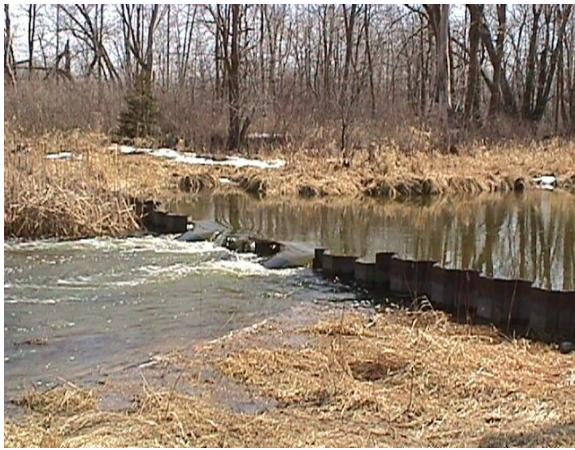
Sheet Piling Weir with 2 adjustable stoplog bays

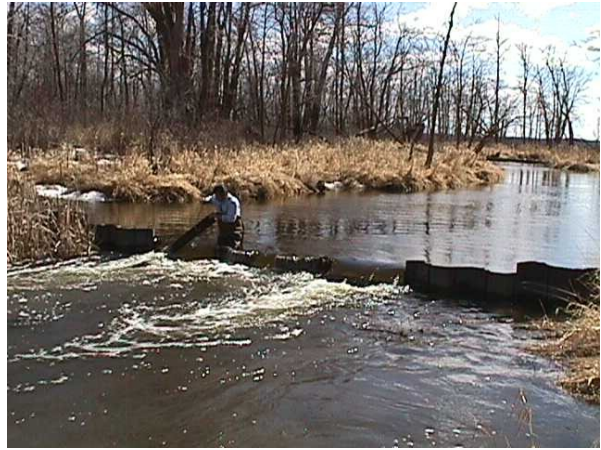
Removing stoplogs to manage lake level

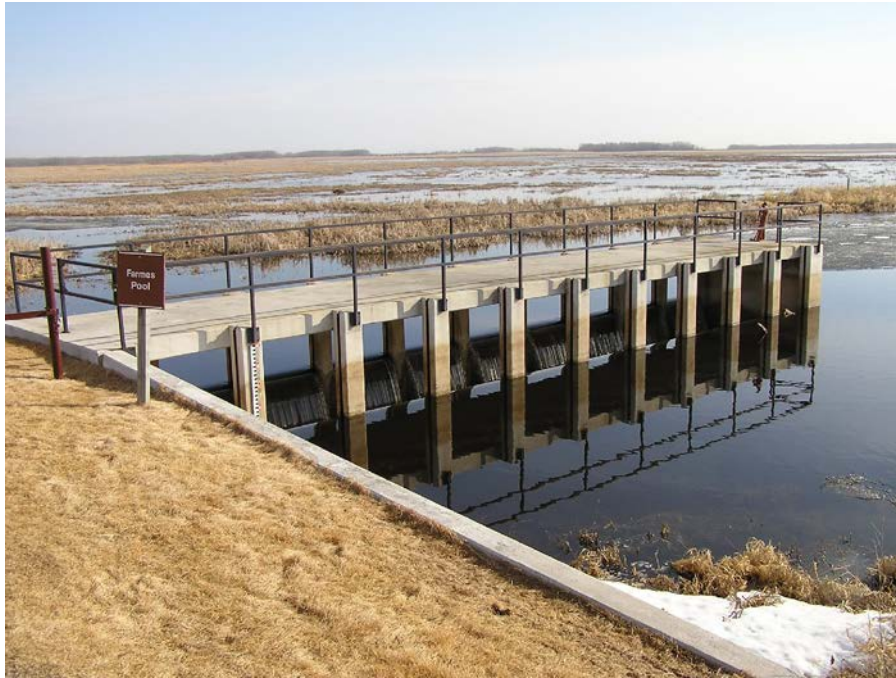
Principal Outlet Structure  
Outlets to Marshall County Ditch #200  
approximately 2 miles upstream of the Thief River

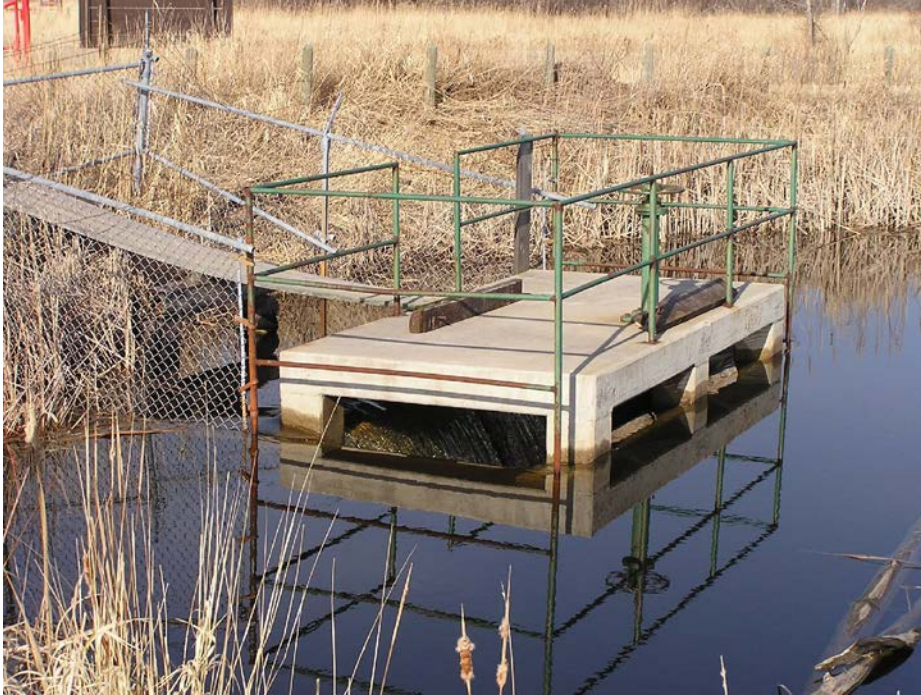
Outlet Control Structure  
Outlets to Marshall County Ditch #200

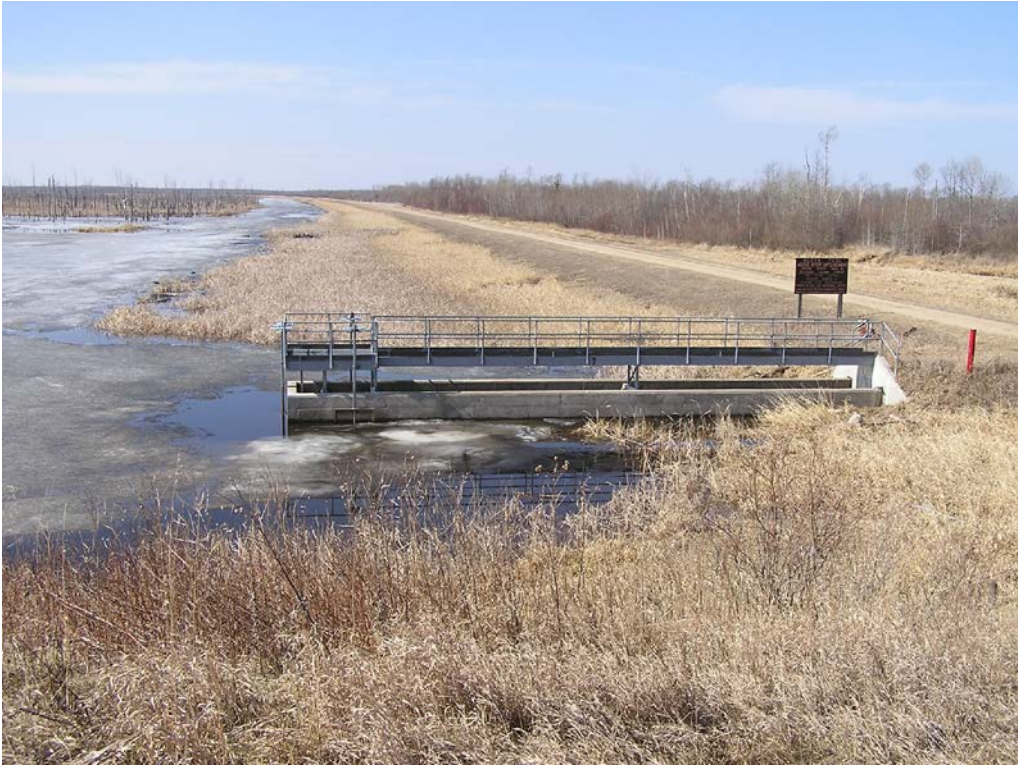
North Pool Principal Outlet Structure  
Outlets to Judicial Ditch #21 (Moose River)

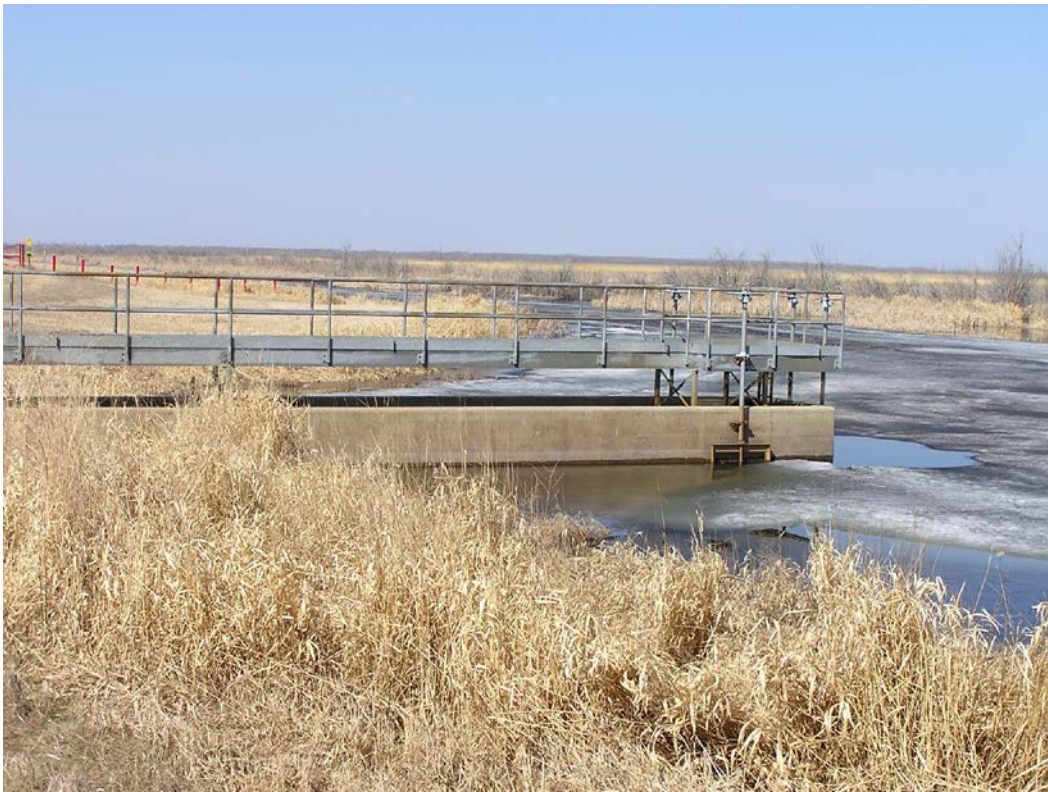
South Pool Principal Outlet Structure  
Outlets to Judicial Ditch #11 (Mud River)

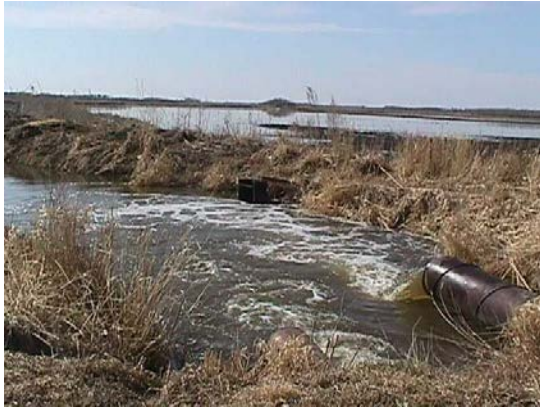
Wild Rice Water Allocation Pumping Station, Clearwater River

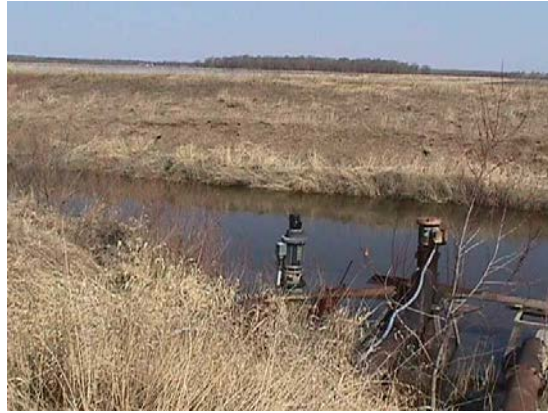
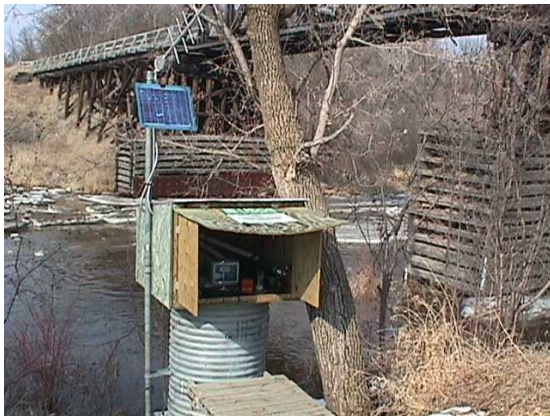
Clearwater River at Red Lake Falls  
automated river level gage

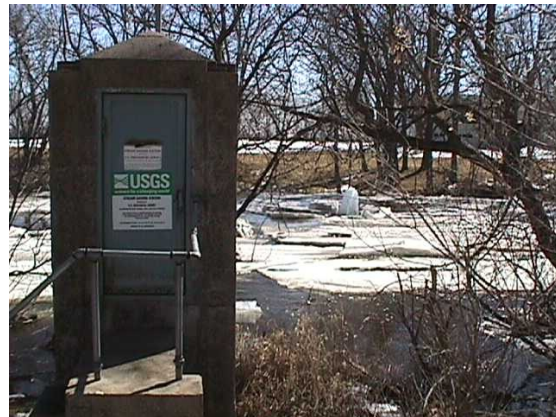
Thief River near Thief River Falls  
automated gaging station

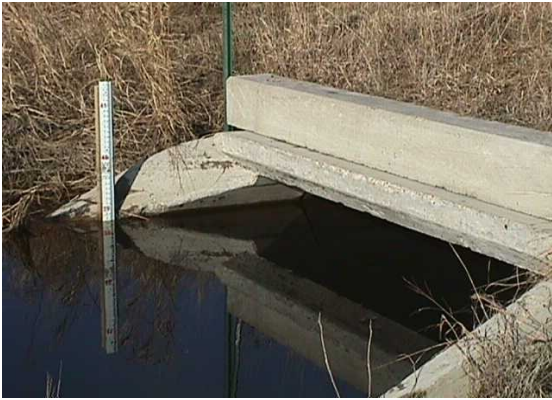
Streamgaging - Stage Gage
