2012 ANNUAL REPORT

Red Lake Watershed District

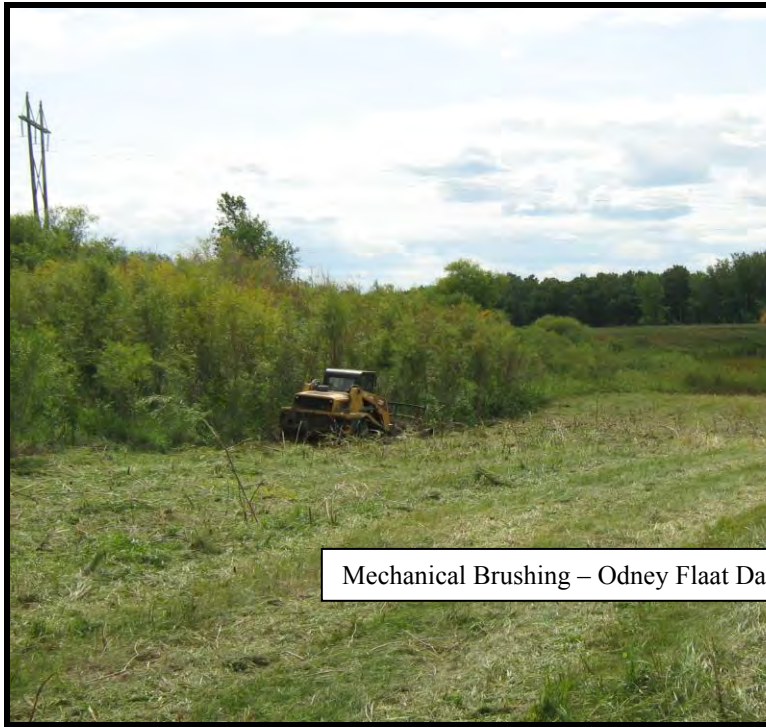
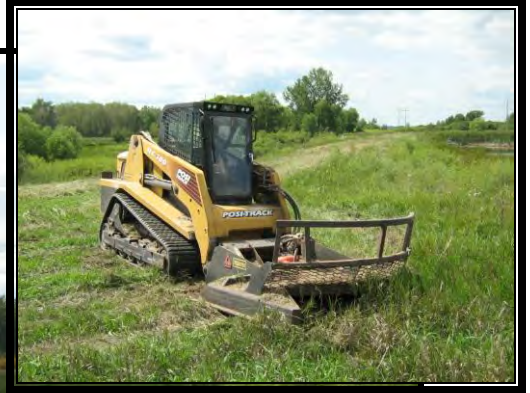
Mechanical Brushing – Odney Flaas Dam – Polk County

Structure Repair – Miller Dam, Red Lake County

Routine inspections are performed and the condition of the embankment and control structures is evaluated. Typical maintenance includes flood damage repairs, debris removal, removal of beaver dams/debris, nuisance beaver, and vegetation control.

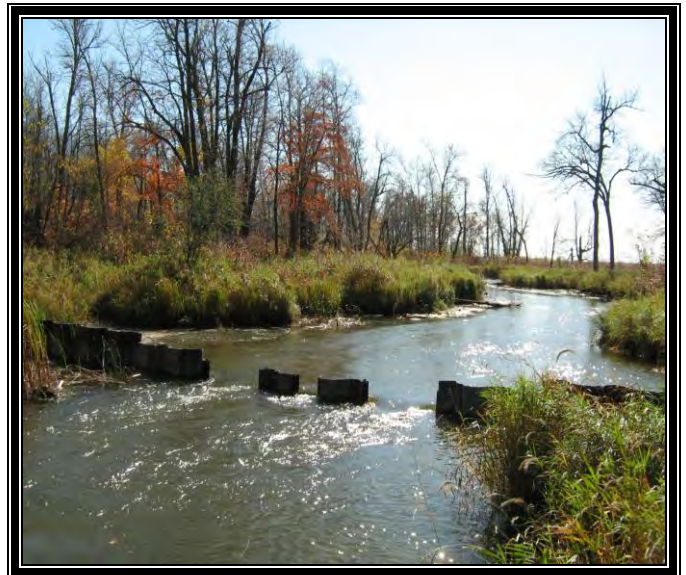
Typical Fall Drawdown with Stoplogs Removed

The Pine Lake control structure is a sheet pile dam with 2 – four foot wide adjustable stop-log bays. The stoplogs can be adjusted between elevations 1281.5 to 1283.5. There is also 26 feet of fixed crest weir at elevation 1284.0, and 65 feet of fixed crest weir at elevation 1284.5. Based primarily on lake elevation, stop-logs may be removed from the dam to allow additional outflow until the lake recedes, and then they are replaced to the typical summer or winter elevation.

The dam is also designed with a small fixed crest weir at elevation 1282.5, which is one foot lower than the normal summer stop-log elevation. This was an innovative design in the early 1980's, and allows for minor outflows that provides stream flow maintenance. This is very important for keeping some flow in the Lost River especially during periods of low flow. Factors to consider when adjusting the stop-logs are: monitoring "inflows" to the lake, existing lake elevation, downstream conditions and predicted runoff. Staff personnel at the Sportsman's Lodge are very helpful in reading the lake elevation gauge located inside the business and a local resident records rainfall data at the lake.

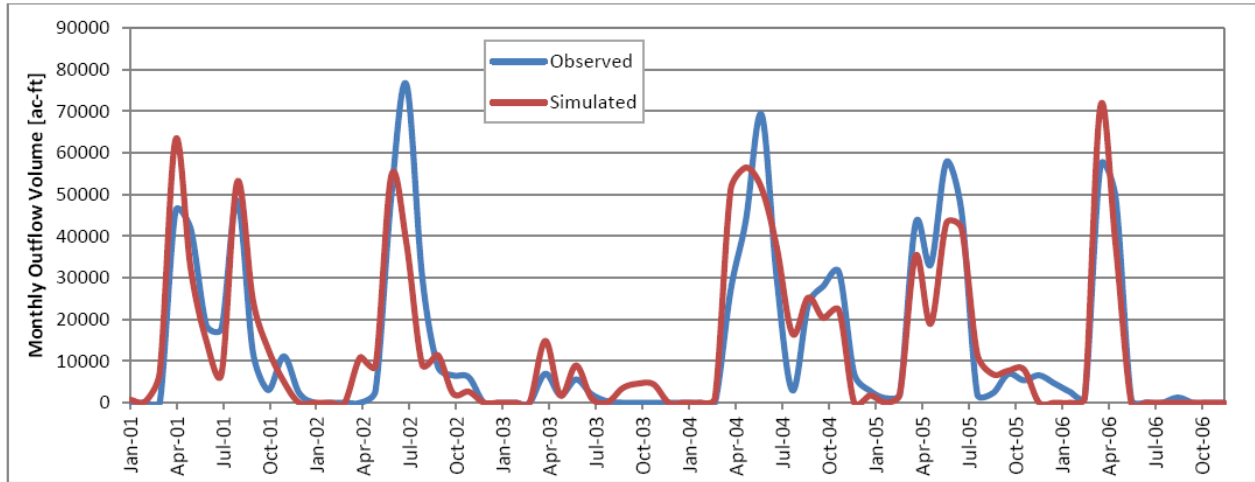
The following graph shows a comparison of simulated and observed monthly outflows for Agassiz Pool in the Thief River watershed. The watershed was represented by the model where the lines are close together. Overall, the model appears to do a good job at predicting flows from the entire watershed. When it comes to predicting flows at specific points throughout the watershed, it did well in some areas (Agassiz Pool outflows) and not as well in others (Moose River Impoundment outflows).

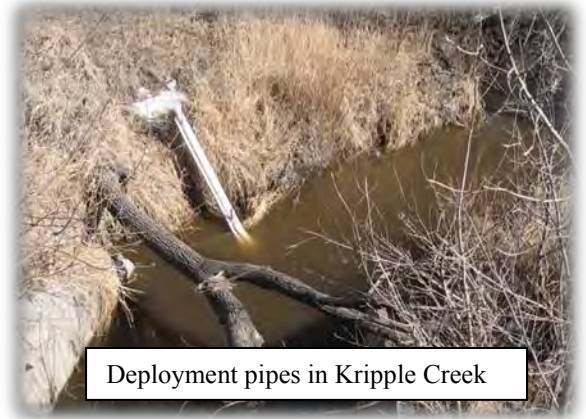
PVC pipes are used for deploying the water quality monitoring equipment. Those pipes were purchased and prepared for installation in early 2012. The pipes needed to be perforated with holes in order to allow water to flow past the sensors and still provide protection for the equipment. Cables are installed on the inside of the pipes. The upper end of the cable is attached to an eye-bolt near the top of the pipe and the monitoring equipment is attached to the other end of the cable so that it can be suspended within the pipe.

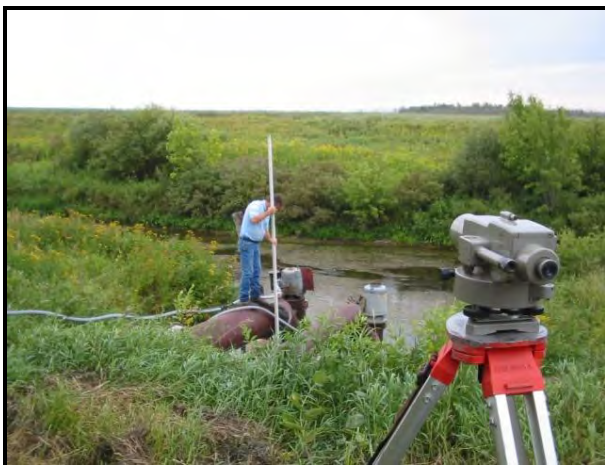
Surveying water lift from river to pump

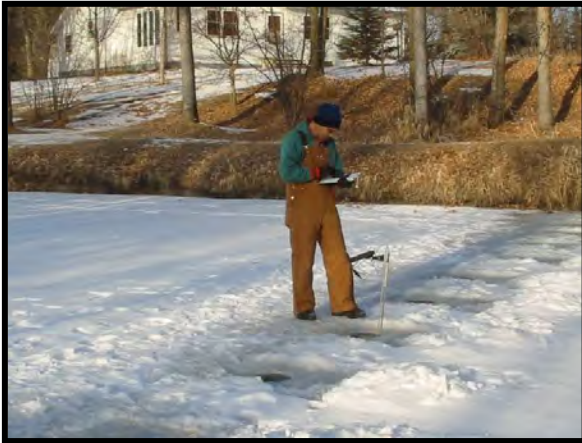
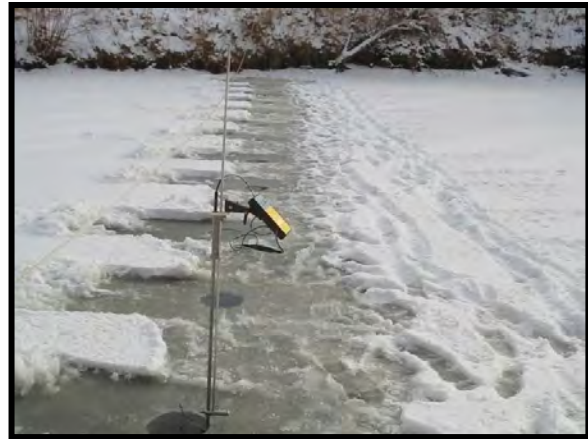
Measuring flow beneath ice

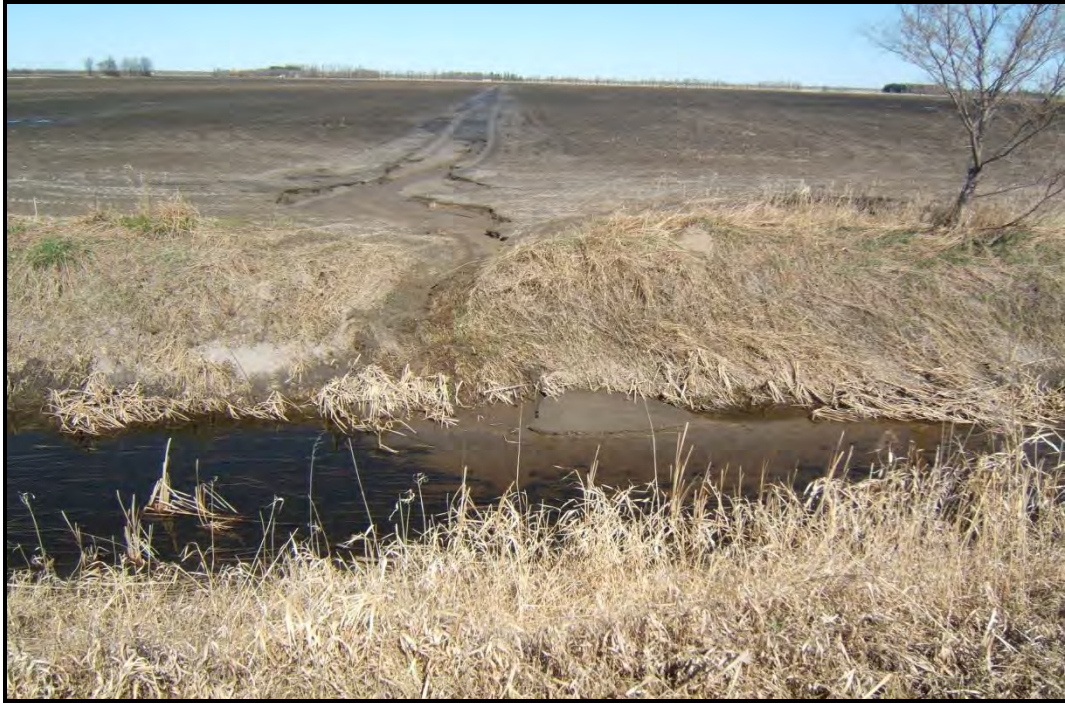
Location of a side water inlet that will be installed in 2013 on JD 72

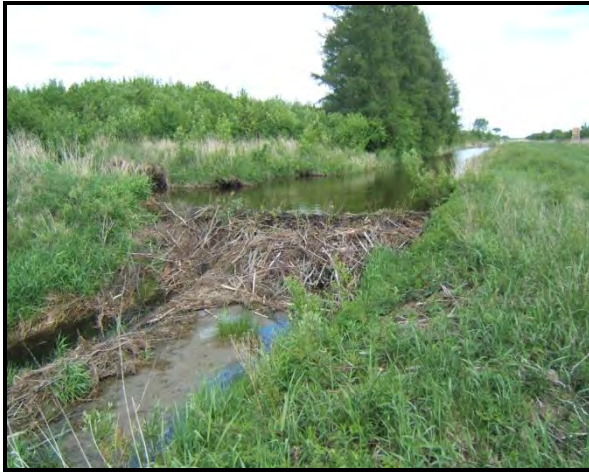
Beaver Dam

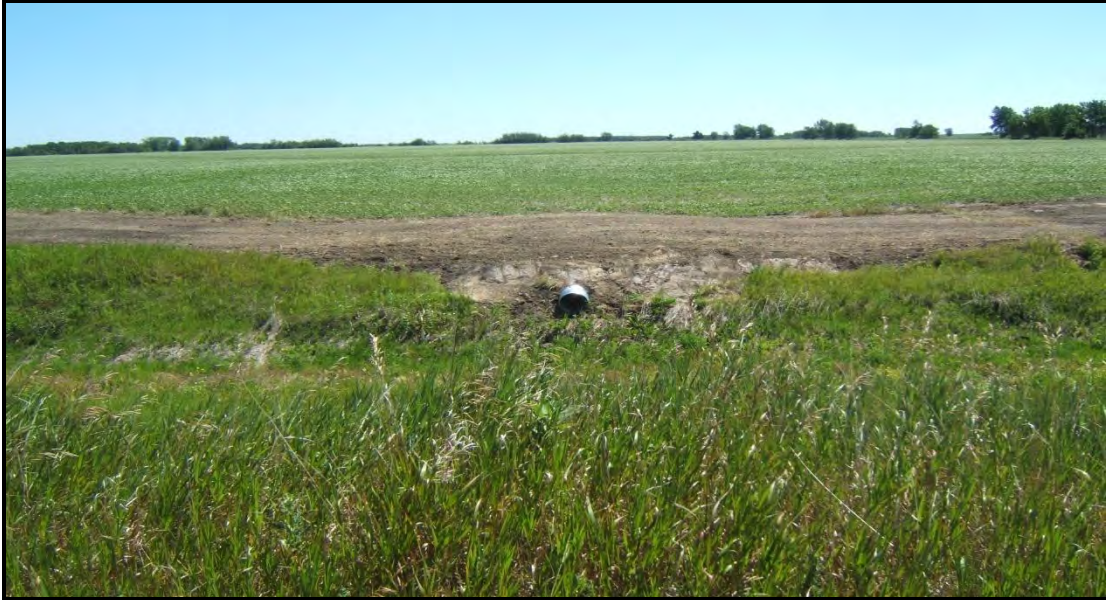
Side inlet pipe in RLWD Ditch 3

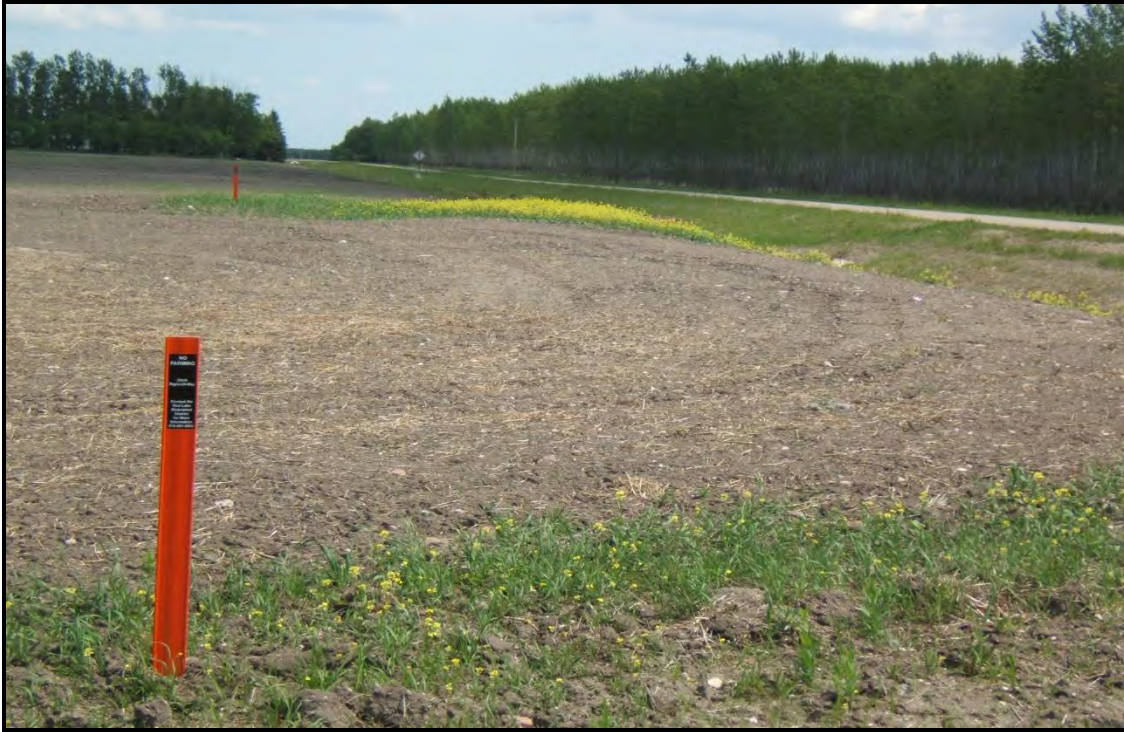
Right-of-way violation of grass buffer strip on Project # 117

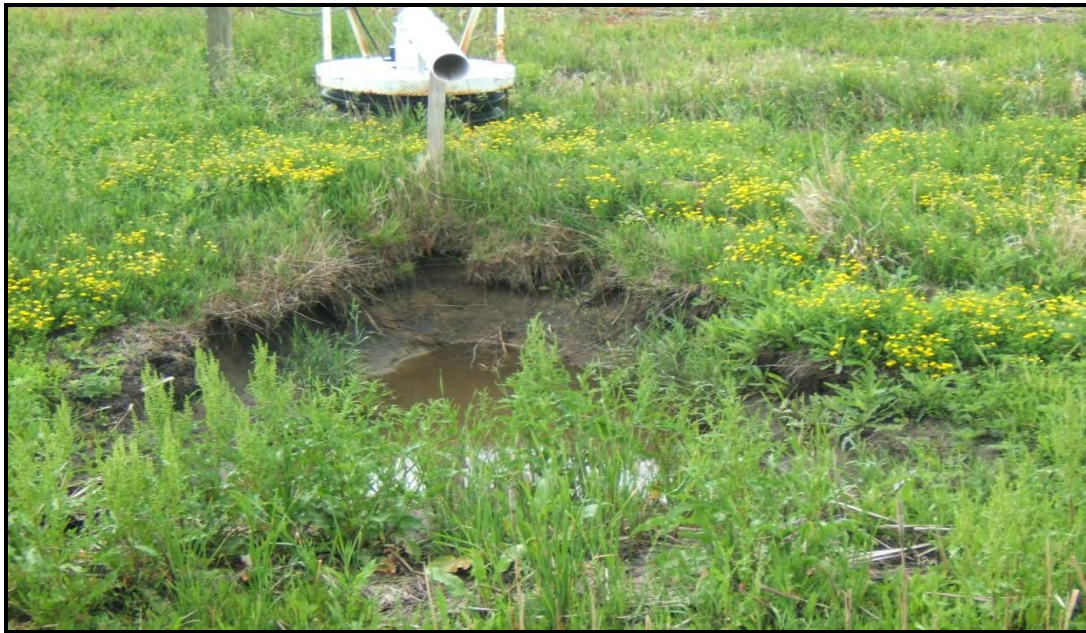
Erosion from a tile line pump that needs to be fixed in Project # 119

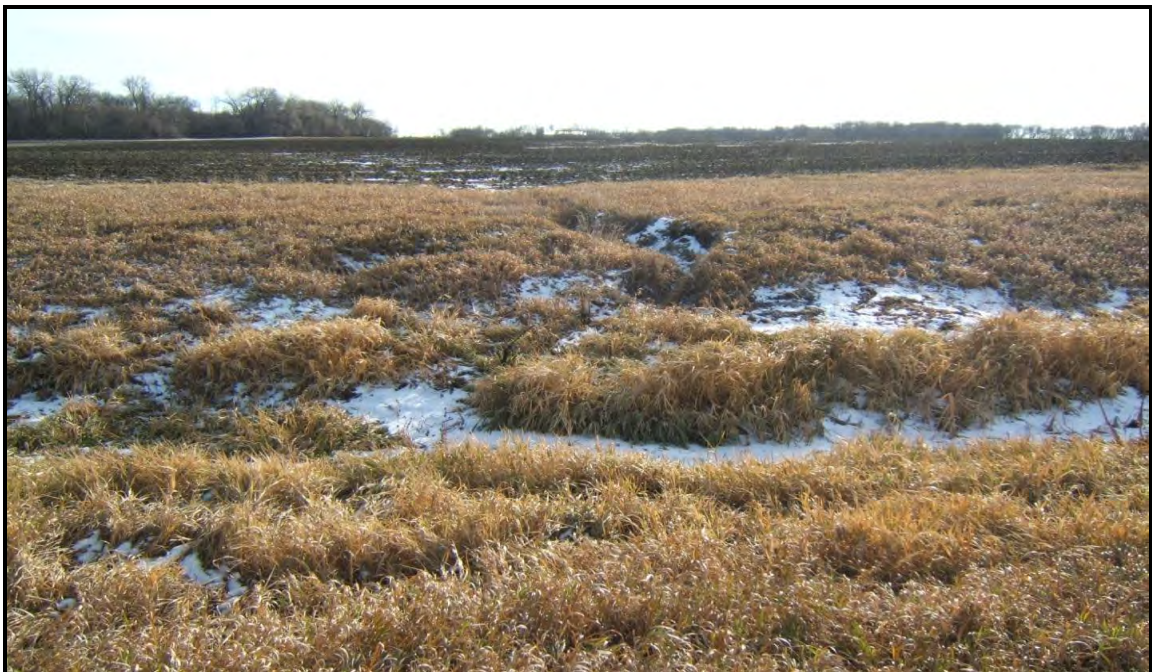
Area of erosion that will need a side water inlet pipe in project # 134

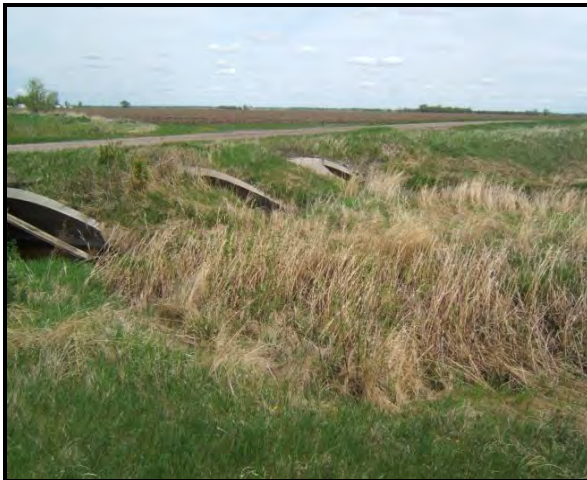
Sediment in Burnham Creek

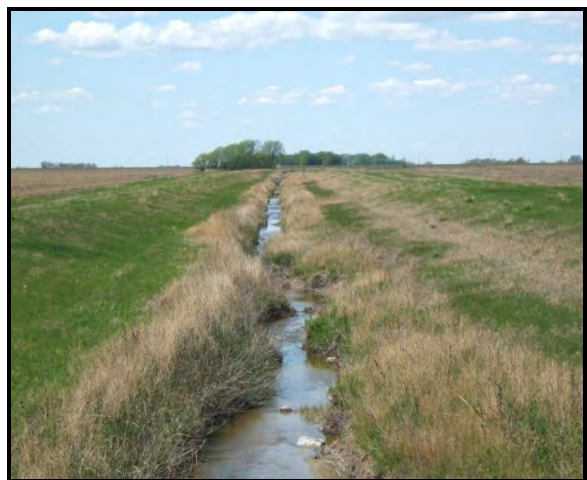
Head cutting in Burnham Creek

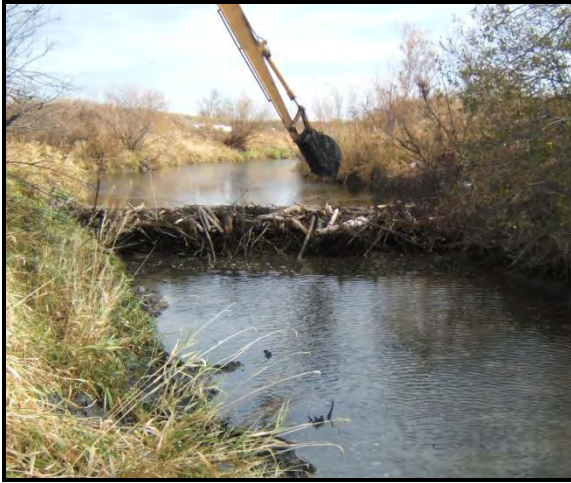
Beaver dam in State Ditch 83
