**Red Lake  
Watershed  
District**

**2013  
Annual  
Report**

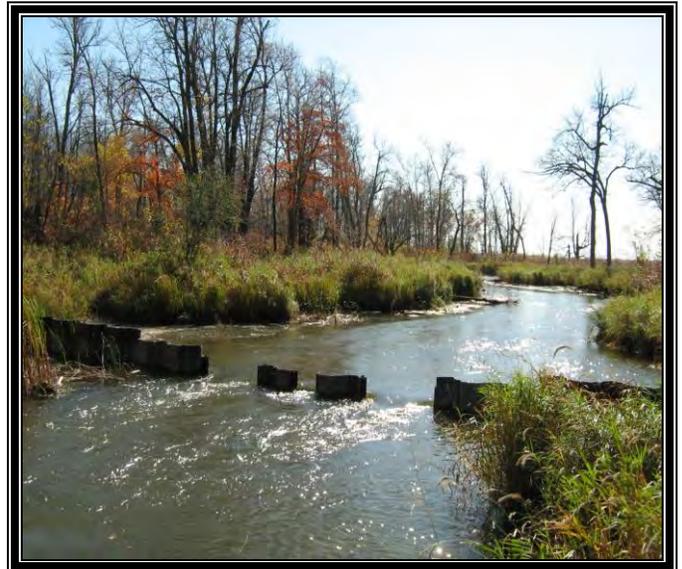
The Pine Lake control structure is a sheet pile dam with 2 – four foot wide adjustable stop-log bays. The stoplogs can be adjusted between elevations 1281.5 to 1283.5. There is also 26 feet of fixed crest weir at elevation 1284.0, and 65 feet of fixed crest weir at elevation 1284.5. Based primarily on lake elevation, stop-logs may be removed from the dam to allow additional outflow until the lake recedes, and then they are replaced to the typical summer or winter elevation.

The dam is also designed with a small fixed crest weir at elevation 1282.5, which is one foot lower than the normal summer stop-log elevation. This was an innovative design in the early 1980's, and allows for minor outflows that provides stream flow maintenance. This is very important for keeping some flow in the Lost River especially during periods of low flow. Factors to consider when adjusting the stop-logs are: monitoring "inflows" to the lake, existing lake elevation, downstream conditions and predicted runoff. Staff personnel at the Sportsman's Lodge are very helpful in reading the lake elevation gauge located inside the business and a local resident records rainfall data at the lake.

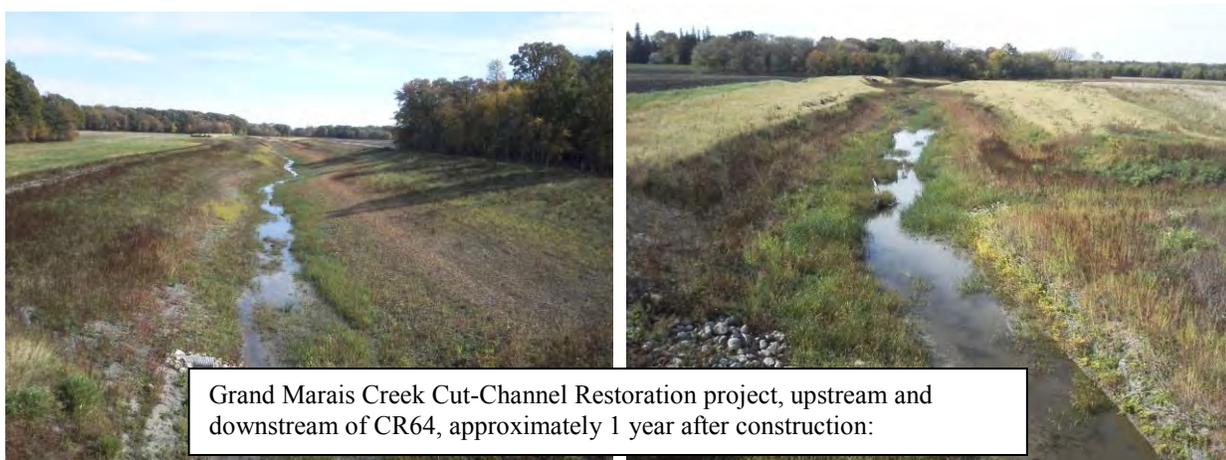
Grand Marais Creek Cut-Channel Restoration project, upstream and downstream of CR64, approximately 1 year after construction:

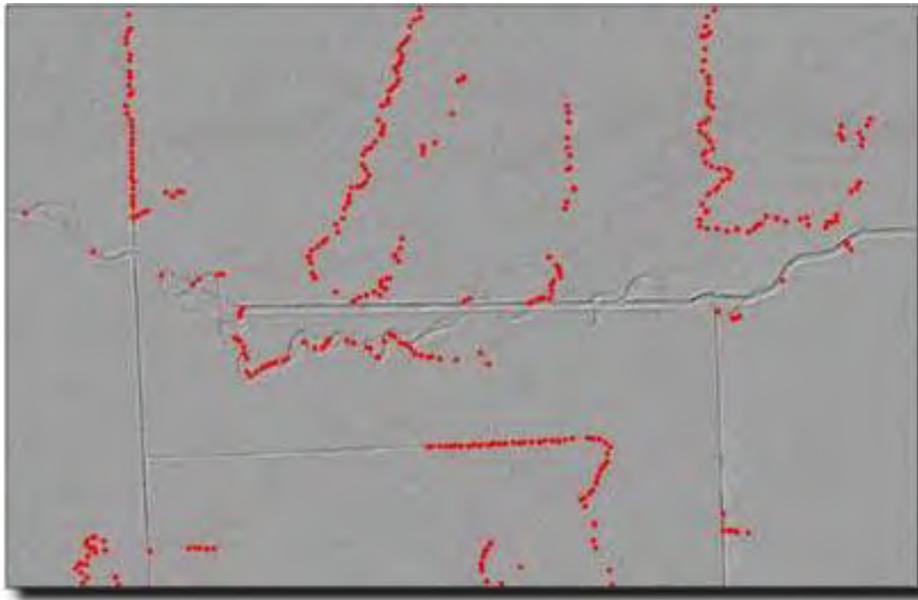
Red points indicate grid cells that exhibit a Stream Power Index in the 99.5 percentile (highest one-half percent of the values).

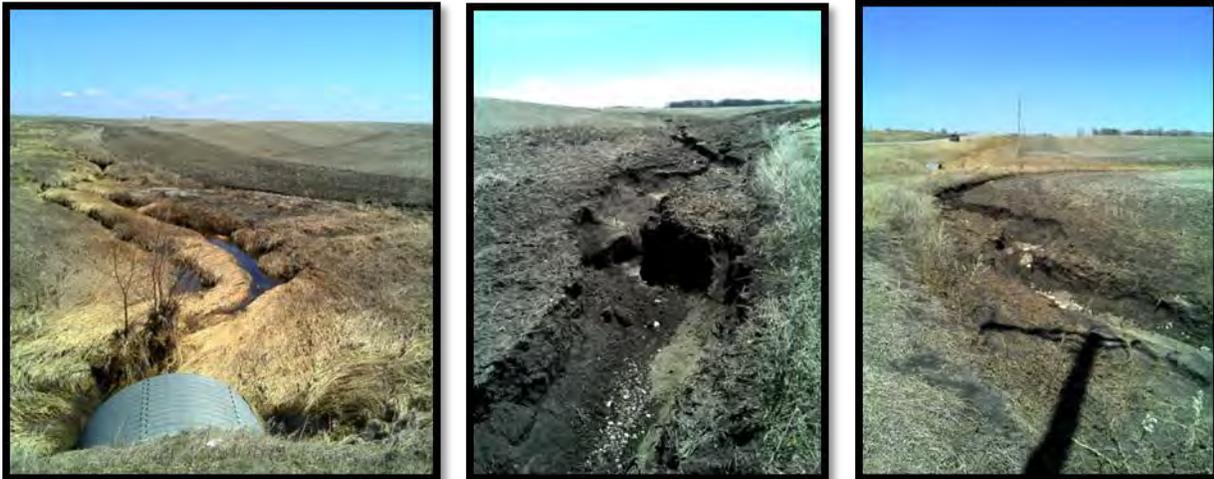
There is a lot of sloughing, erosion, and sedimentation occurring along Polk County Ditch 1, much of which is visible from the CR64 crossing.

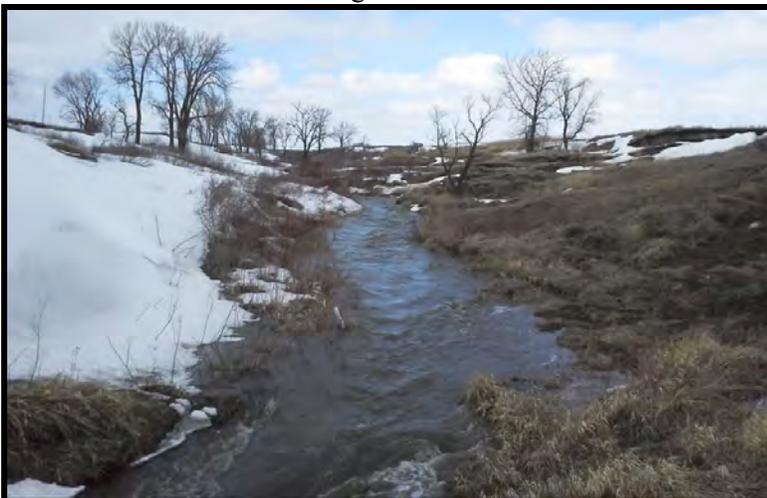
**Rapidly flowing runoff in Polk County Ditch 1. A lot of bank failure and sloughing is occurring along the channel.**

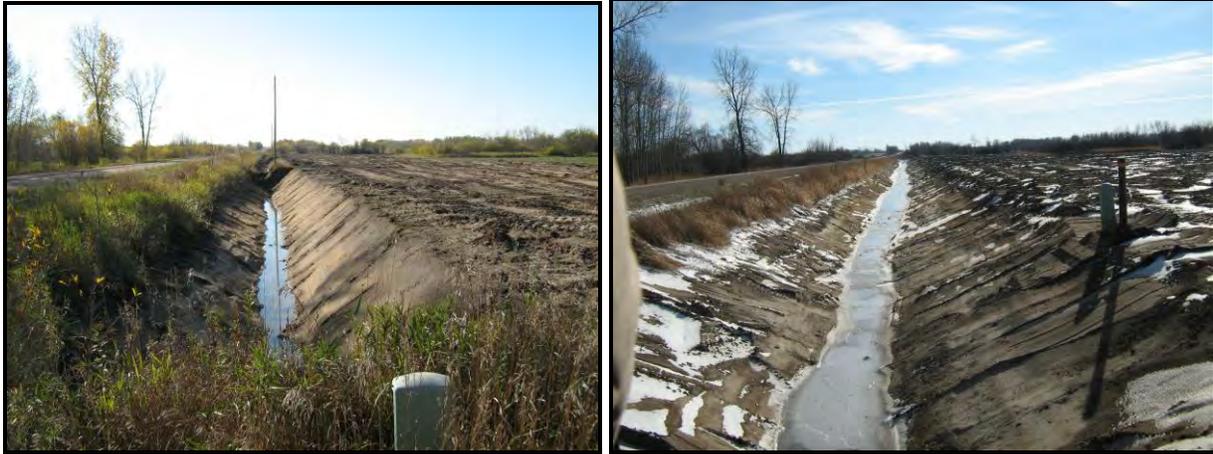
Examples of poor/unacceptable work & after request to repair)

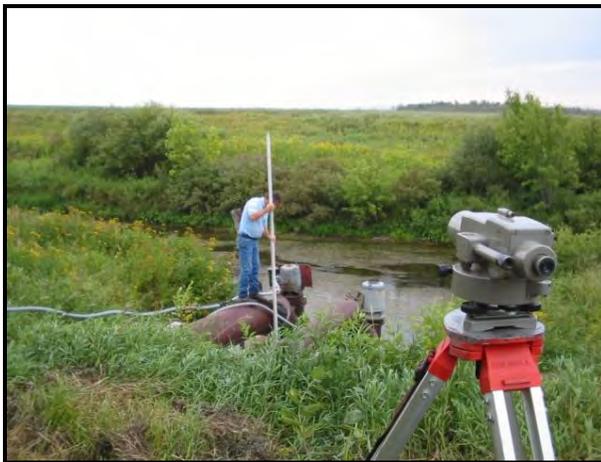
Surveying water lift from river to pump

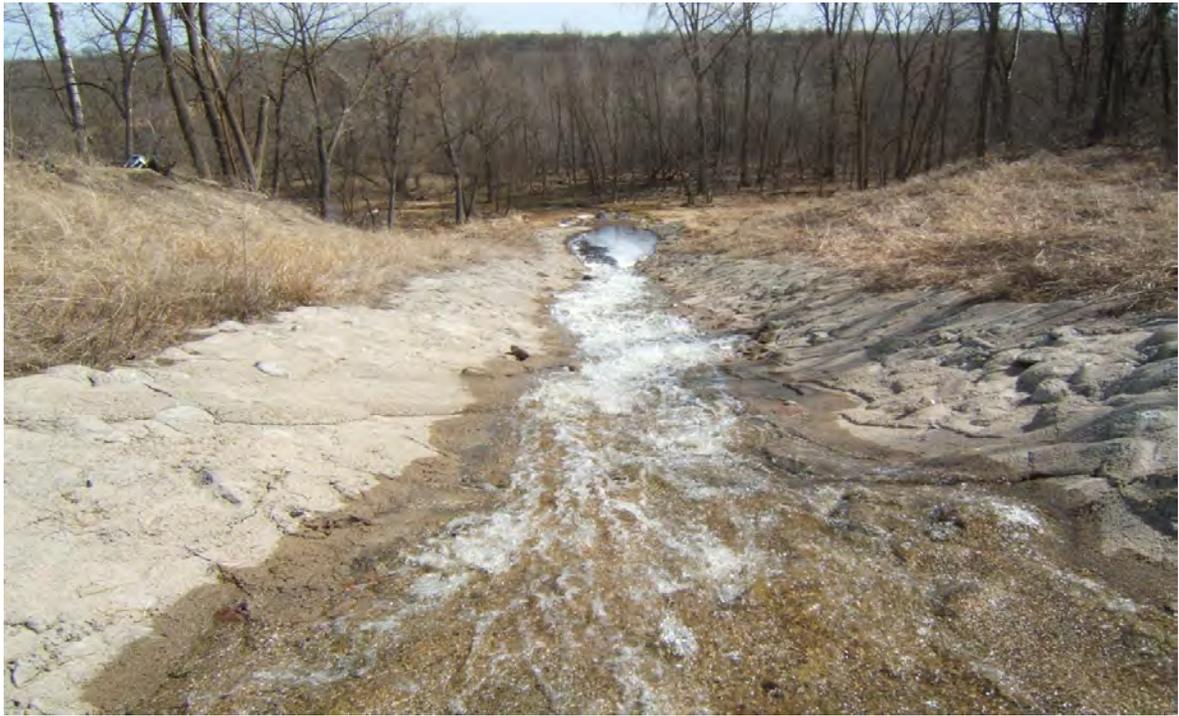
Runoff water flowing in the rock chute on RLWD Ditch 10 (Project #161)

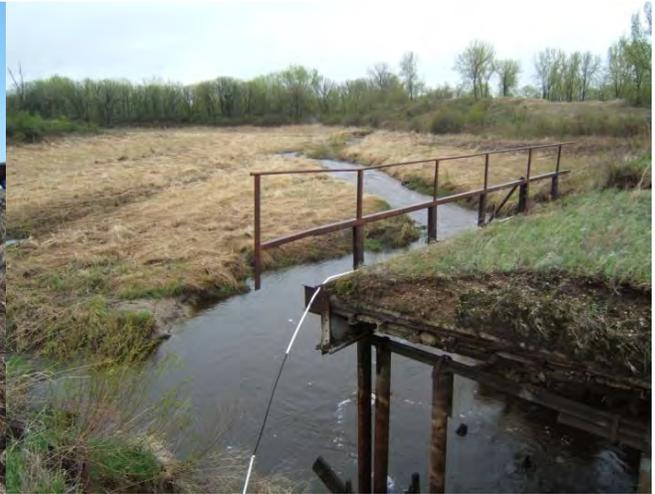
Washed out old bridge will be removed

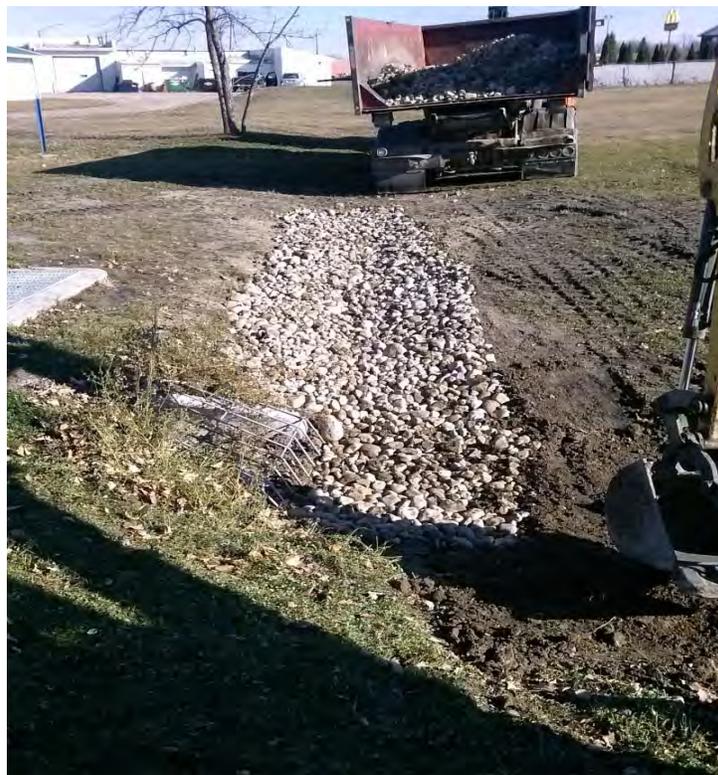
Reierson Construction with completed rock erosion site

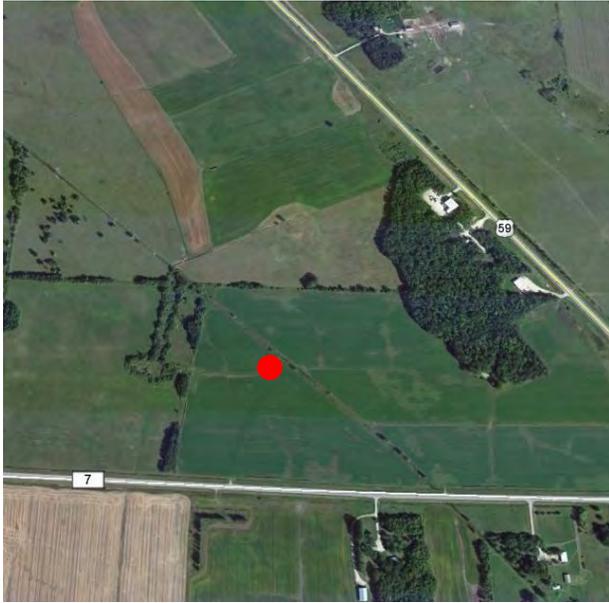
Red dot is the approximate location of additional rip-rap to the pipe. According to the Plans and Specs for Ditch 14, the pipe is at Station 146+68, pipe #25, located Section 12 of Rocksbury Township, Pennington County.
