RED LAKE RIVER FARM TO STREAM TILE DRAINAGE STUDY

- Red Lake Watershed District -

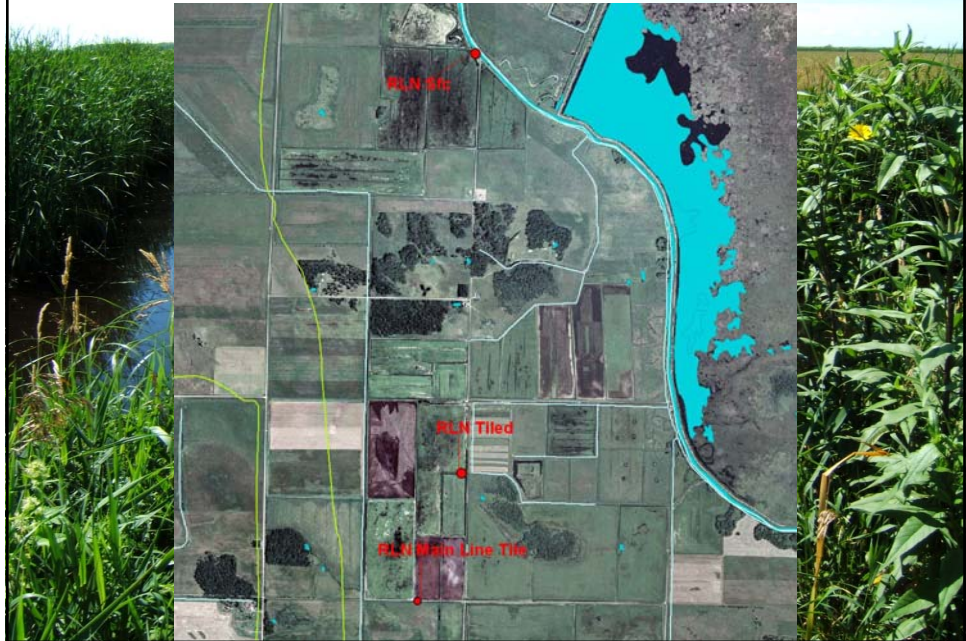
Clearwater County (Wild Rice) Sites

- **Marshall County (near Grygla)**
 - Gravity tile, pumped tile, surface drainage, “reference” natural background site
- **Red Lake County near Brooks**
 - Tile and surface drainage from tiled field
 - Surface drained field
- **Clearwater County Hangaard Township**
 - Red Lake Nation wild rice paddies
 - Completely surface drained
 - Combination of tile and surface drainage
 - Completely tile drained (pattern to main line, out of the paddy to a grassed waterway)

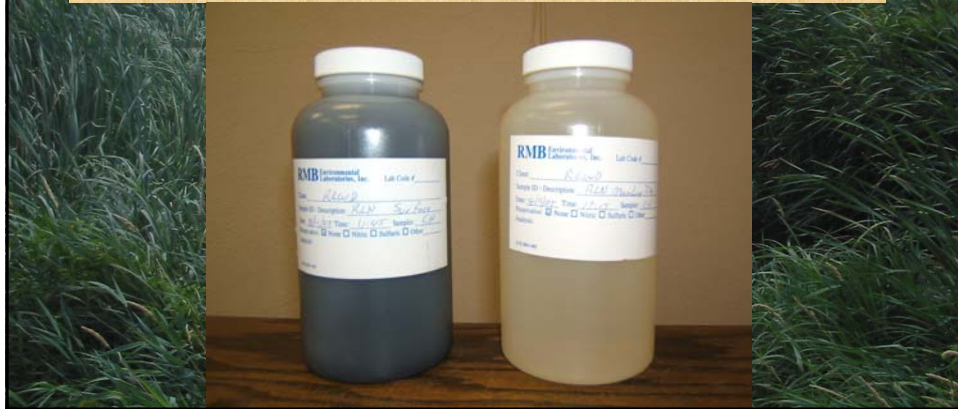
Wild Rice Paddy Water Quality Results

- Main line tile had much cleaner water than the surface drained paddy and the tile & sfc drained paddy

- Simply having tile within a paddy is not enough to achieve WQ benefits
 - Need main line tile
 - Eliminate internal surface drainage
- Wild rice paddy sites had low nitrate levels
 - Saturated/ponded conditions?
 - Plant Uptake?
- Main line tile nearly meets drinking water standards. Occasional measured suspended solids could be due to mineral buildup on inside of outlet/pipe

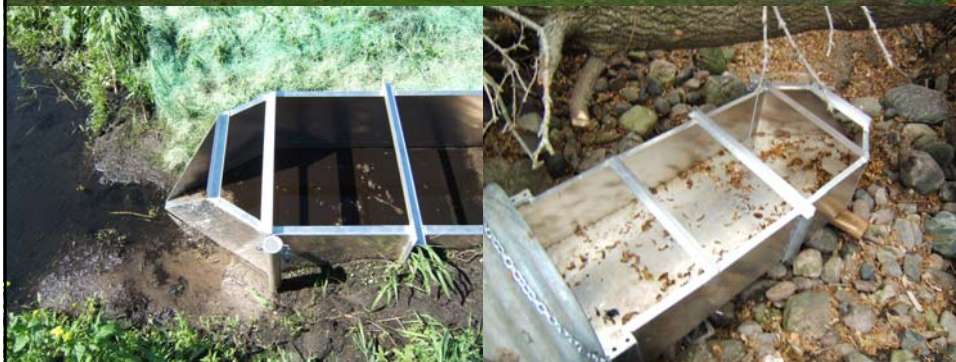
How will surface flow be measured?

- H flumes
 - Yaggie 2 Surface Drained Field
 - Sfc Drainage from Bachand Tiled Field

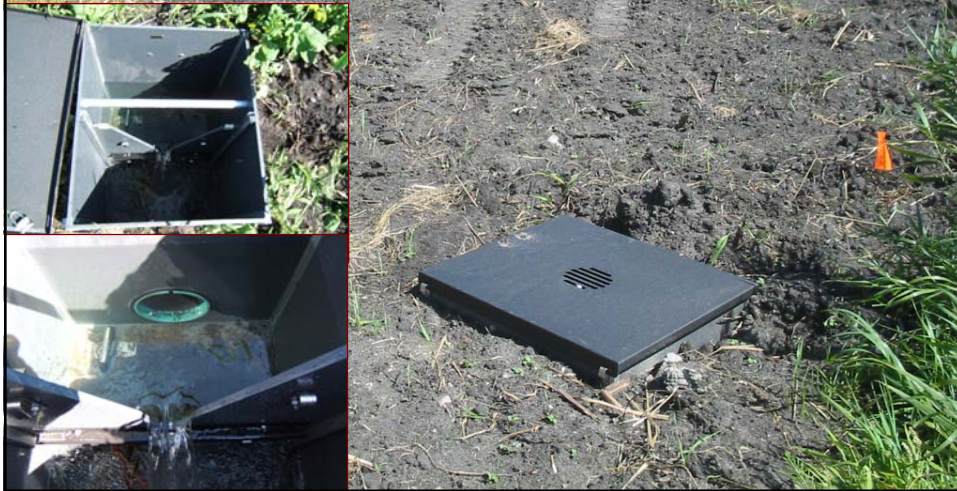
How will tile flow be measured?

- Water control structure w/ v-notch weir

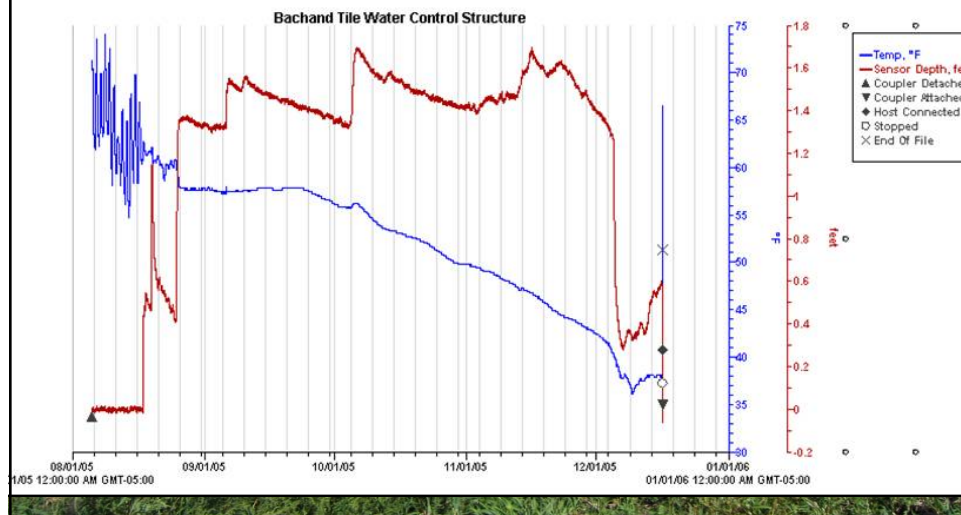
Flow Monitoring Results

- Late start in 2005 – will get a more complete record in 2006
- Surface drainage is “flashy”
- Tile drained field
 - Very little surface runoff
 - Tile drainage – storage in soil
 - Field was plowed perpendicular to flow
 - Delayed drainage during a storm
 - Flow from tile continues long after a storm
