CLEARWATER RIVER DISSOLVED OXYGEN AND FECAL COLIFORM TMDL STUDY

Red River Basin Water quality Team

December 15, 2008

Review Impaired Reaches of the TMDL Study

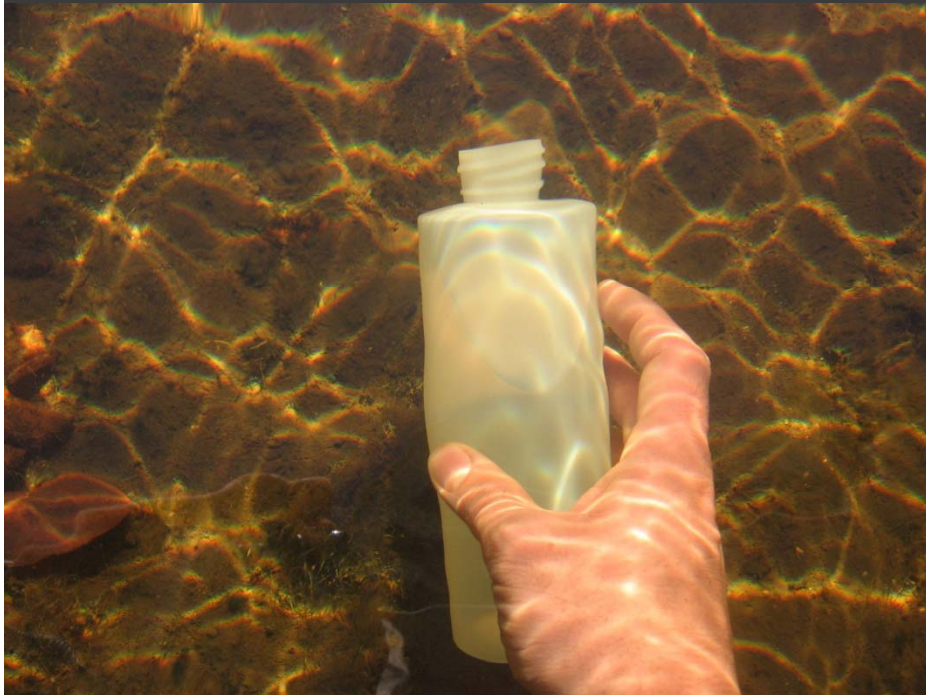
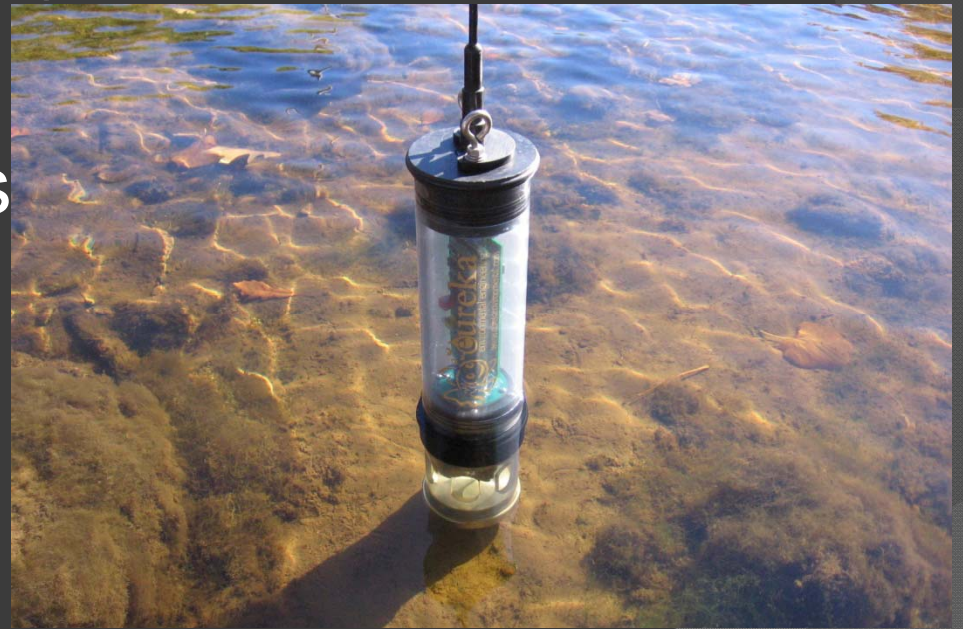
Monitoring Strategies

- Spot Measurements
- Continuous Monitoring
- Samples
- Longitudinal Surveys

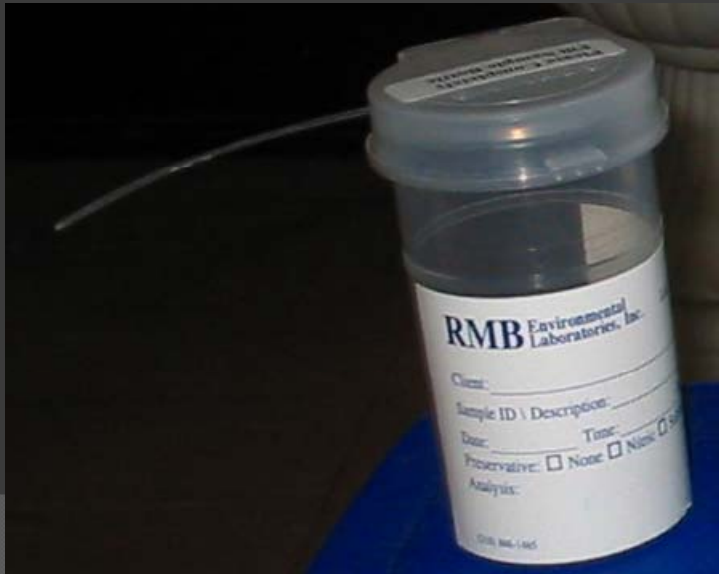
~~Fecal Coliform~~ E. coli Monitoring

- At least 5 samples/month for April – Oct.
- Limited amount of \$ for sample collection
- 2 sites per each of the 3 reaches
- Red Lake/Pennington SWCD Data also

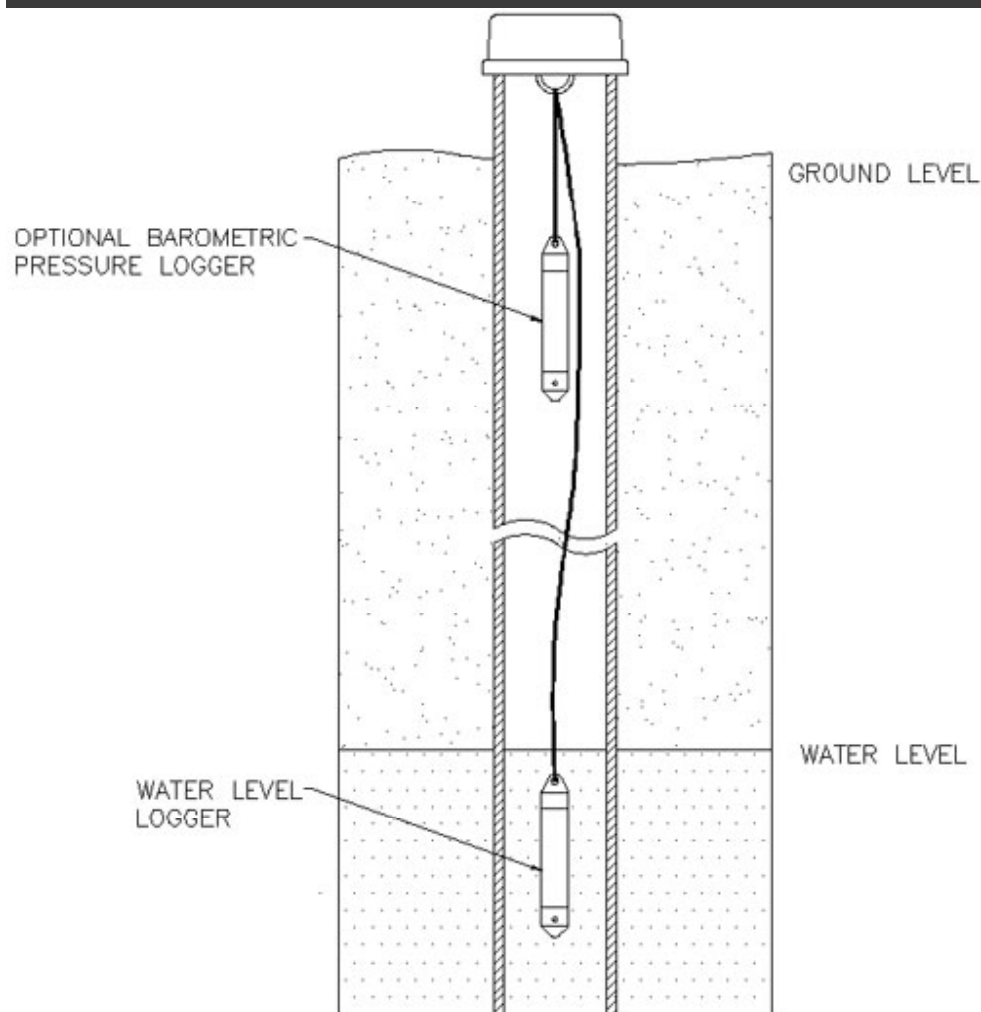
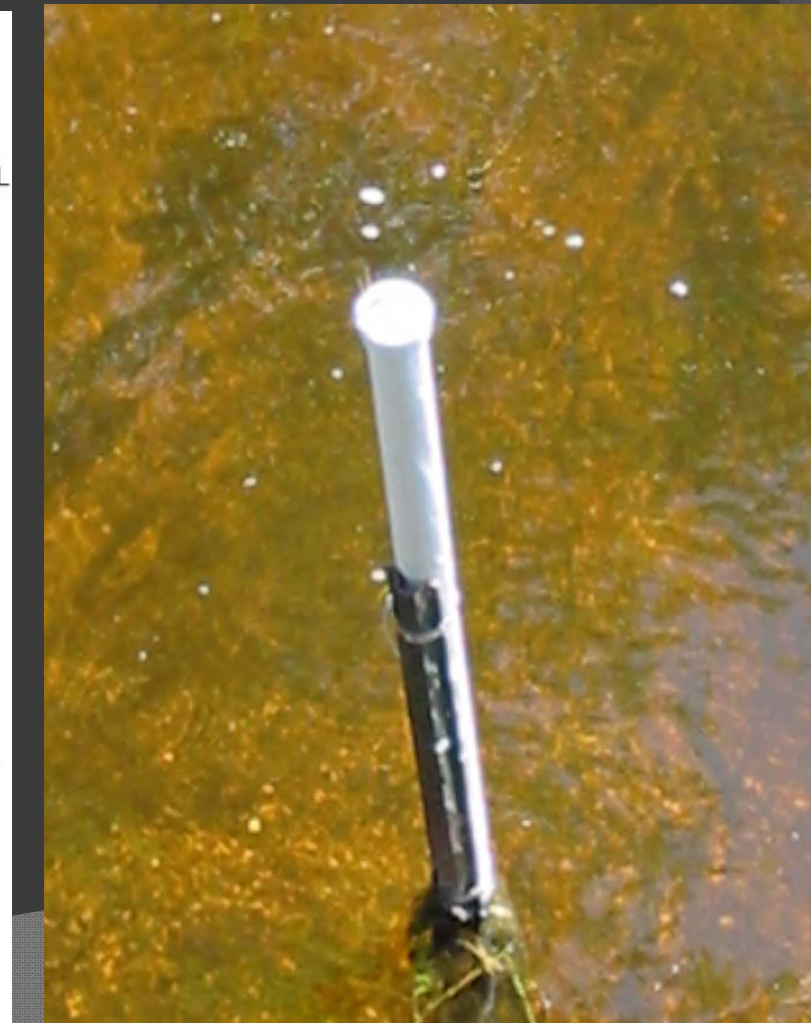
Water Level Monitoring

● HOBO Water Level Loggers

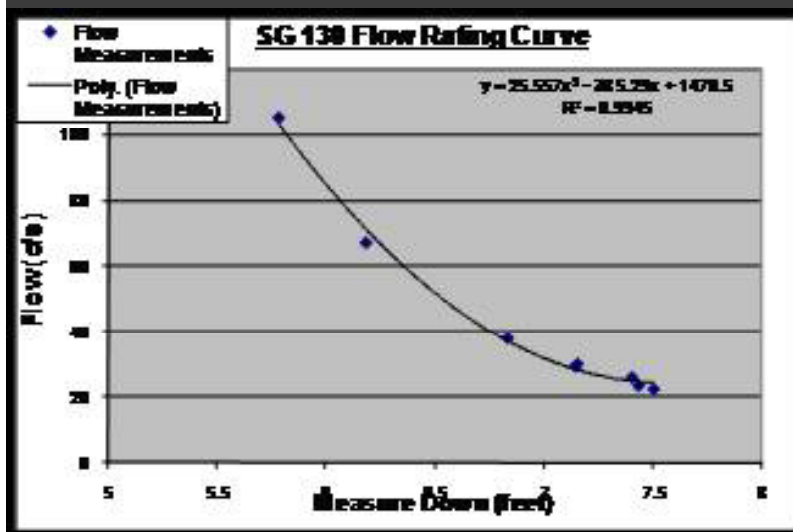
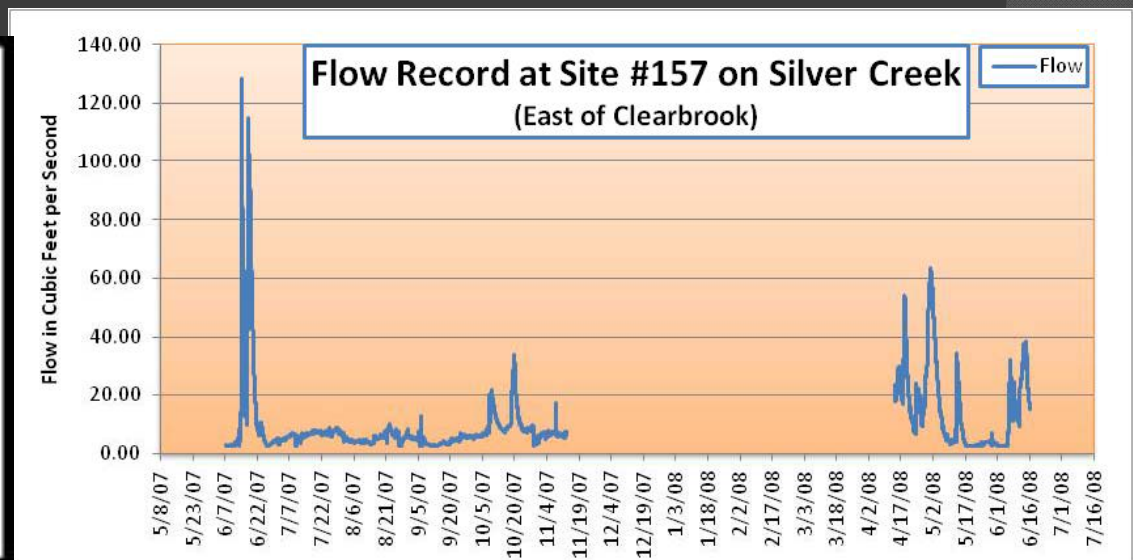
Flow Monitoring

- Continuous water levels at each continuous DO monitoring site and at each E. coli sampling site
- HOBO level loggers, In-Situ TROLL depth sensors
- USGS Gauges where possible
- Rating Curves

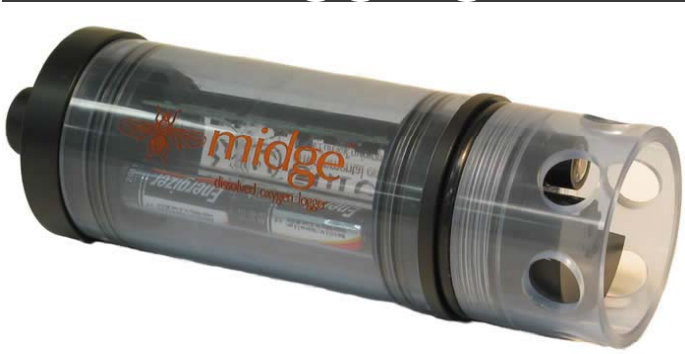
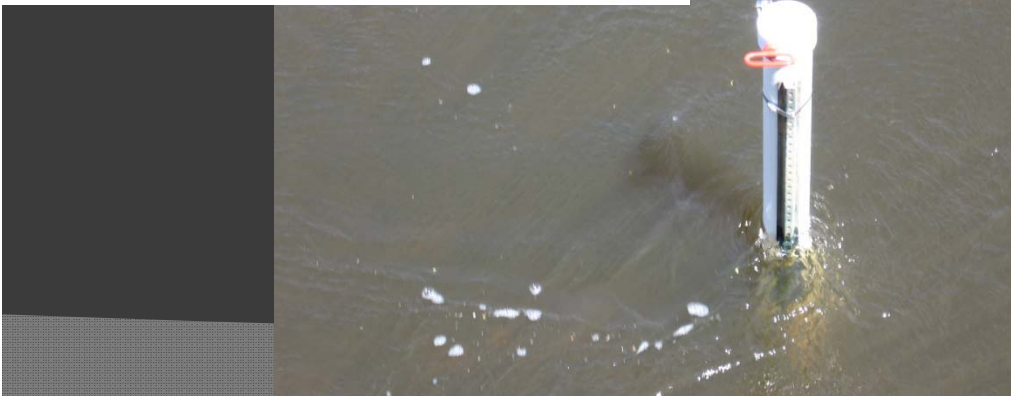
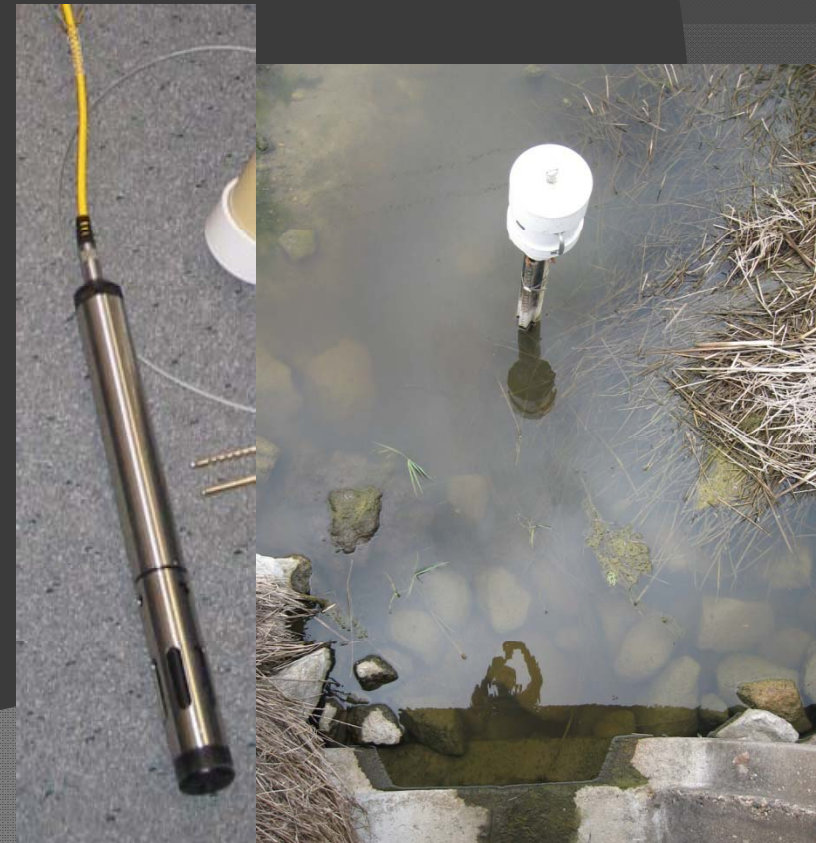
Continuous Dissolved Oxygen

- Eureka Midge Dissolved Oxygen Logger
 - 5 purchased by the MPCA for this project
- In-Situ TROLL 9000 Multiparameter Logging sonde

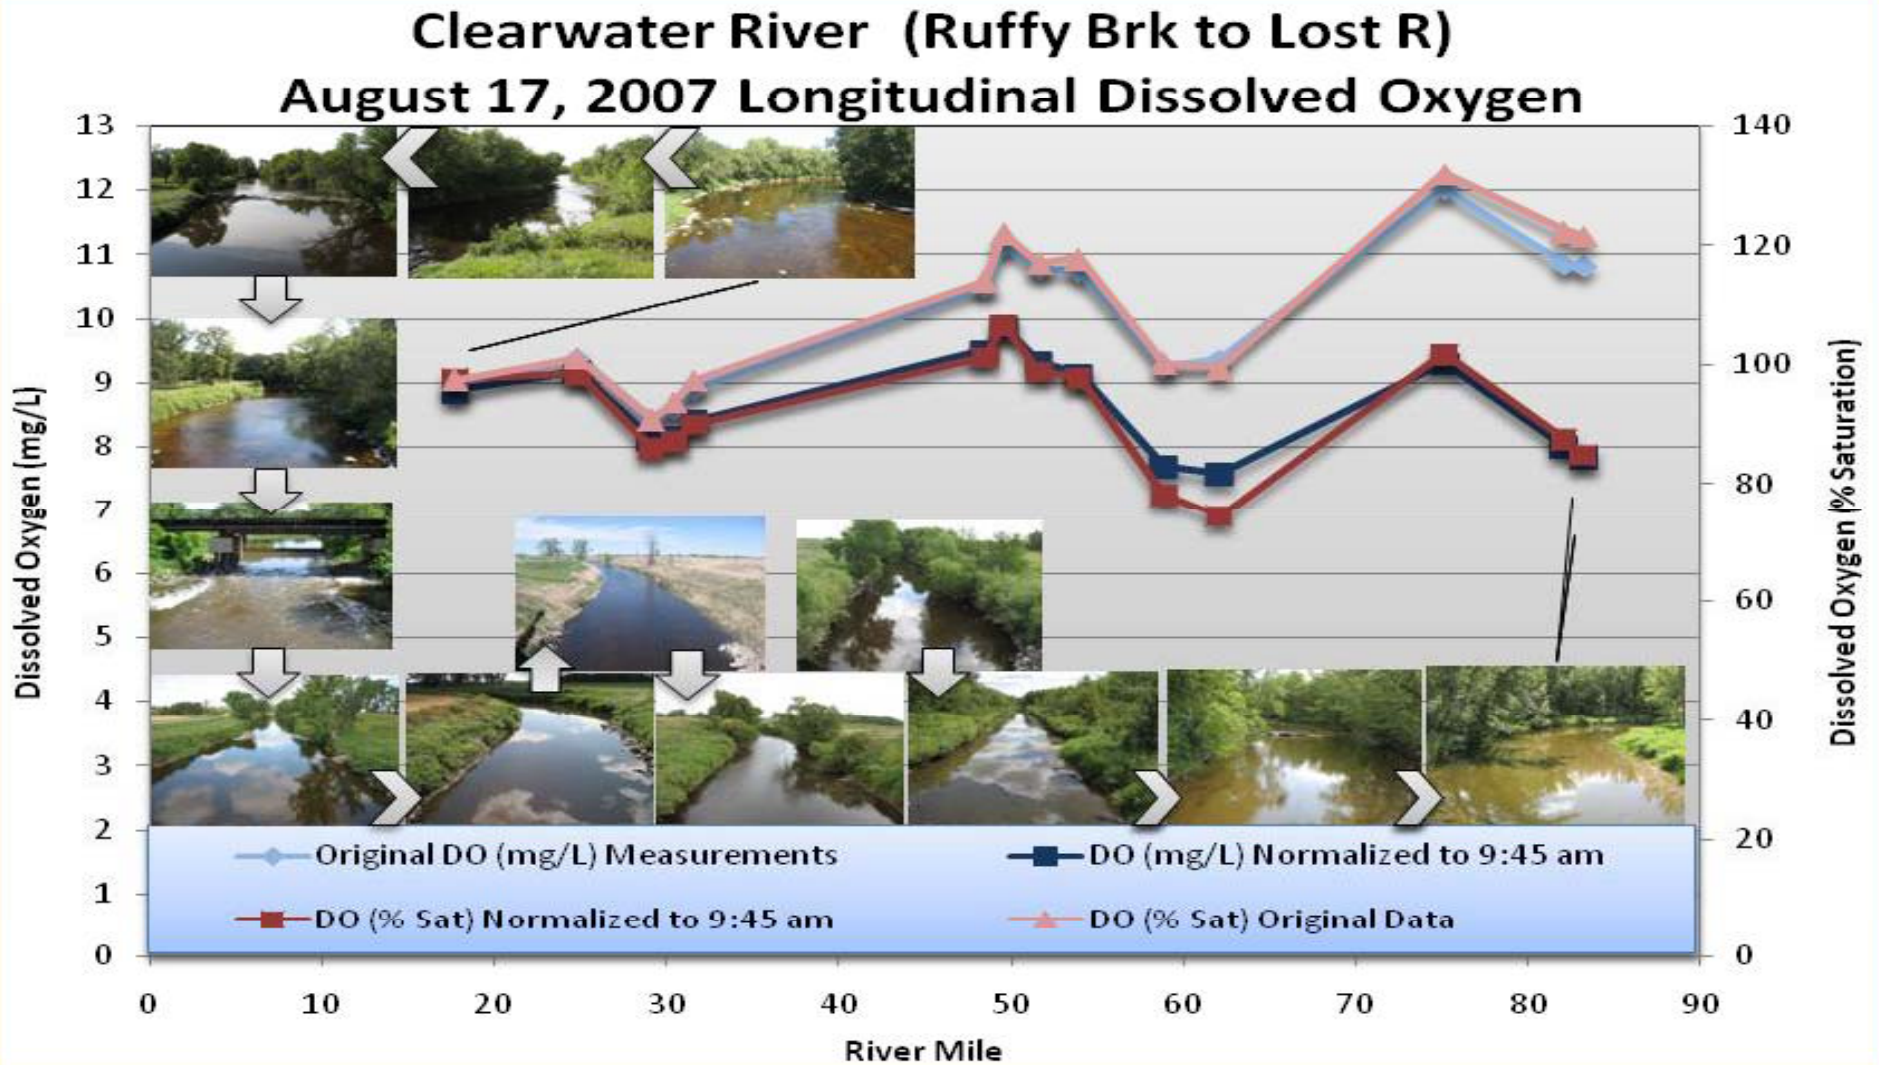
Longitudinal D0 – Clearwater River

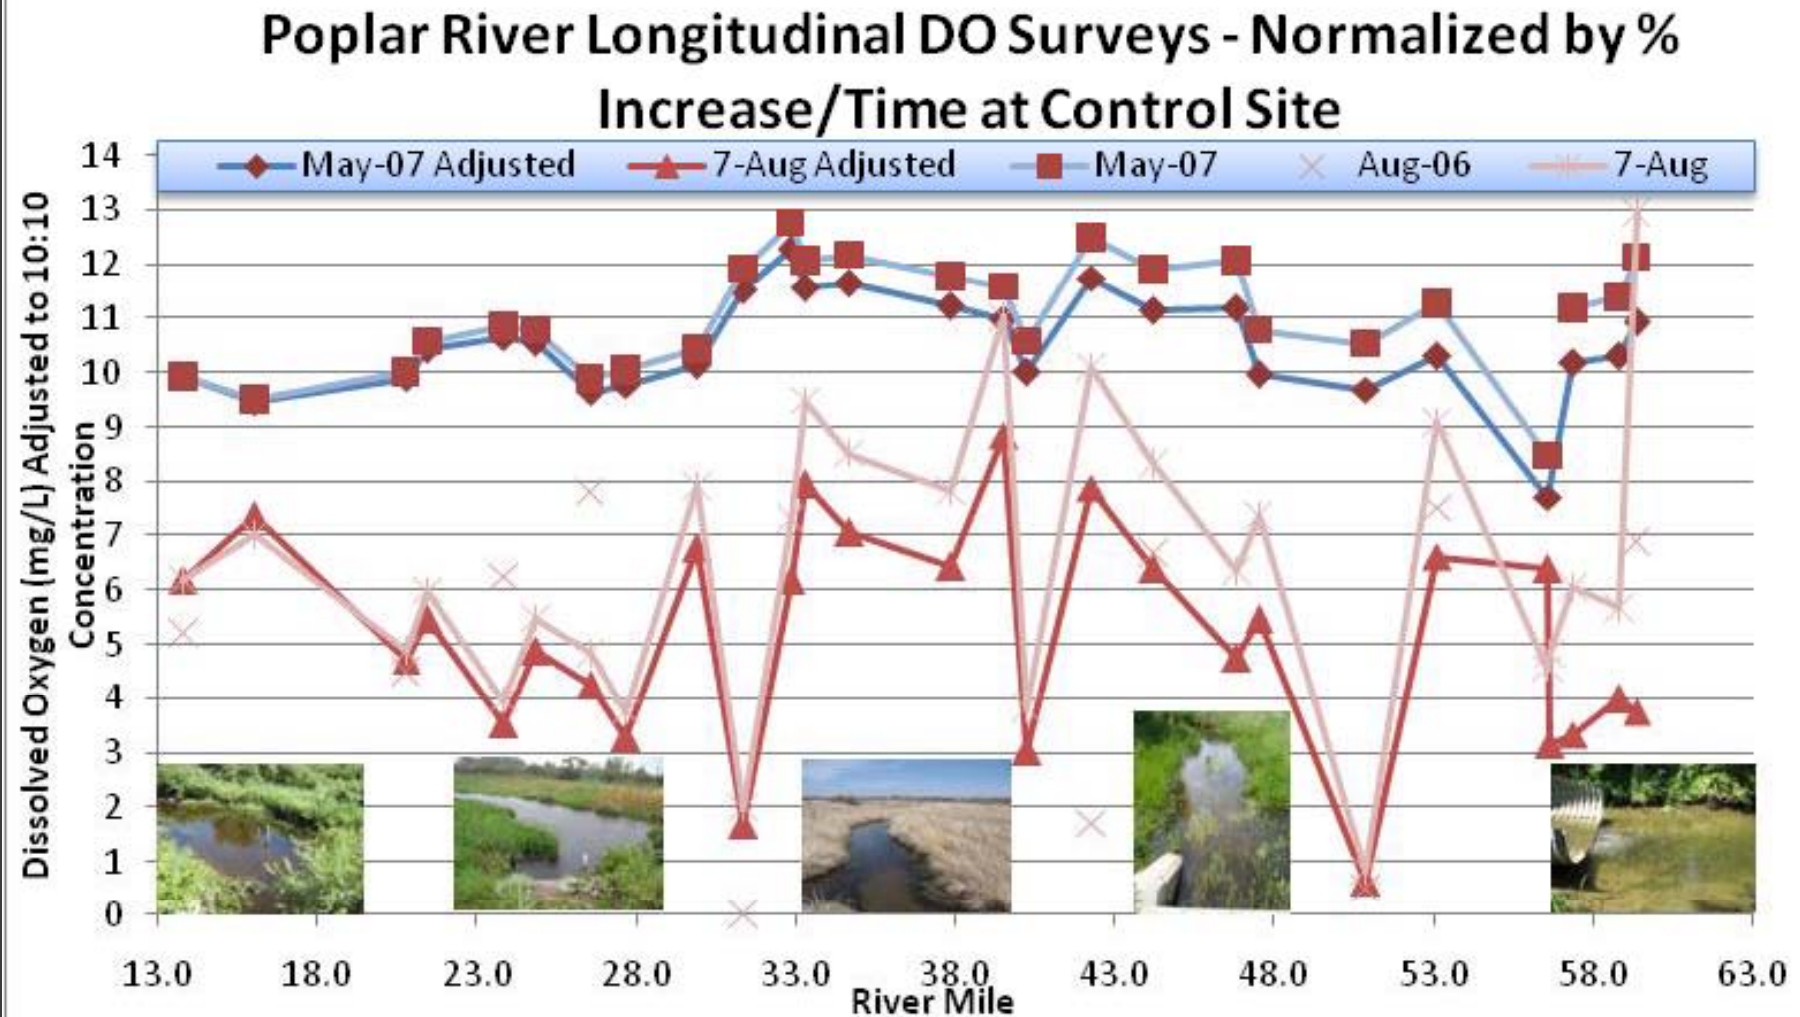
Longitudinal DO – Poplar River

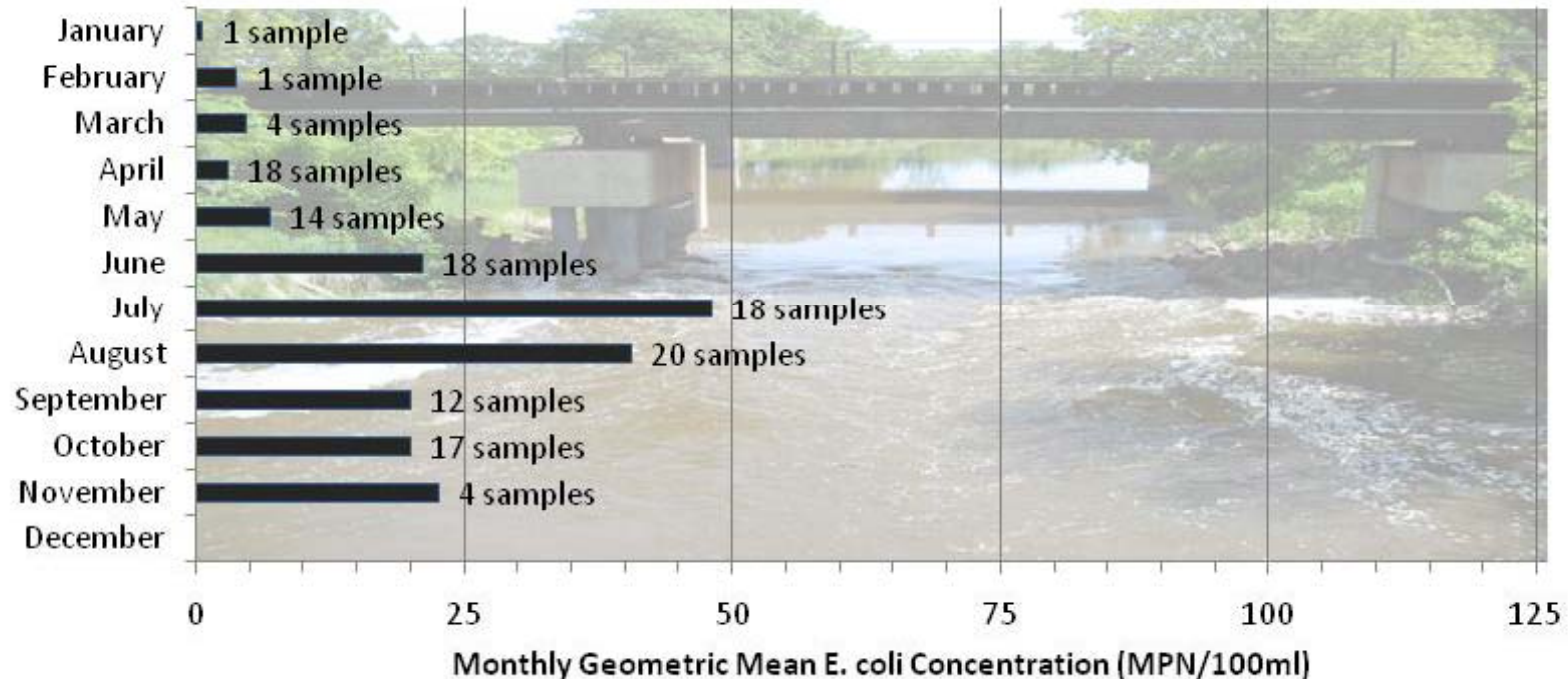
E. coli - Step 1			
Standard	# of Measurements	# of Exceedances	% Exceedance
126 CFU/100ml	127	4	3.1%
1260 CFU/100ml	127	1	0.8%

Clearwater River at Plummer USGS Gauge (Site 780) Monthly Geometric Mean E. Coli Concentrations

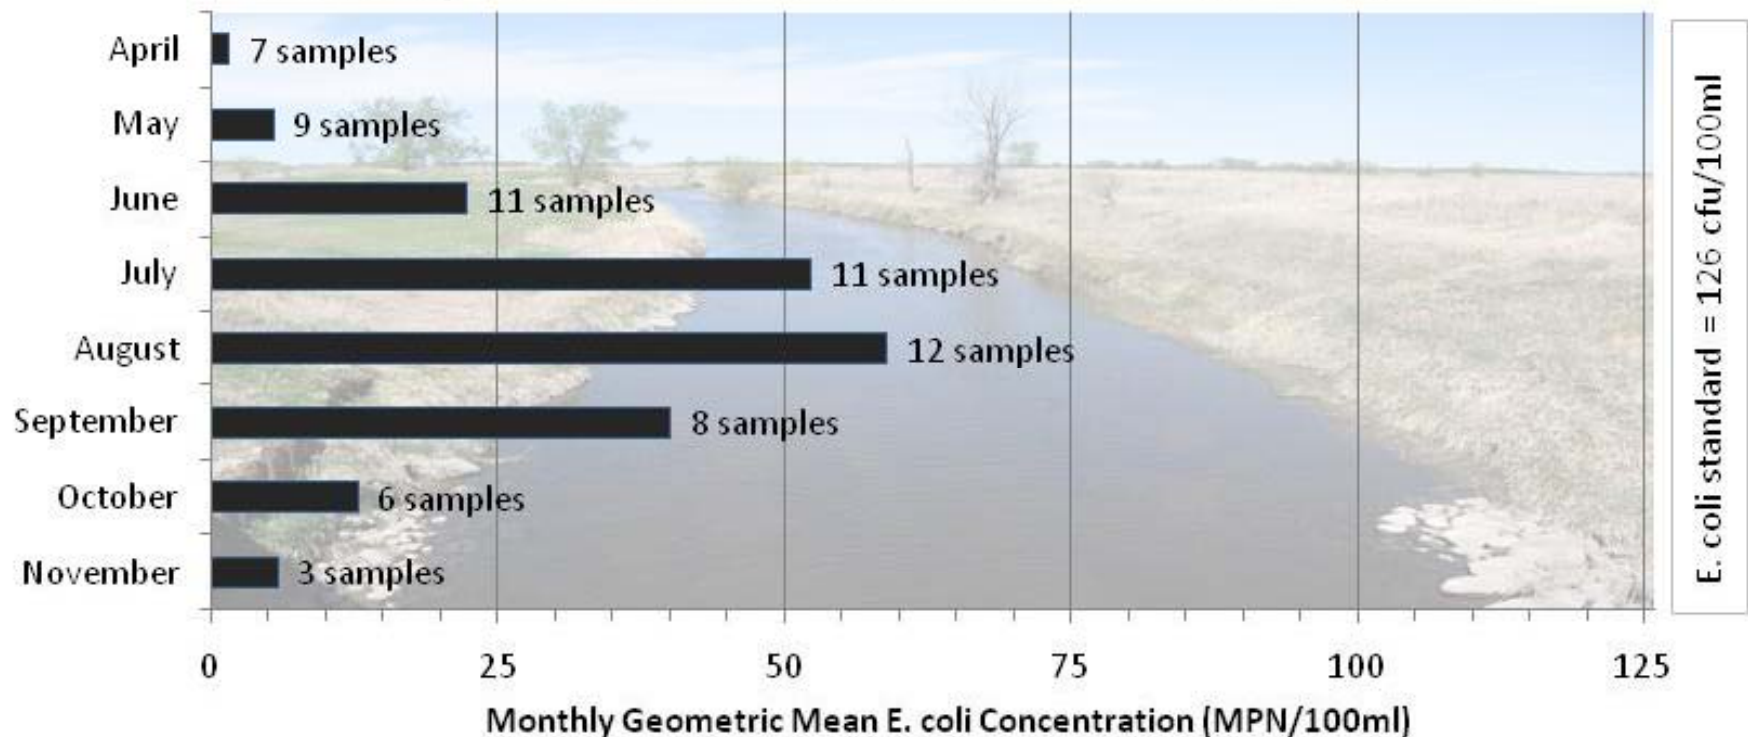
E. coli - Step 1			
# of Measurements	# of Exceedances	% Exceedance	Standard
67	3	4%	126 CFU/100ml
67	1	1%	1260 CFU/100ml

Clearwater River at the Roland Bridge (CSAH 10) Monthly Geometric Mean E. Coli Concentrations

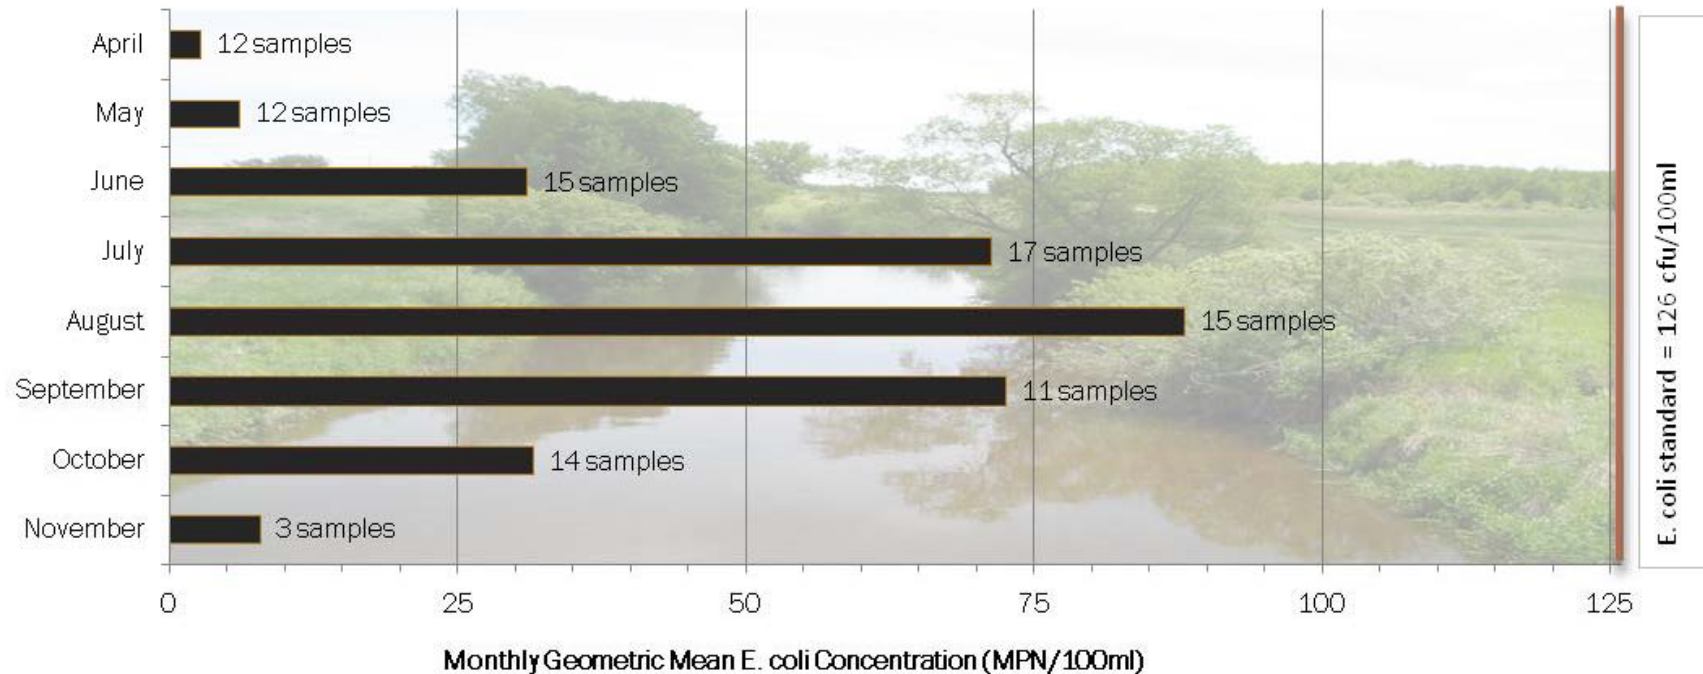
E. coli - Step 1			
# of Measurements	# of Exceedances	% Exceedance	Standard
102	10	9.8%	126 CFU/100ml
102	0	0.0%	1260 CFU/100ml

Clearwater River at the Trail Road (260th St NE, Site # 37) Monthly Geometric Mean E. Coli Concentrations

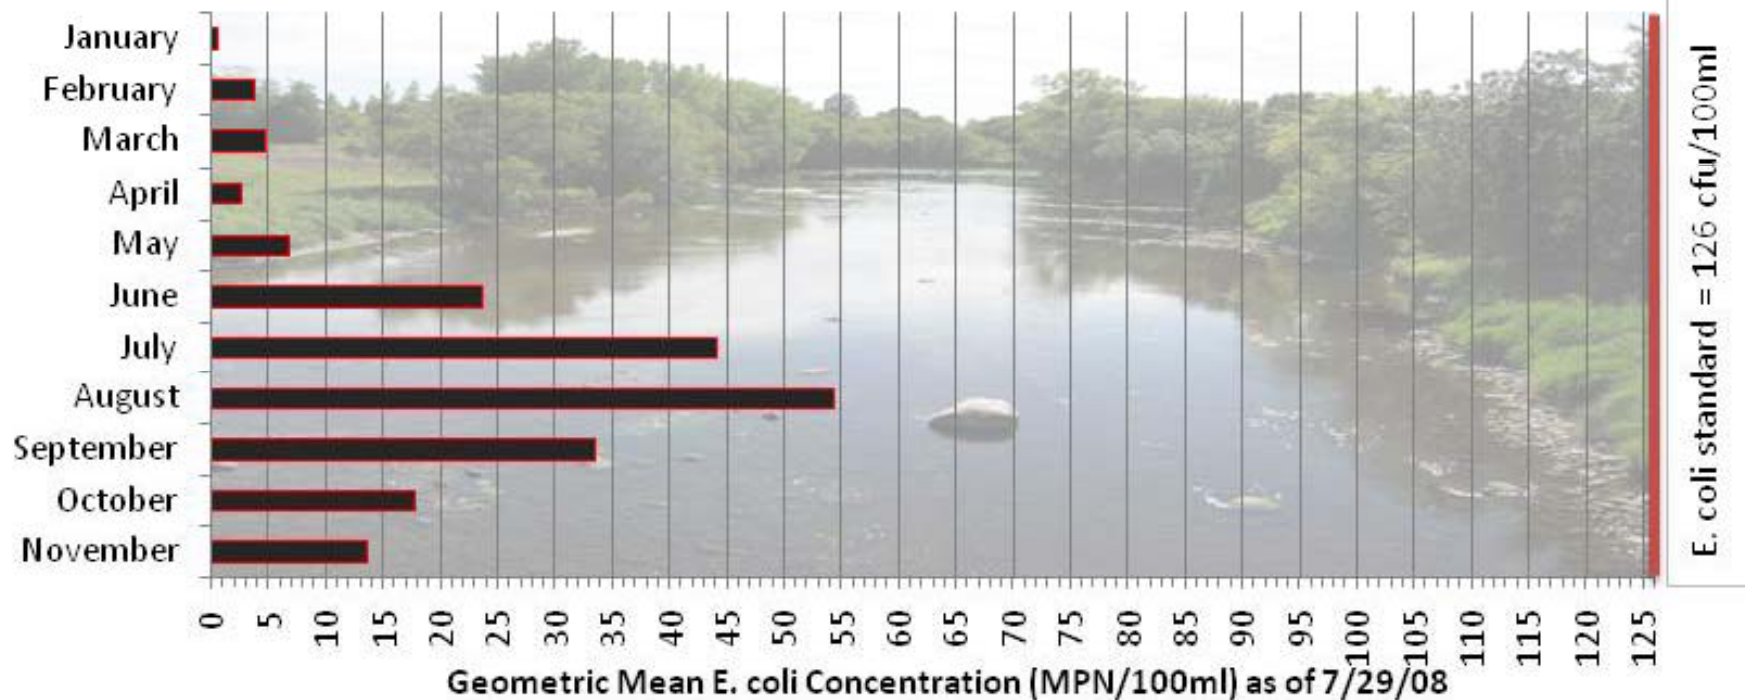
E. coli - Step 1			
# of Days Sampled	# of Exceedances	% Exceedance	Standard
154	8	5.2%	126 CFU/100ml
154	0	0.0%	1260 CFU/100ml

Clearwater River E. Coli GeoMeans

Ruffy Brook to the Lost River

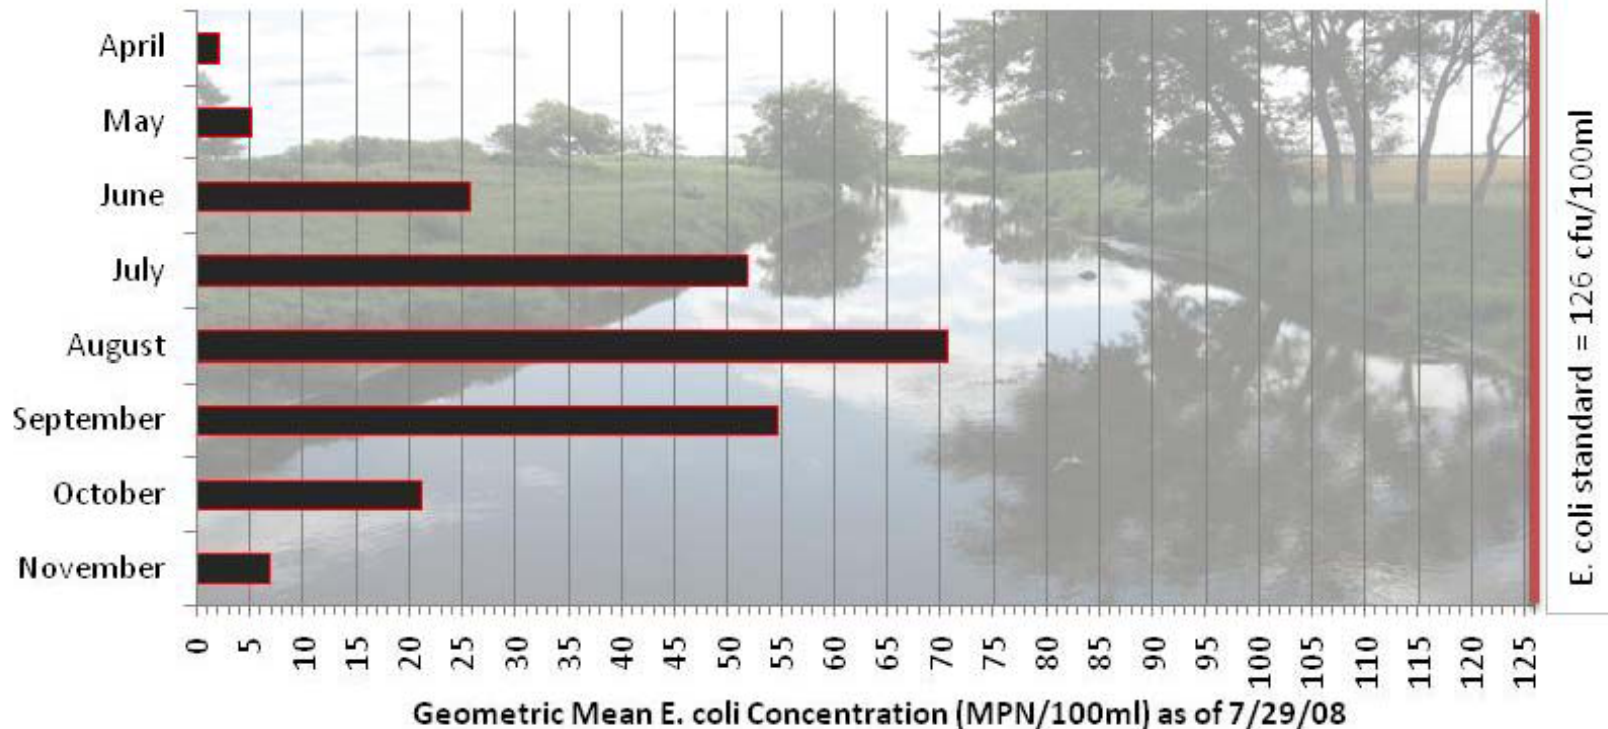
E. coli - Step 1			
# of Days Sampled	# of Exceedances	% Exceedance	Standard
118	10	8.5%	126 CFU/100ml
118	1	0.8%	1260 CFU/100ml

Channelized Clearwater River E. Coli GeoMeans

Roland Bridge and Trail Road Monitoring Sites

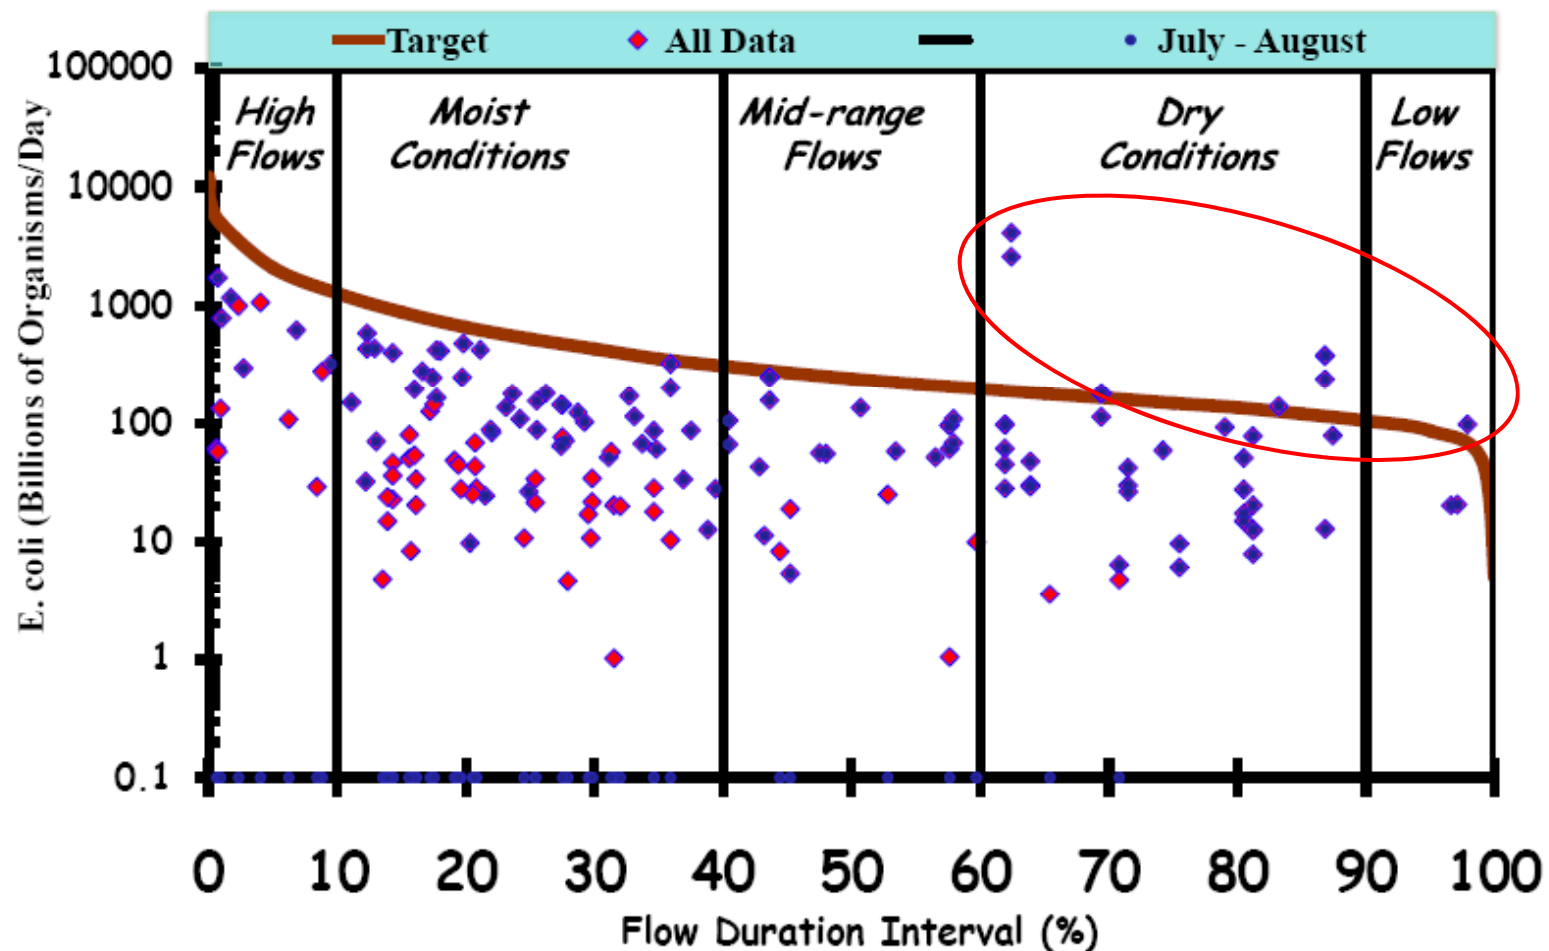
Clearwater River at Plummer
Load Duration Curve (1998 - 2008 Monitoring Data)
Site: 05078000

IDEM Data & USGS Gage Duration Interval

555 square miles

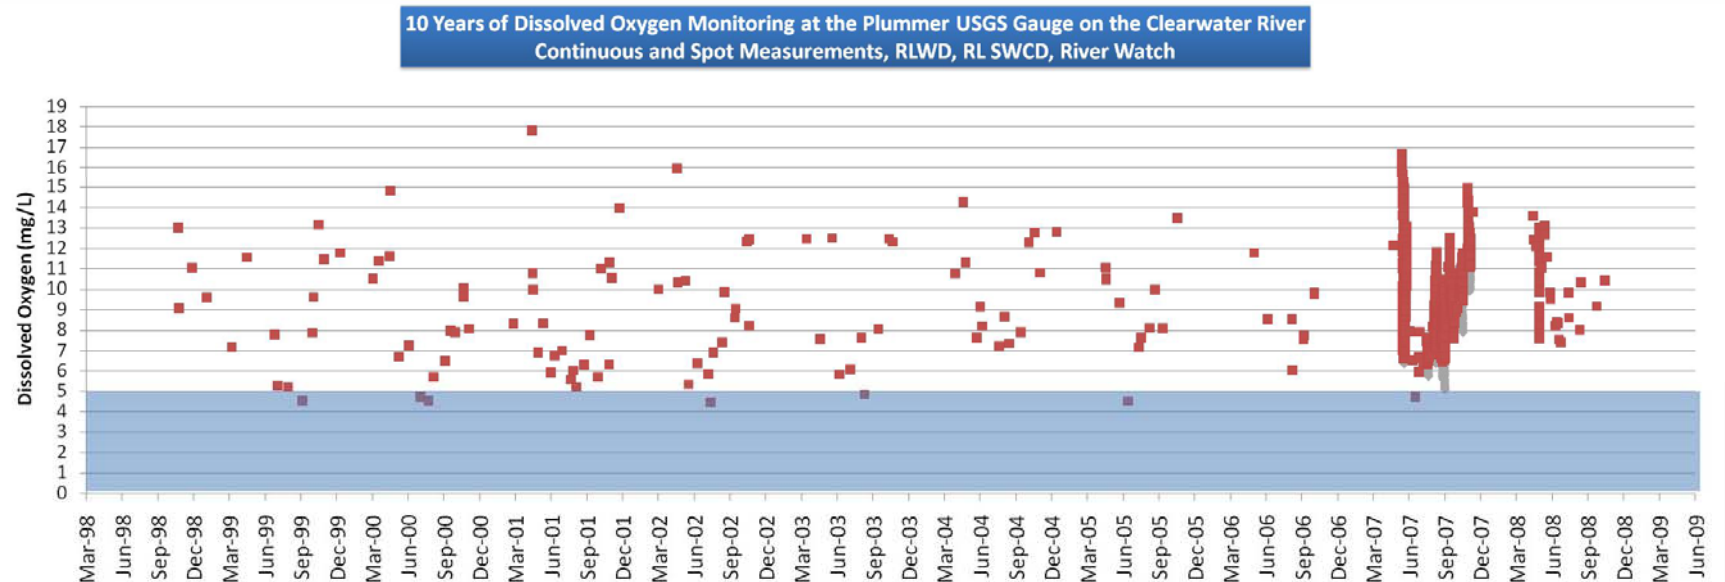
Clearwater River Low Dissolved Oxygen Assessment Results

- Entire reach, all sites
 - 5.1% of Daily Minimums are below the 5mg/L
- Sites 21 and 37 in the channelized reach
 - 12.5% and 3.81% of daily minimums are below 5 mg/L, respectively

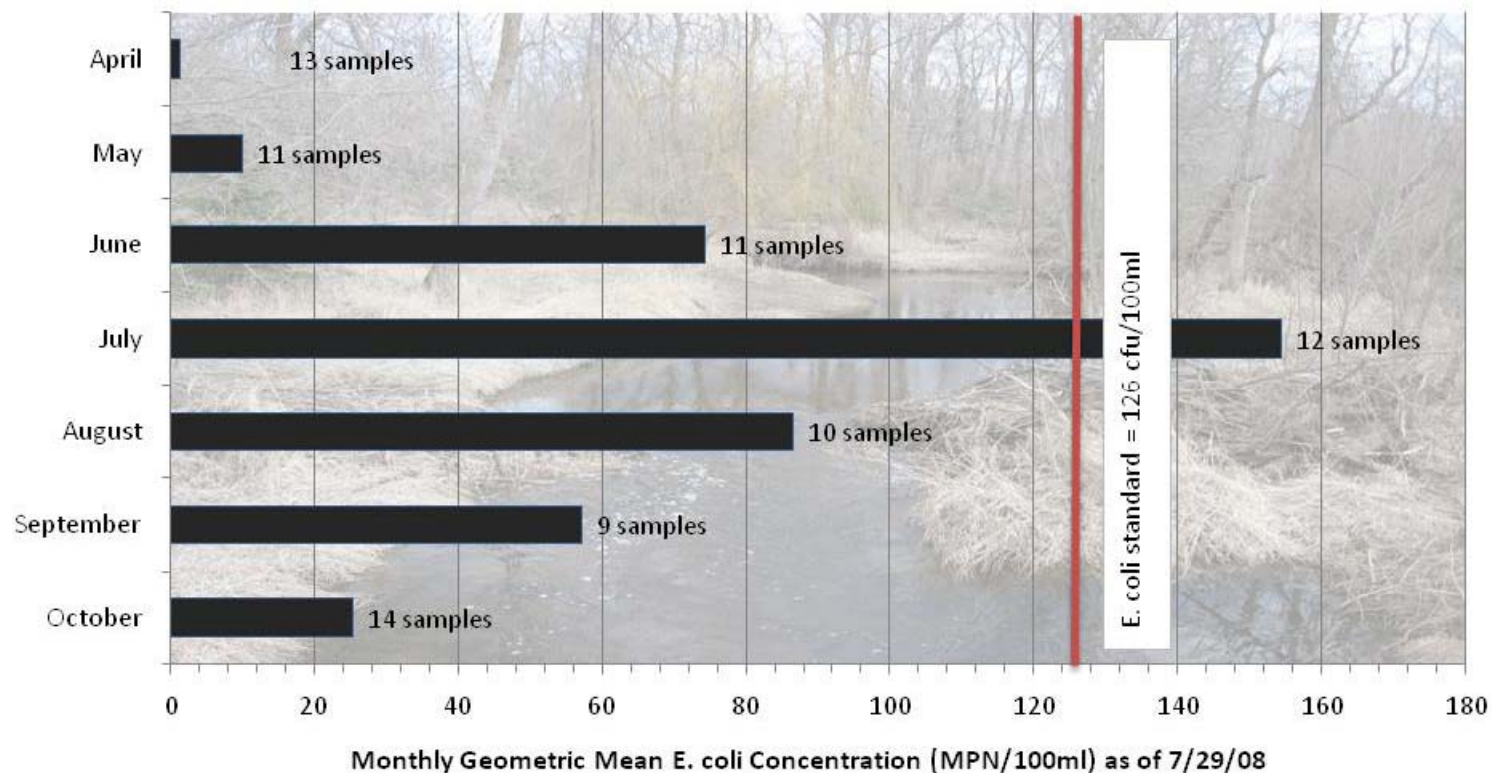
E. coli - Step 1			
# of Measurements	# of Exceedances	% Exceedance	Standard
91	19	21%	126 CFU/100ml
91	2	2%	1260 CFU/100ml

Silver Creek at CR111 (Site #81)
Monthly Geometric Mean E. Coli Concentrations

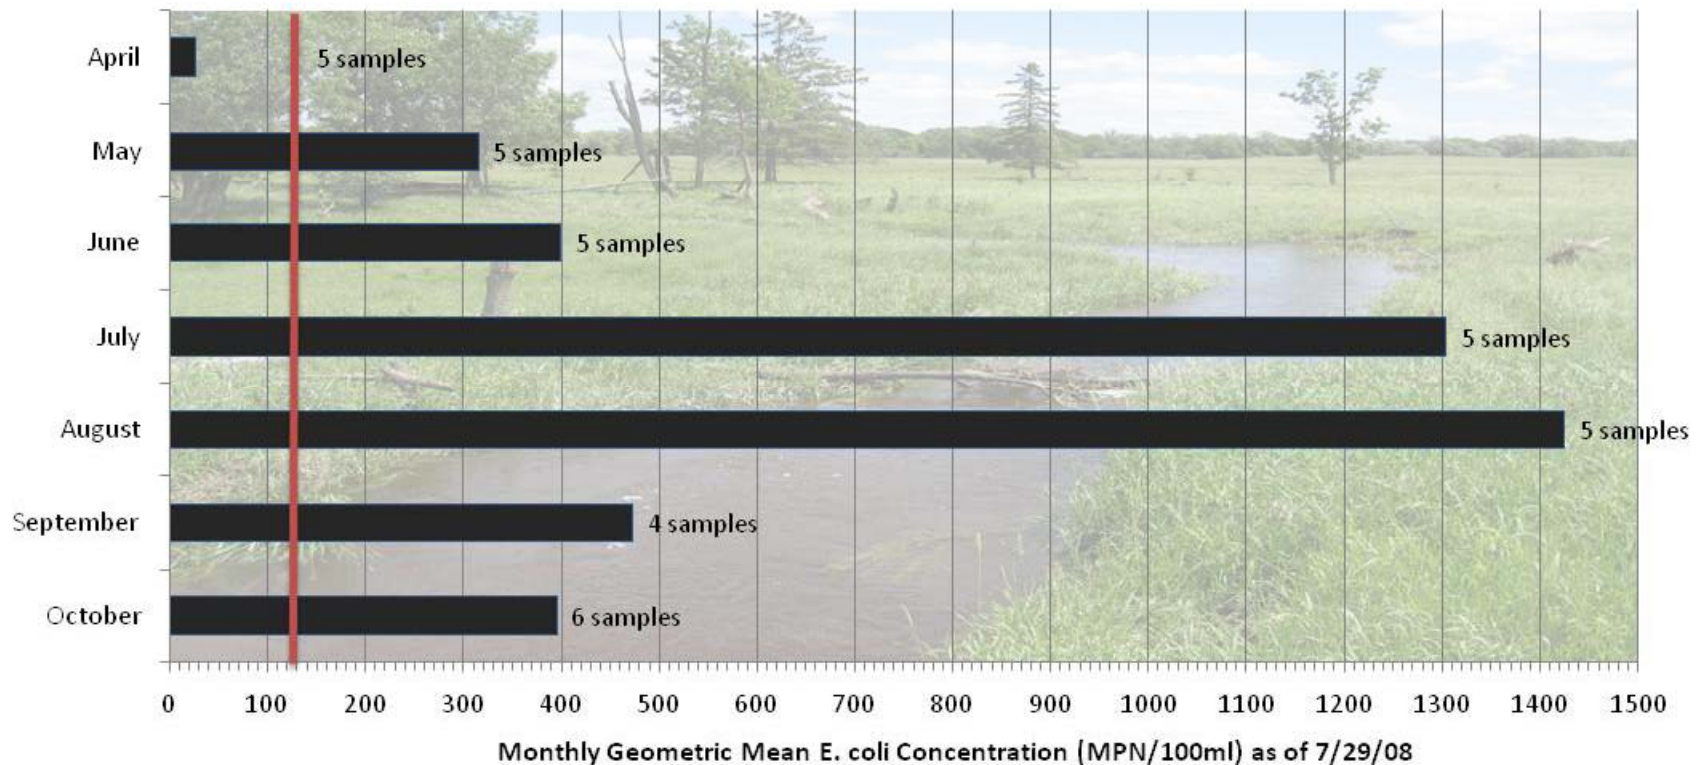
E. coli - Step 1			
# of Measurements	# of Exceedances	% Exceedance	Standard
35	28	80%	126 CFU/100ml
35	7	20%	1260 CFU/100ml

Silver Creek East of Clearbrook (Site 157)
Monthly Geometric Mean E. coli Concentrations

E. coli standard = 126 cfu/100ml

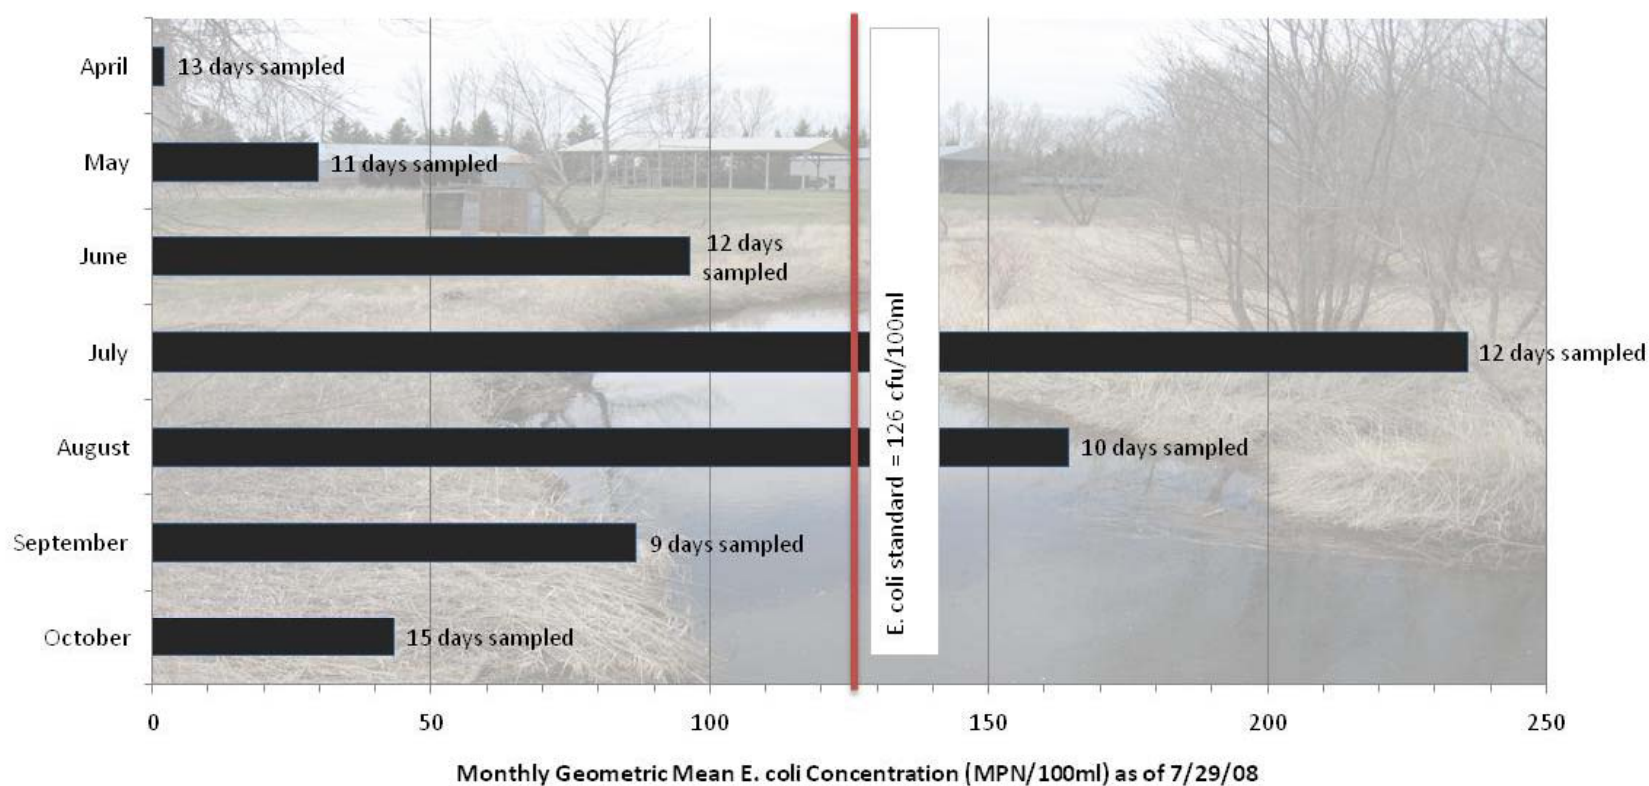
E. coli - Step 1			
# of Days	# of Exceedances	% Exceedance	Standard
93	29	31.2%	126 CFU/100ml
93	1	1.1%	1260 CFU/100ml

Silver Creek - Combined
Monthly Geometric Mean E. Coli Concentrations
