CLEARWATER RIVER DISSOLVED OXYGEN AND FECAL COLIFORM TMDL STUDY

Red River Basin Water quality Team

December 15, 2008

Review Impaired Reaches of the TMDL Study

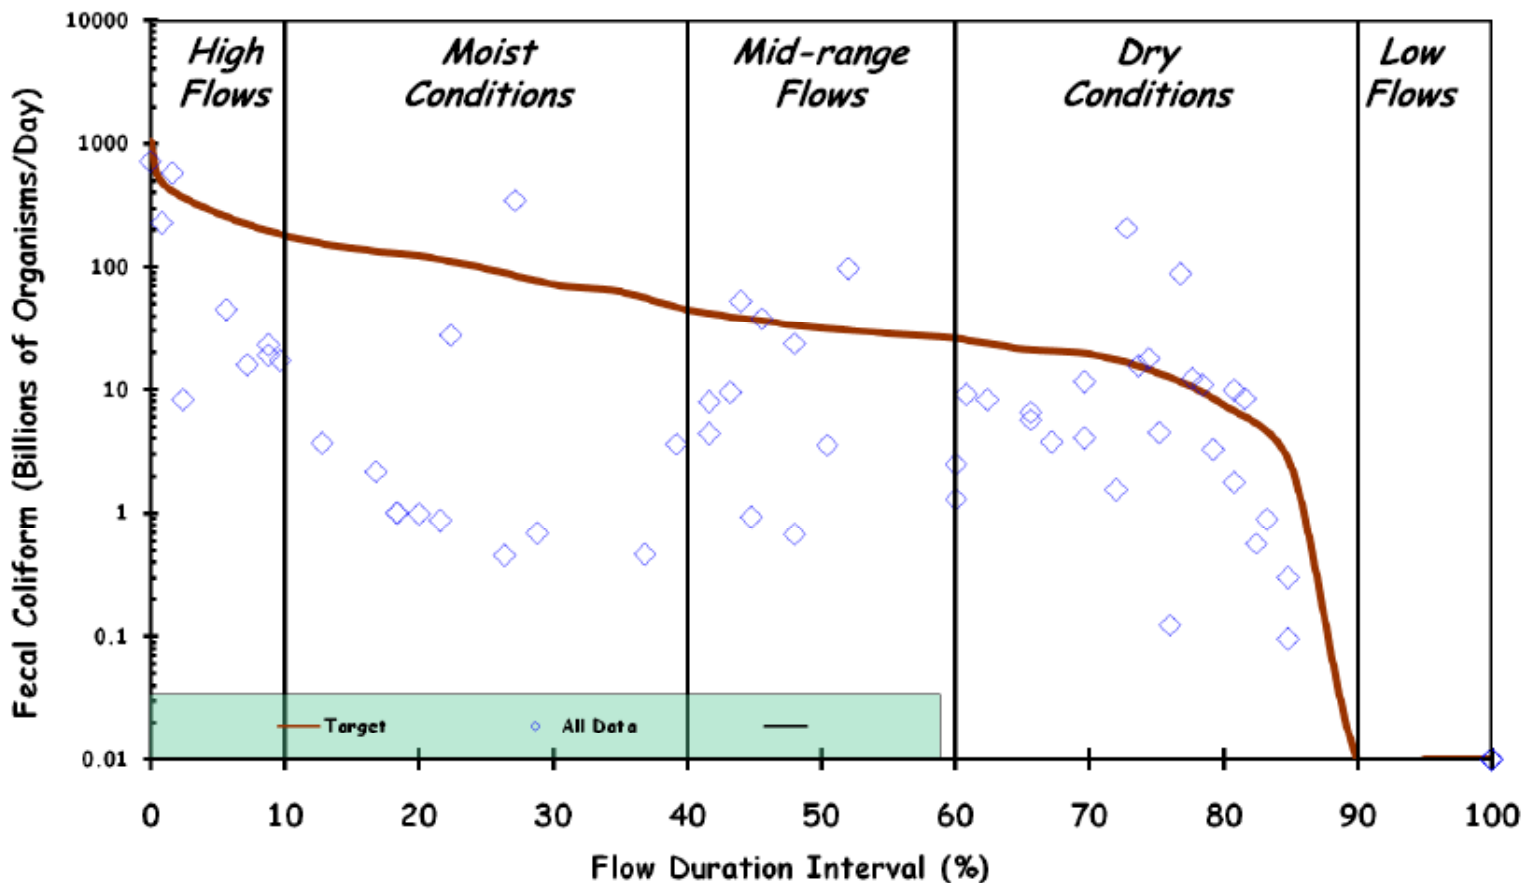
Silver Creek at CR111 NE of Gonvick, MN

Load Duration Curve (2002 - 2008 Monitoring Data)

RLWD Water Quality Monitoring Site #81

34.3 square miles

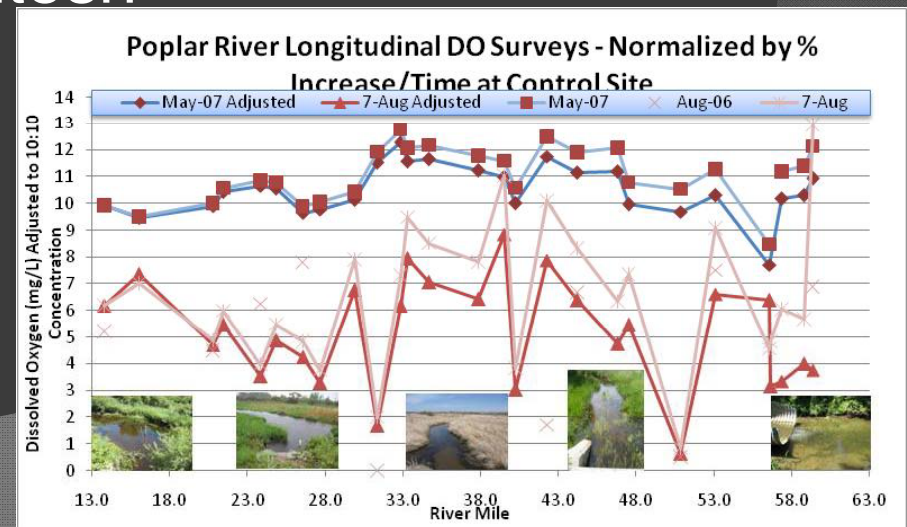
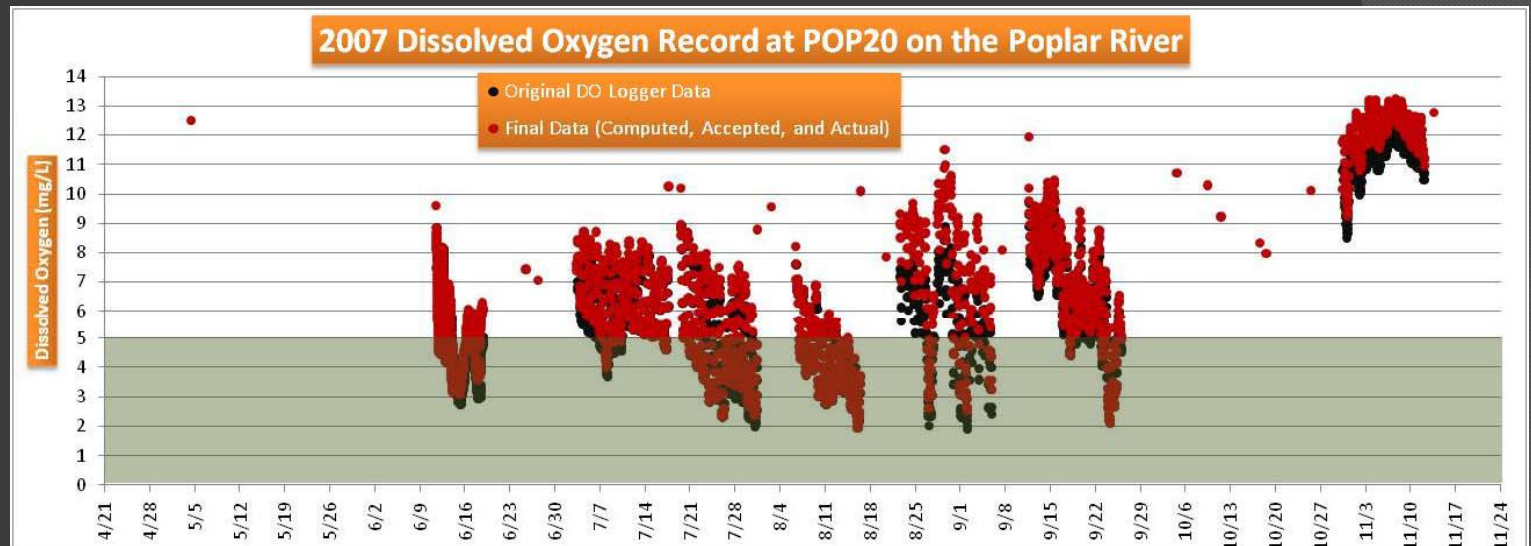
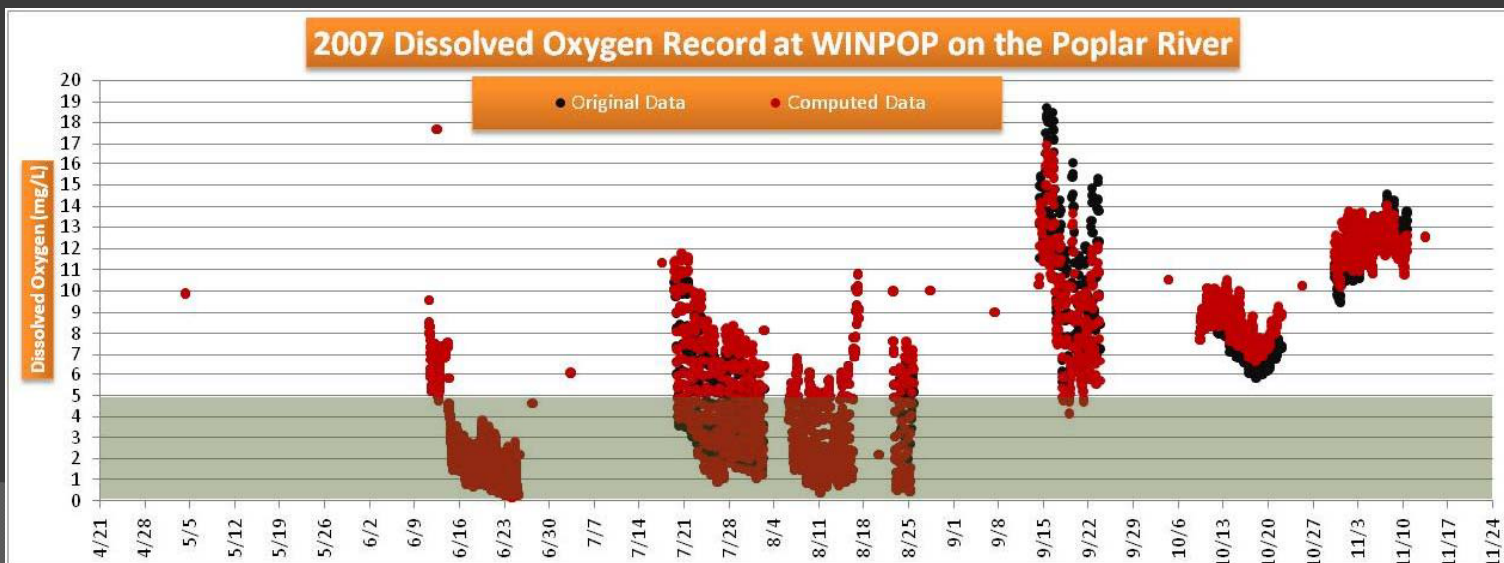
Poplar River Low Dissolved Oxygen Assessment Results

- Rate at which daily minimums fail to meet the 5 mg/L standard increases from upstream to downstream
 - 11% at Spring Lake
 - 40% downstream of Fosston
 - 47% downstream of McIntosh
 - 53% near Highway 59

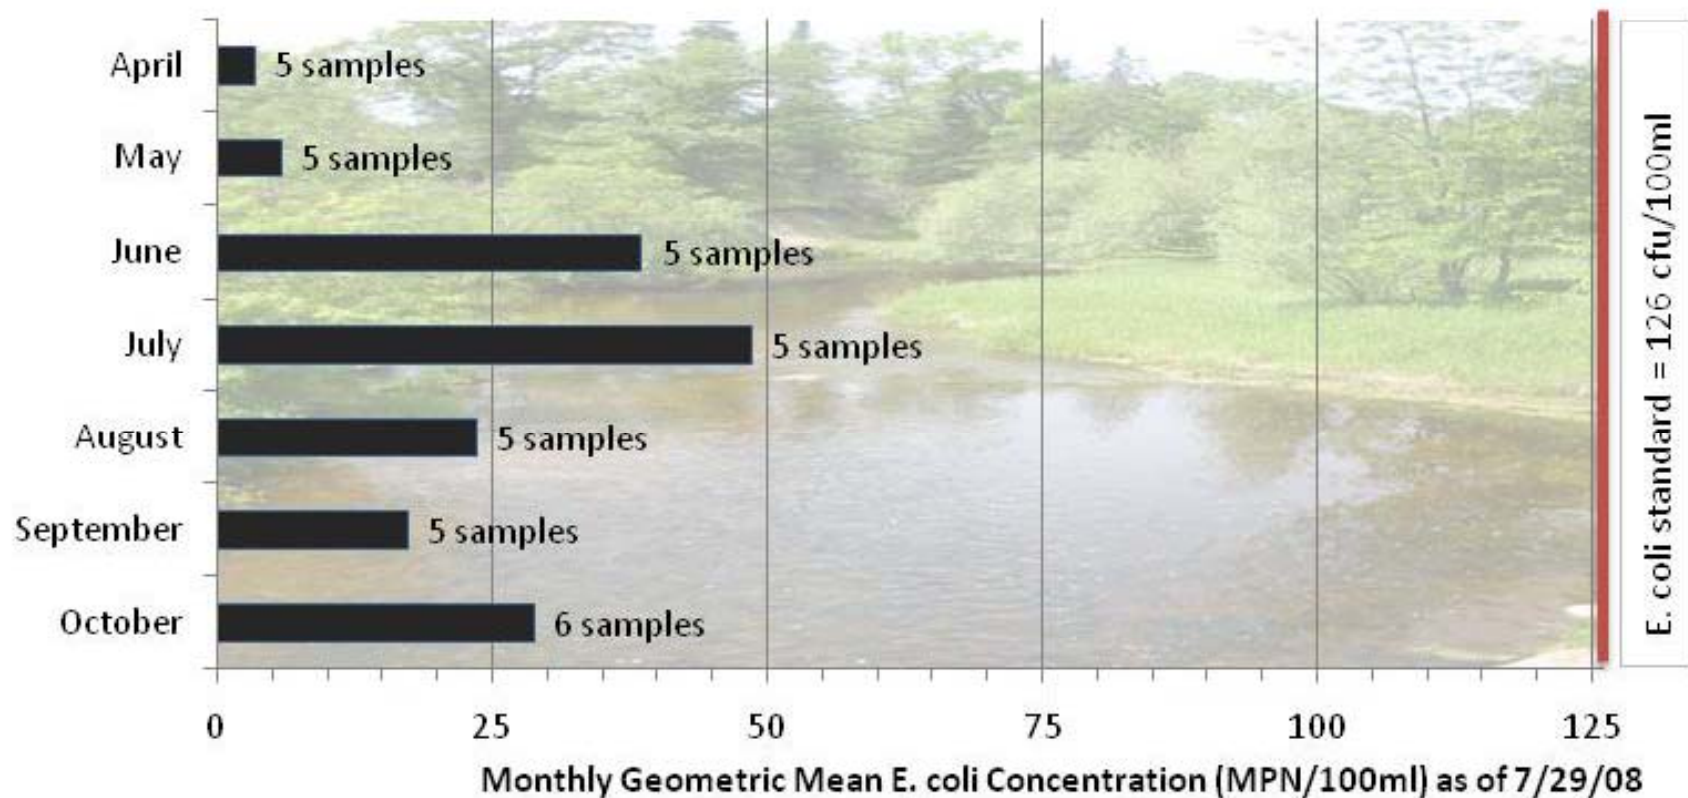
E. coli - Step 1			
# of Days Samp	# of Exceedances	% Exceedance	Standard
36	2	6%	126 CFU/100ml
36	0	0%	1260 CFU/100ml

Lost River at CSAH 7 North of Gonvick Monthly Geometric Mean E. Coli Concentrations

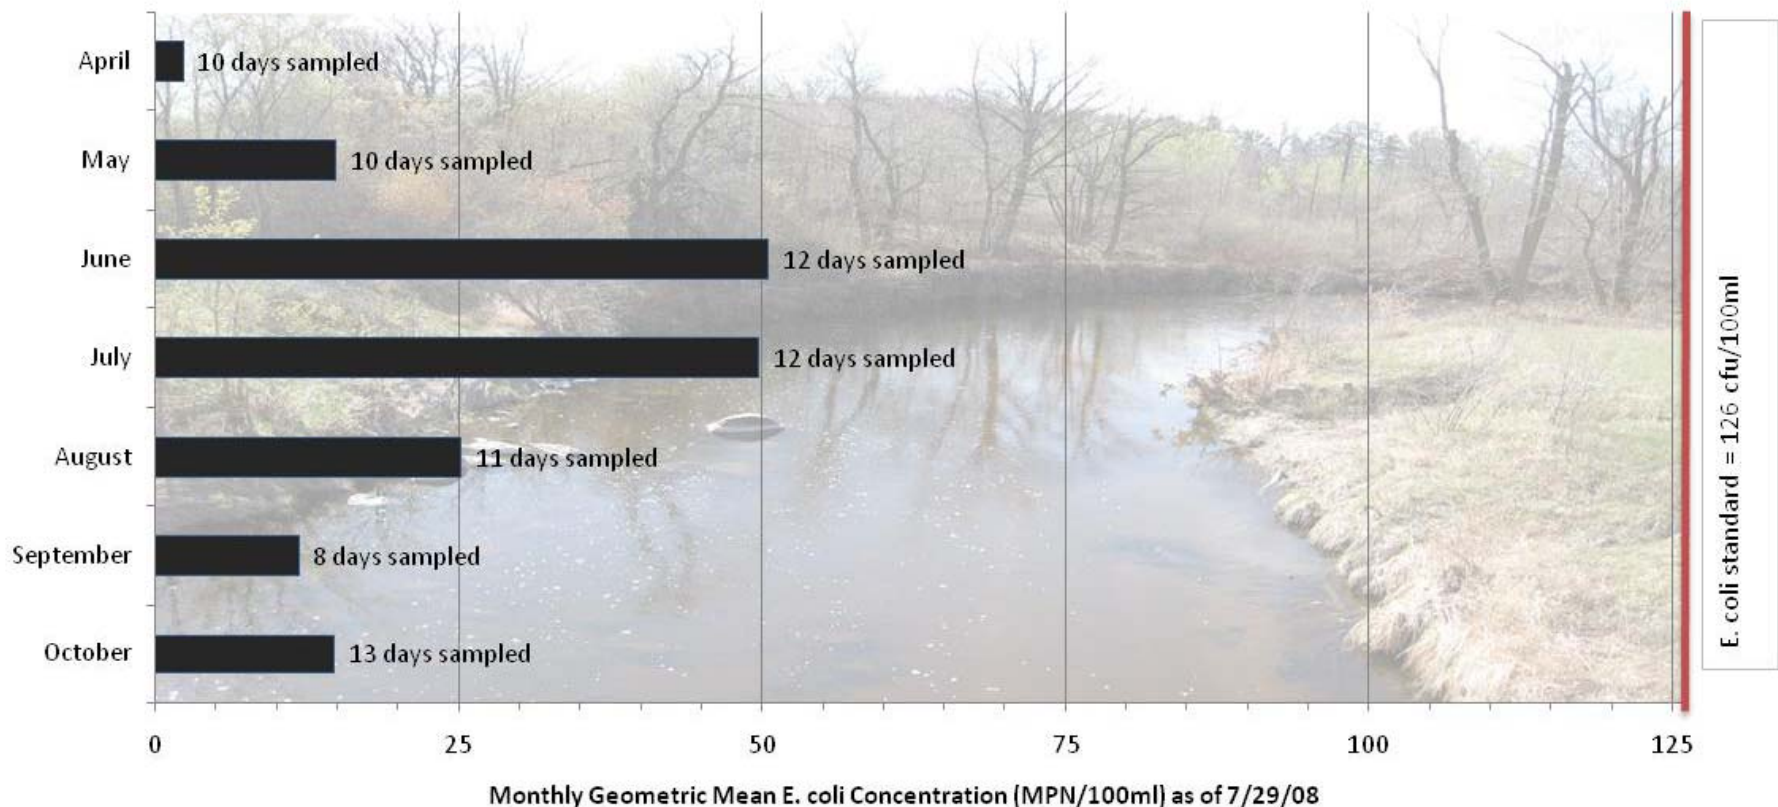
E. coli - Step 1			
# of Measurements	# of Exceedances	% Exceedance	Standard
86	7	8.1%	126 CFU/100ml
86	0	0.0%	1260 CFU/100ml

Lost River Monthly Geometric Mean E. Coli Concentrations

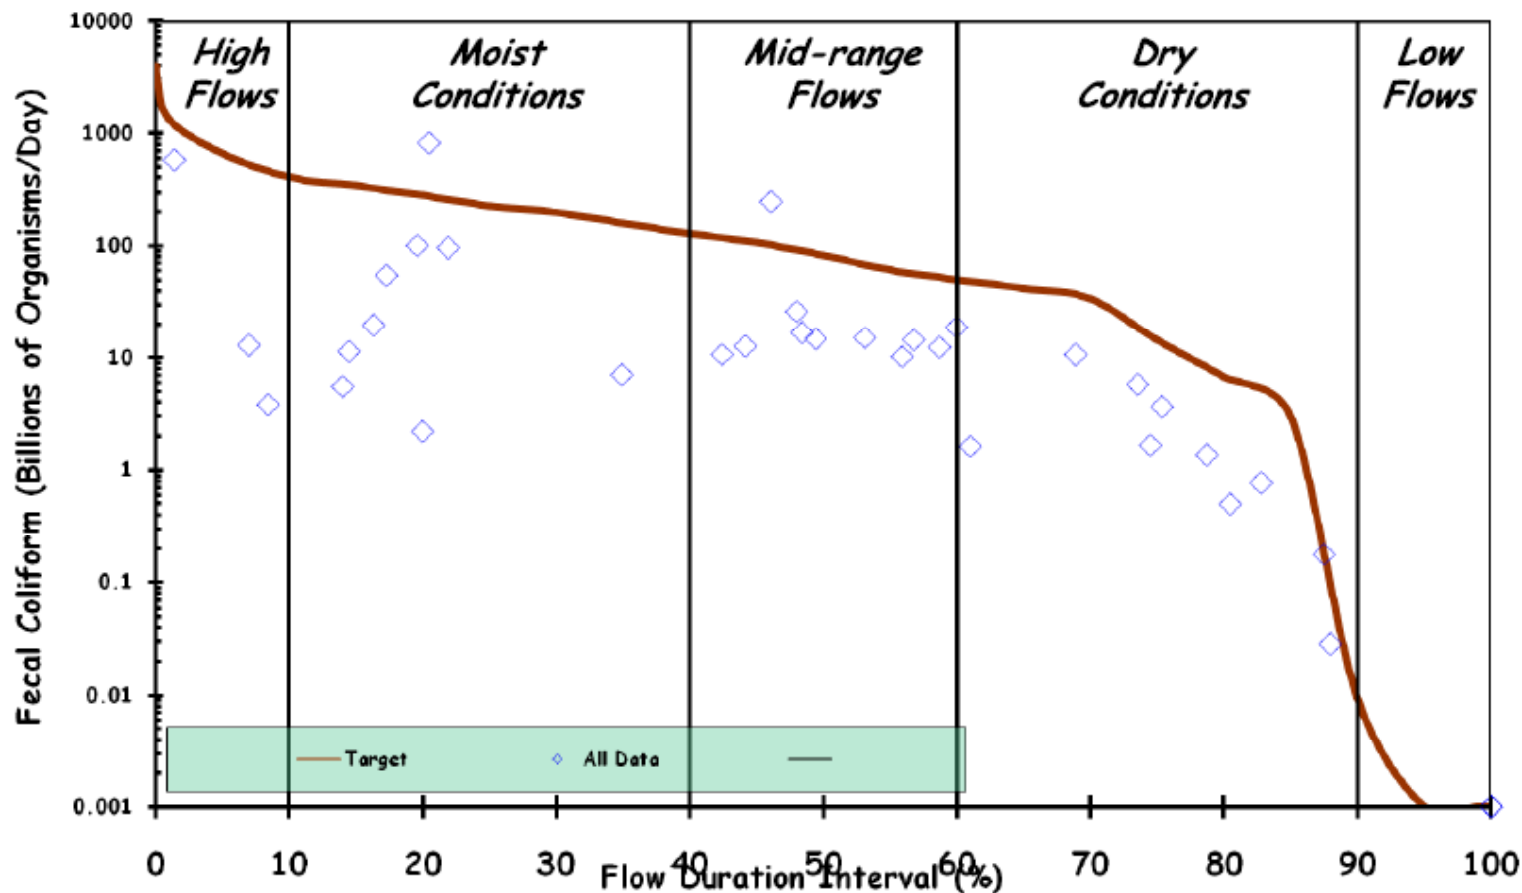
Lost River at CR7, North of Gonvick, MN Load Duration Curve (2007 - 2008 Monitoring Data) RLWD Monitoring Site #51

105.7 square miles

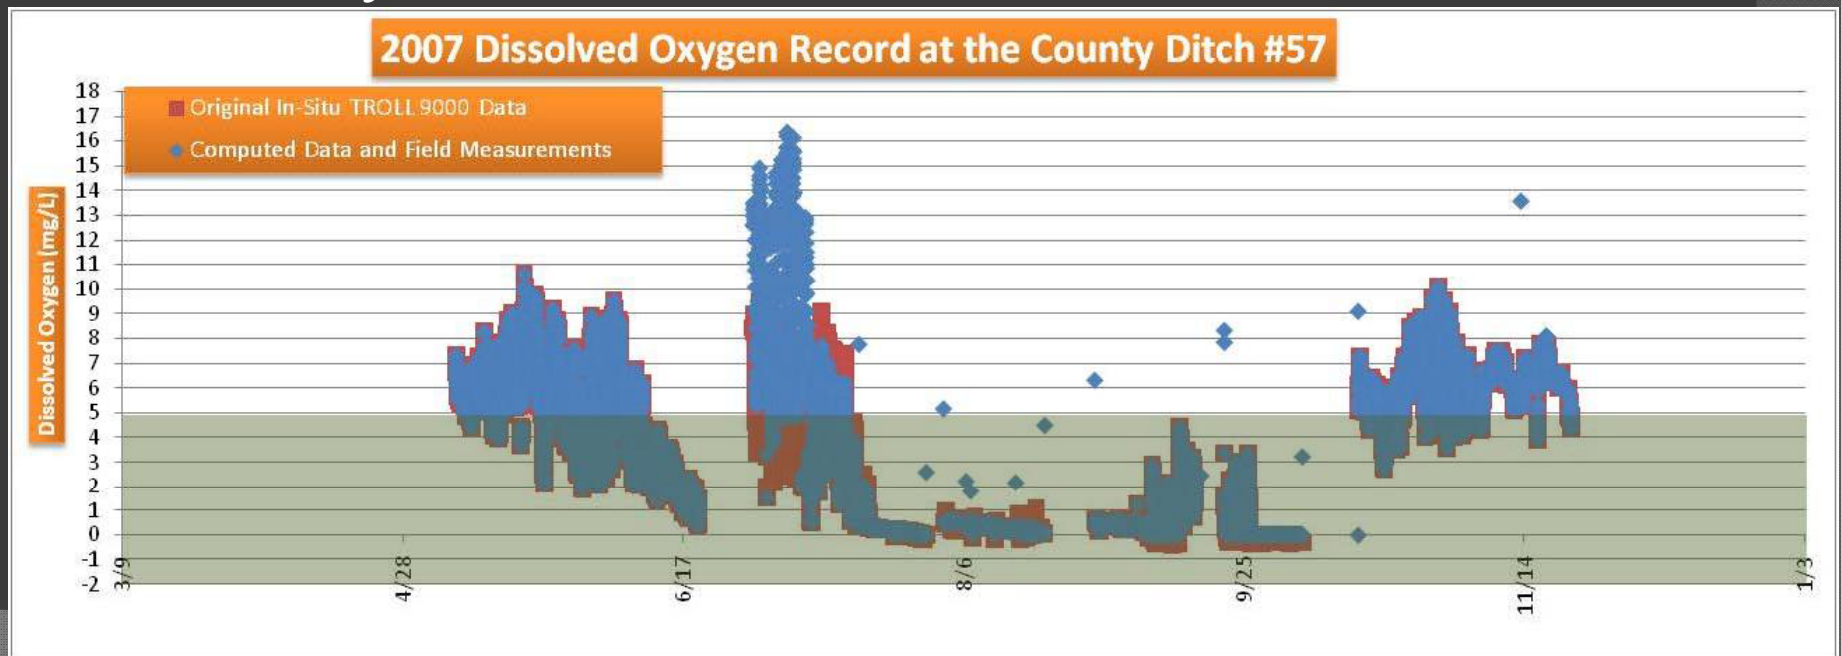
County Ditch 57 Low Dissolved Oxygen

- 78.74% of daily minimums fail to meet the 5 mg/L standard
- Should a road ditch meet warm water fishery standards?

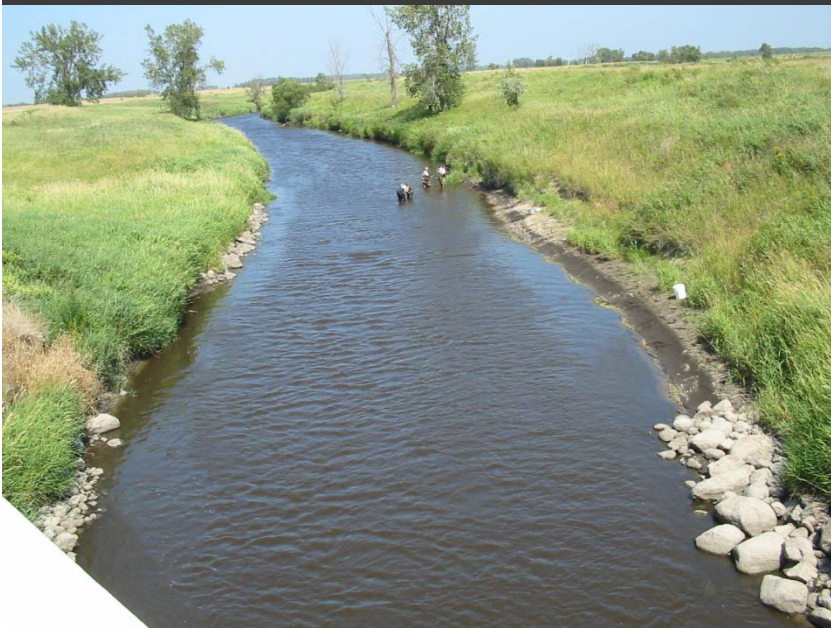
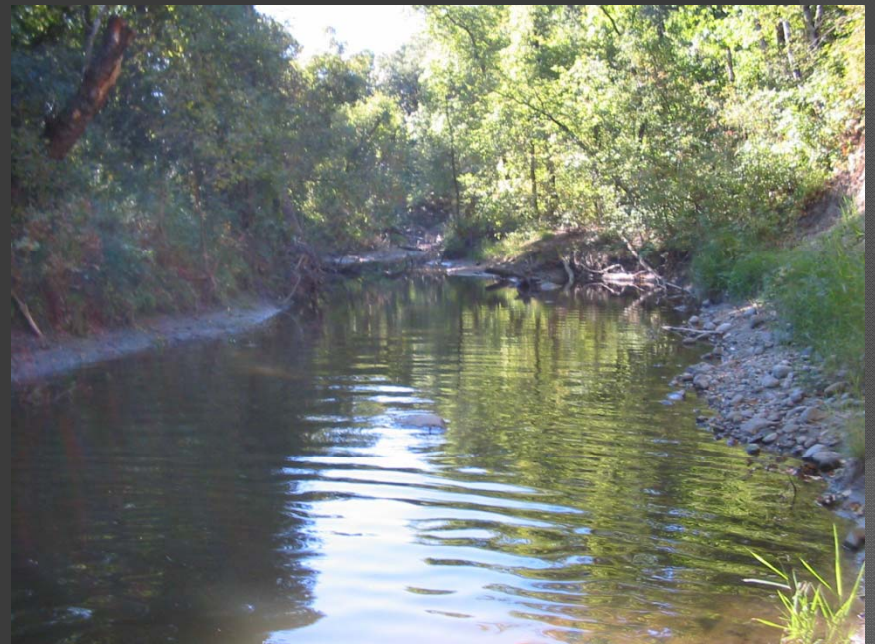
Address Lack of Shade

- Implement/Improve Riparian Buffers

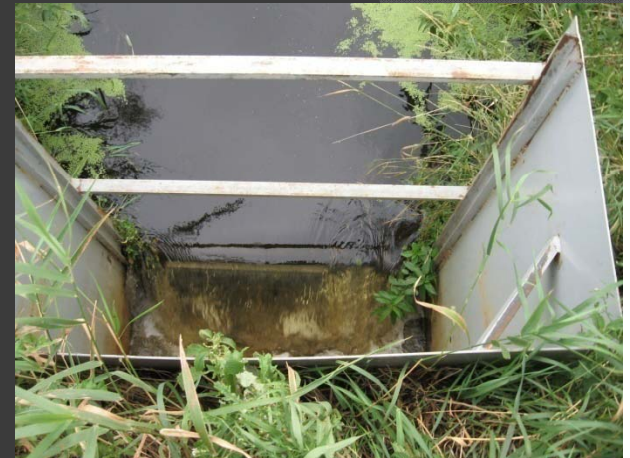
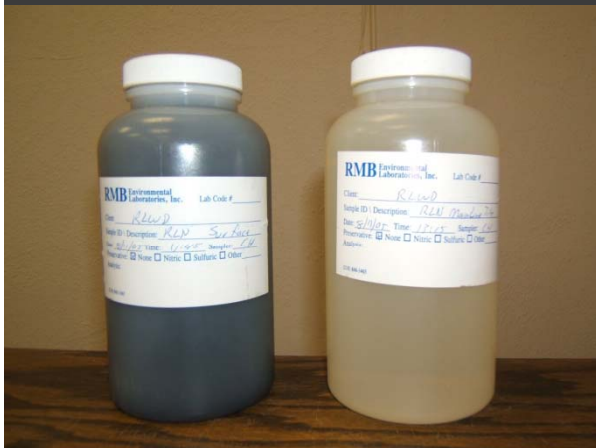
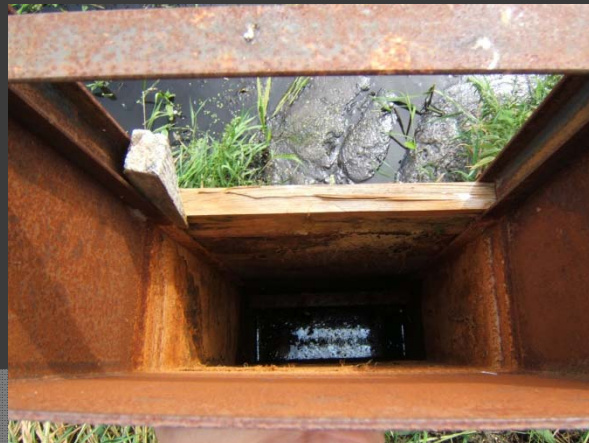
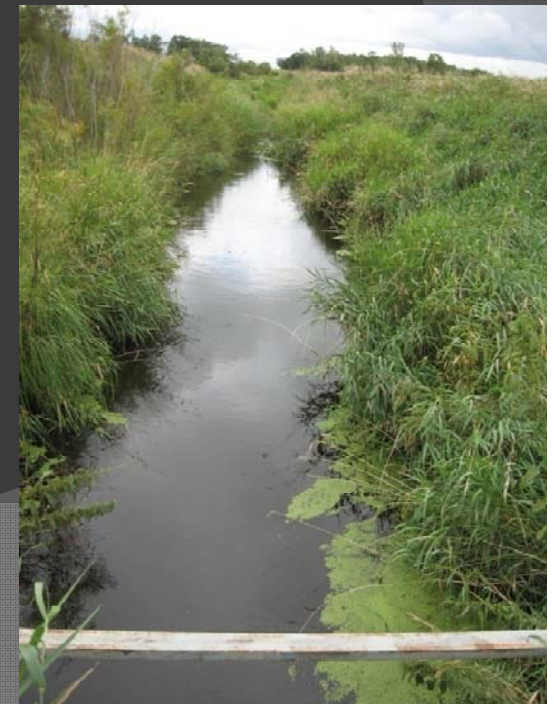
Wild Rice Paddy BMPs

- Main Line Tile
 - Fecal coliform data
- Catch Basins
- Keeping a buffer on the river
- Stabilizing outlets with rock
- Fords acting as riffles
