# Clearwater Lake

MANAGEMENT PLAN

Section F. Lake Water Quality Assessment and  
Water Quality Recommendations

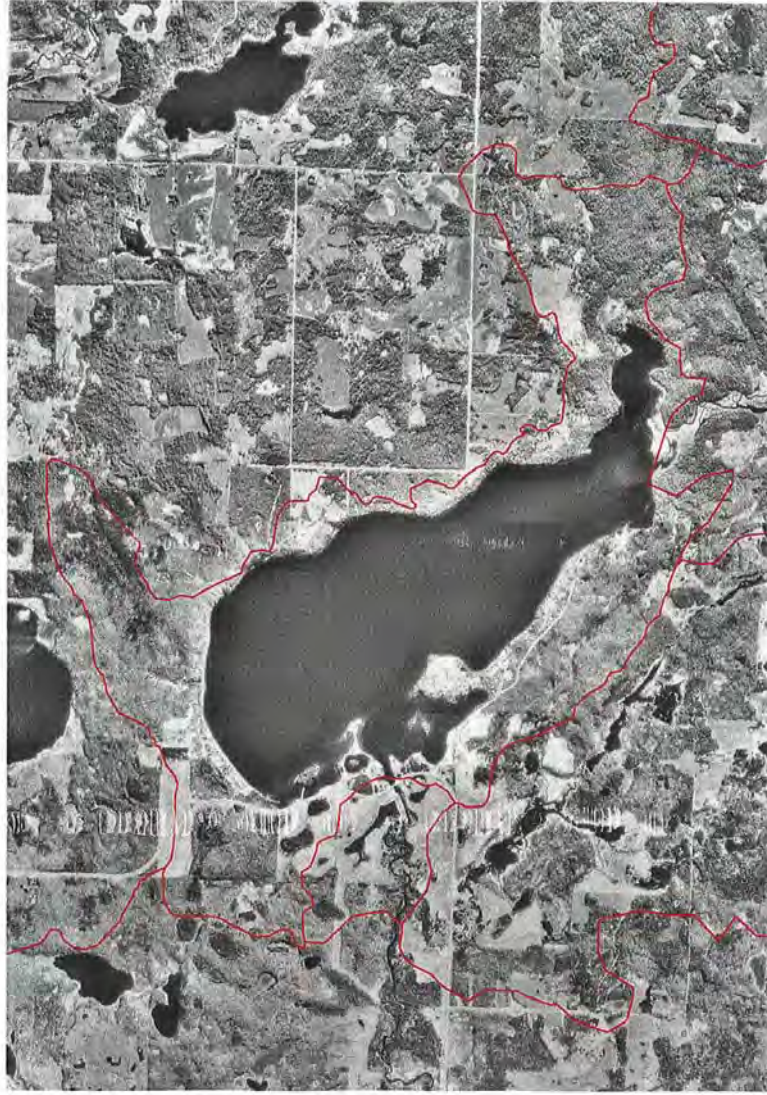
# Clearwater Lake Watershed

*Aerial Photography*

□ Minor Watersheds

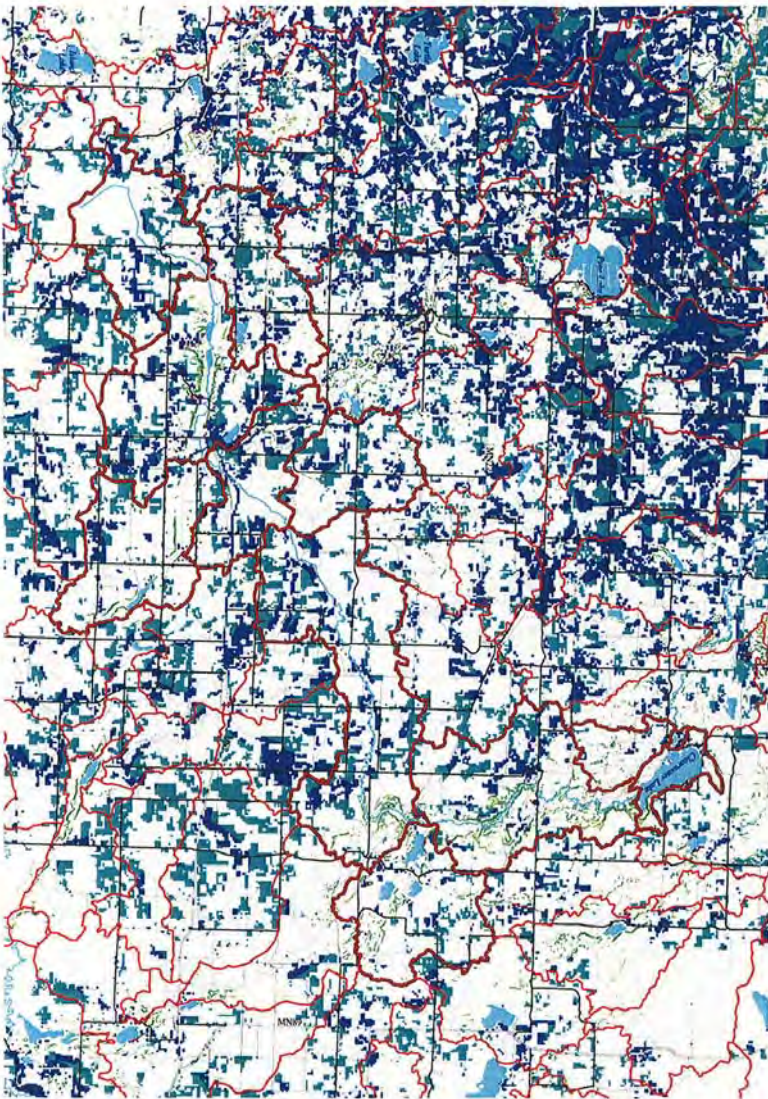
# Clearwater Lake Watershed and Surrounding Area *Erosion (Runoff) Susceptibility*

- Minor Watersheds
- Major Roads
- County Roads
- Township Roads
- State Trails
- Lakes
- Rivers
- Streams
- Water Features
- Uplands
- Wet meadow
- Wooded swamps
- Shrub swamp
- Shallow marsh
- Deep marsh
- Bores
- Shallow open water
- Riverine systems
- Seasonally flooded
- Municipal and industrial activities

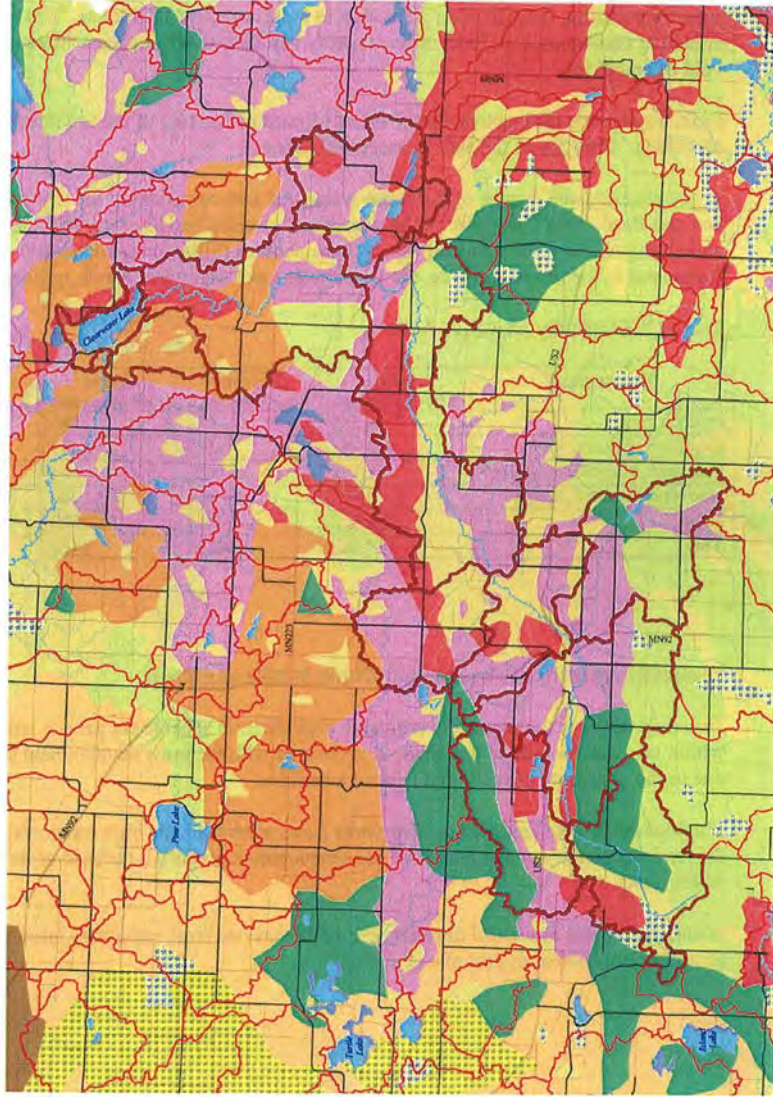
# Clearwater Lake Watershed and Surrounding Area *Pre-Settlement Vegetation*

- Minor Watershed
- County Roads
- Township Roads
- State Trails
- Roads
- Streams
- Pre-Settlement Vegetation
- Undeveloped
- Open Prairie
- Aspen-Oak Land
- Aspen-Birch (tending to hardwoods)
- Aspen-Birch (tending to Conifers)
- Big Woods - Hardwood (Oak, Maple, Hickory)
- Mixed White Pine and Red Pine
- Jack Pine Barrens and Openings
- Lower Ropes and Swamps
- Lakes (open water)

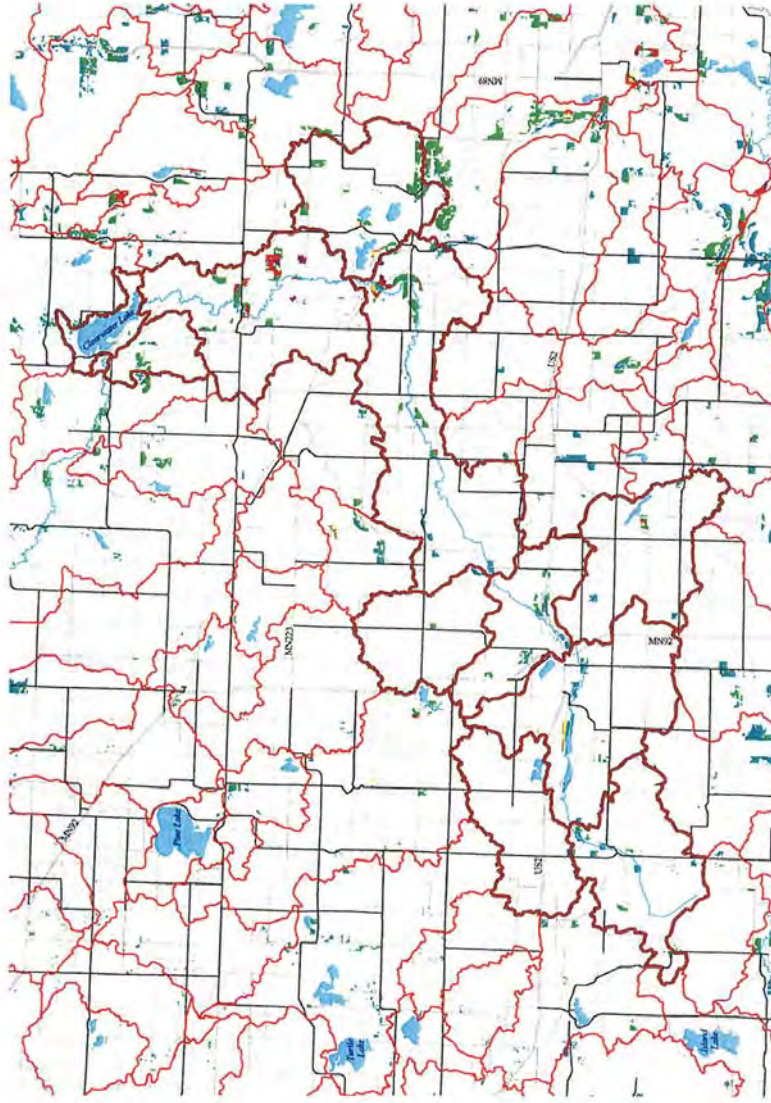
#### **Scenically Attractive Public Land Within ¼ Mile of a Road**

- Minor Watersheds
- Major Roads
- County Roads
- Township Roads
- State Trails
- Lakes
- Rivers
- Streams
- Wetlands
- Scenically Attractive Areas
- Forested, Rough
- Near water, Forested, Fair
- Near water, Forested, Rough
- Near water, Forested, Rough
- Near water, Forested, Rough

Data provided by the Minnesota Department of Natural Resources  
Map created by the Science Museum of Minnesota's Map Lab

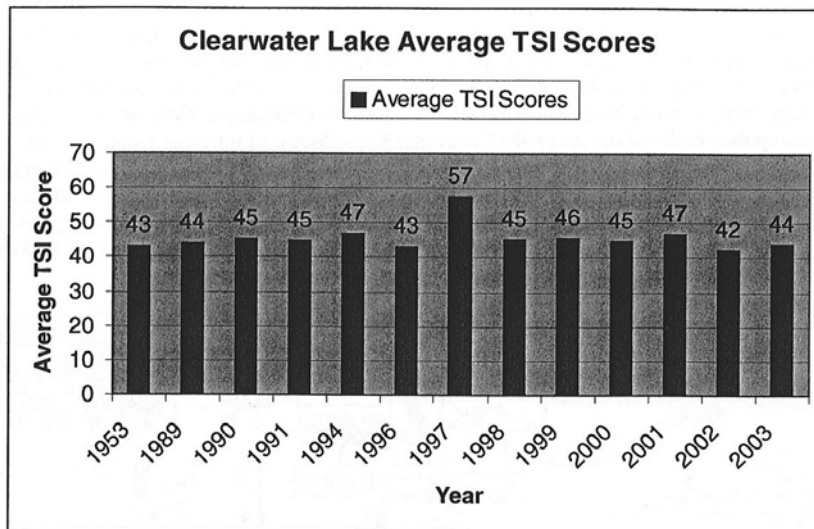
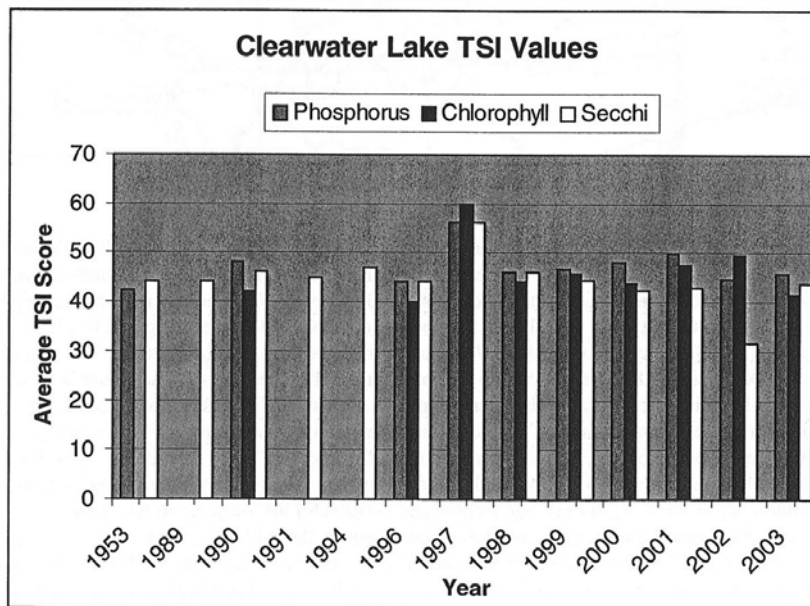
### Lake Monitoring Results

The monitoring site used to determine the trophic state of the lake is CL1 (also called site #204 by the MPCA), which is located at the deepest point of the lake. The trophic state index (TSI) is a score based upon total phosphorus, secchi disk, and chlorophyll-a readings used to classify the growth and productivity of a lake. Lakes may be oligotrophic (<30), mesotrophic (40-50), eutrophic (50-60), or hypereutrophic (>70). The average trophic state index score for Clearwater Lake in 2002 was 42.18. This score is on the lower end of the mesotrophic range and is better than it has been in several years. The average trophic state of the lake is normally around the middle of the mesotrophic range. This means that the lake has enough nutrients to support aquatic life but does not have an excessive amount of nutrients. This is a desirable condition for the lake. The lake is unable to support salmonids (trout), but walleye are able to predominate. The charts below show yearly average trophic state scores for all the years in which data was collected. Although the average score of the lake is around the mid-40's, there is a great range in scores throughout the year. During the summer of 2002, the TSI scores ranged from 31 to 47. In 2003, the TSI scores ranged from 40-54. The water in Clearwater Lake had been very clear at times. The lake had average secchi disk readings of 7.54 in 2002 and 9.5 in 2003. On June 9, 2003, the secchi disk reading was 16.5 feet.

How does the lake compare to other lakes within the same ecoregion? Based on the 1994 Minnesota Lake Water Quality Data Base Summary, Clearwater Lake has ranked at about the 18<sup>th</sup> percentile for area, at the 25<sup>th</sup> percentile for depth, between the 50<sup>th</sup> and 75<sup>th</sup> percentiles for TSI-phosphorus, between the 50<sup>th</sup> and 80<sup>th</sup> percentiles for TSI-chlorophyll-a, between the 50<sup>th</sup> and the 100<sup>th</sup> percentiles for TSI-Secchi, and between the 50<sup>th</sup> and the 60<sup>th</sup> percentiles for TSI-mean. Here is a comparison of 2002 monitoring results at CL-1 with average values for all lakes within the Northern Lakes and Forests ecoregion.
