Lost River Design Report

Lost River Design Report
Red Lake Watershed District
Thief River Falls, MN 56701
June 23, 2003

Houston Engineering, Inc.
2505 North University Drive
Box 5054
Fargo, ND 58105
H.E. Project No. 3655-040

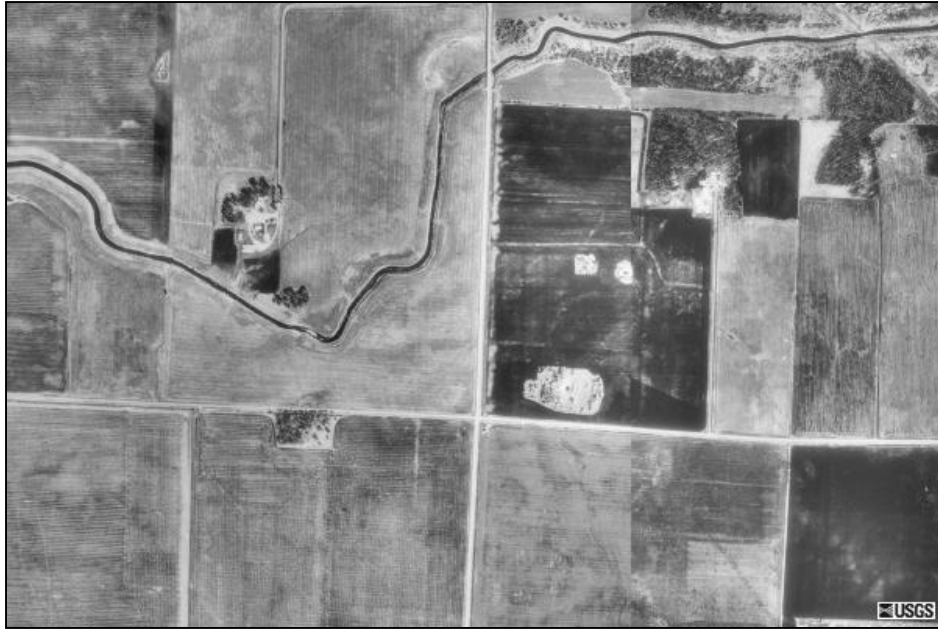
Figure 1. Lost River at CSAH 28, Sections 5 and 6 Gully Township¹

The project site is located on the Lost River within Sections 5 and 6 of Gully Township, Polk County. Figure 1 is an aerial photo of the project location.

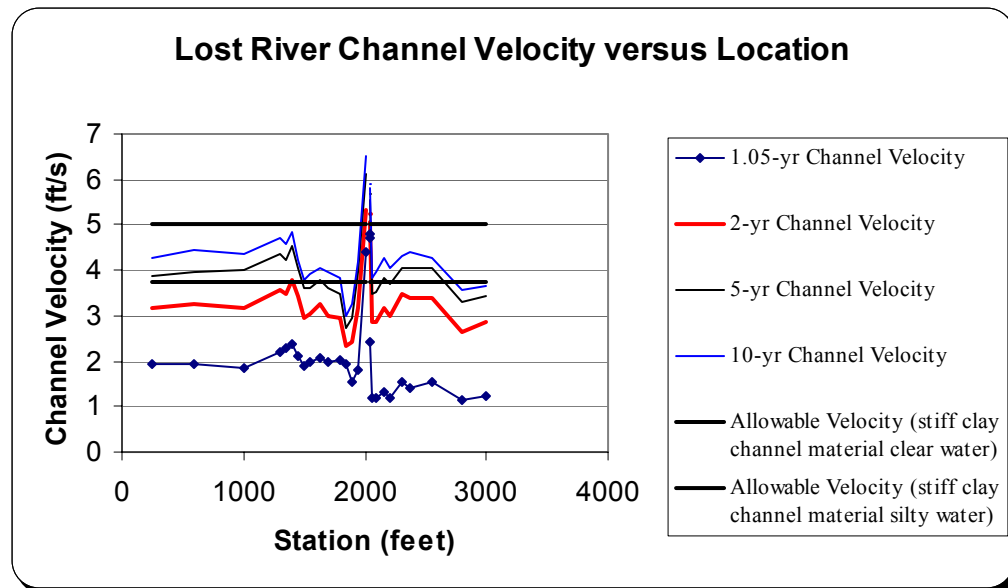
Figure 14. Channel Velocity and Tractive Force Versus Location for Flood Magnitudes

Table 4 lists allowable tractive forces and velocities for a number of channel materials. For a given soil material, flow in the channel that exceeds the allowable velocity or tractive forces will be erosive. Figures 14 and 15 are graphs showing the channel velocity and tractive force versus location for flood magnitudes ranging from 1.05-year to 10-year recurrence intervals. A range of allowable velocities and tractive forces have been shown in each figure for a channel in clay material. Most of the project reach will have flows within the allowable velocity and tractive force ranges—except within the bridge section.

Both velocity and tractive force will be in the erosive range within the bridge section. Since the channel is armored with riprap within the bridge, erosion will probably not occur at the bridge location, but will likely occur immediately downstream. The scour hole that has developed downstream from the bridge has likely resulted from erosive forces and velocities generated due to the rock pile/beaver dam and the channel constriction at the bridge.
