### **District Monitoring**

### **Thief River Watershed Assessment Project (Watershed Restoration and Protection)**

**Red Lake River Watershed Assessment Project (Watershed Restoration and Protection)**

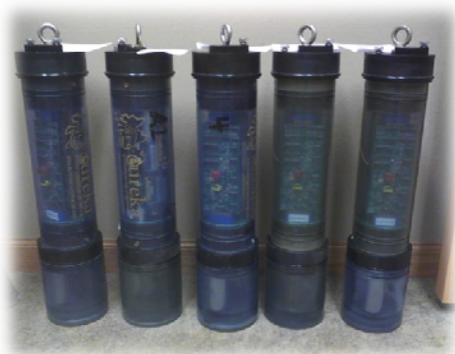
- Task 3 – Continuous Water Quality Monitoring.
  - Eureka Manta and Manta 2 multi-parameter sondes were deployed at five sites throughout the Thief River watershed. They are deployed in the Thief River, JD30, Branch A of JD21, Moose River, and Mud River. Every two weeks, the deployed sondes are retrieved and replaced with clean, freshly calibrated sondes. The formerly deployed sondes are

- then brought back to the lab for data downloading, cleaning, and calibration.
- The Mud River Manta deployment pipe was moved to a deeper part of the channel where there will hopefully be enough water to submerge the sensors during the low water levels that we are seeing this year.

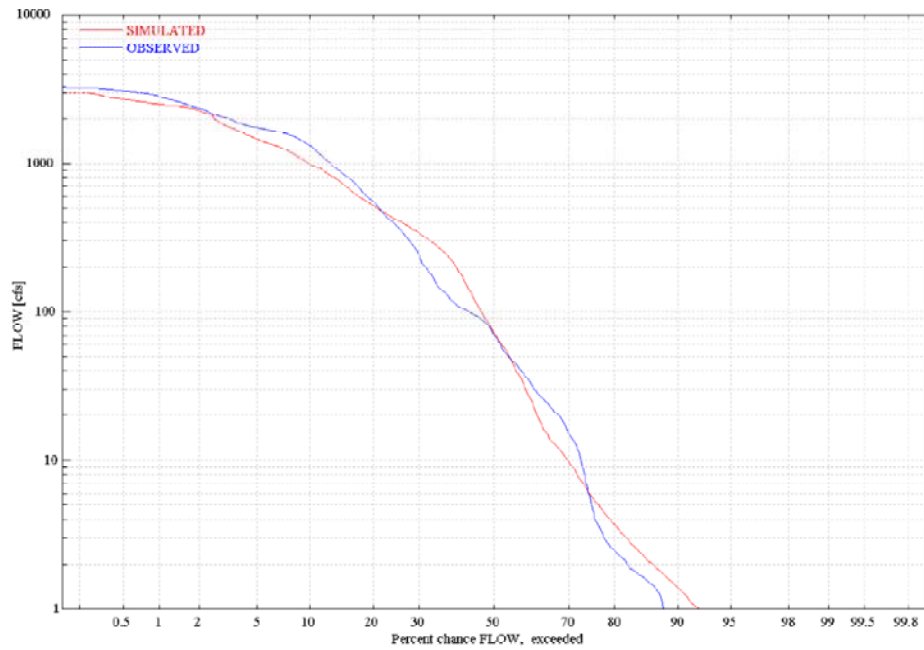
Figure 4: Flow Duration Curve for the Calibration Period (2001-2006) for the Thief River at Thief River Falls, MN.

- Task 5 – Stage and Flow Monitoring
    - A flow measurement was made in Judicial Ditch 30 after a rain event.
  - Task 8 – HSPF Modeling
    - Houston Engineering has completed the hydrologic calibration of the HSPF model of the Thief River Watershed. They have provided project partners with a Final Hydrologic Calibration Report. Here are some figures from the report that show how well the watershed was represented by the model. Overall, the model appears to do a good job at predicting flows from the entire watershed. When it comes to predicting flows at specific points throughout the watershed, it did well in some areas (Agassiz Pool outflows) and not as well in others (Moose River Impoundment outflows).

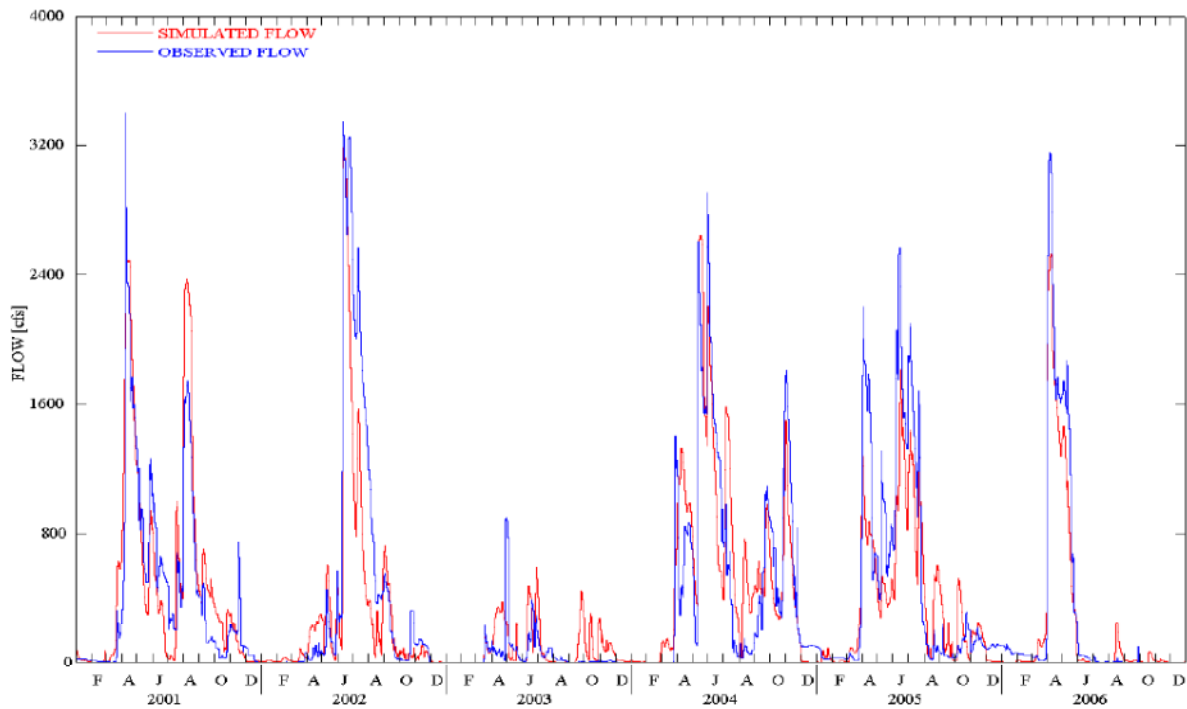
Figure 6: Daily Flows for Calibration Period (2001-2006) from the HSPF Model of Thief River at Thief River Falls.

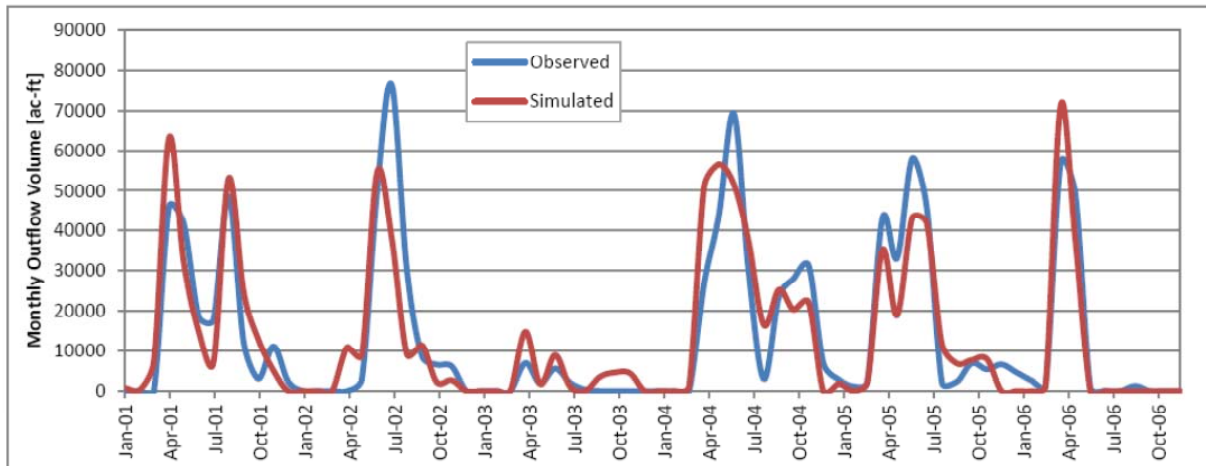
Figure 10: Monthly Outflows for the Agassiz Pool in the TRW.

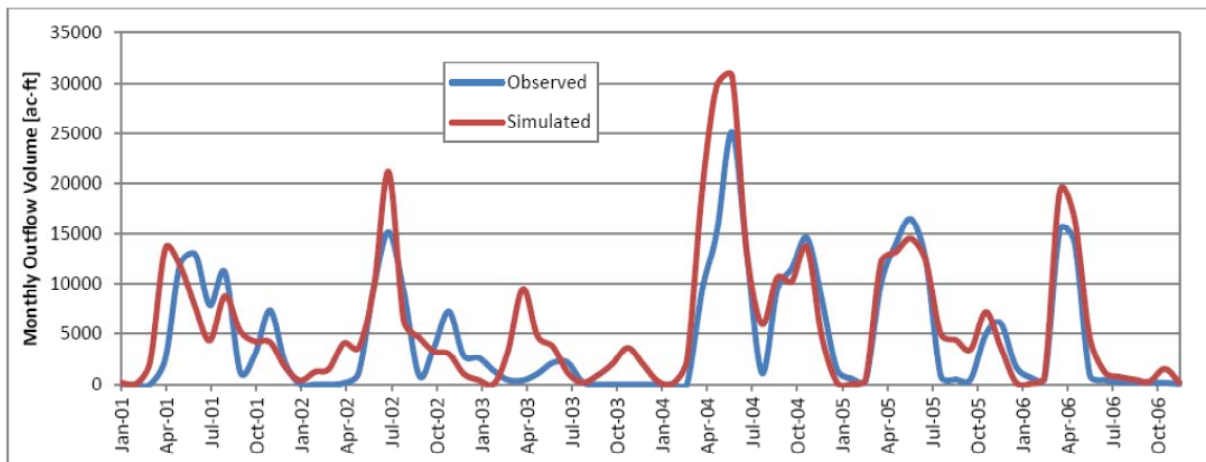
Figure 11: Monthly Outflows for Thief Lake Impoundment in the TRW.

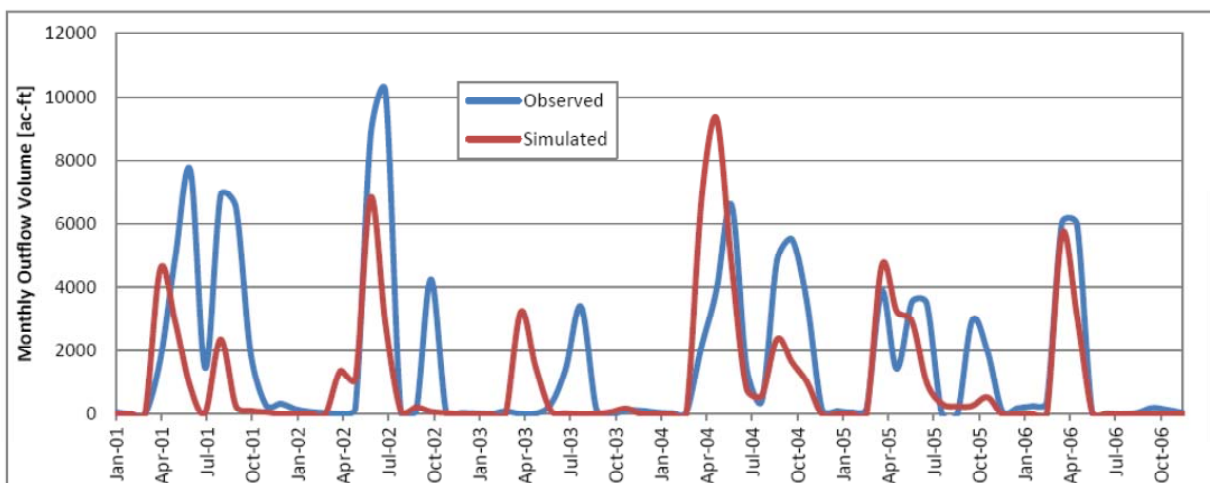
Figure 13: Monthly Outflows for the Moose River Impoundment-North Pool in the TRW.

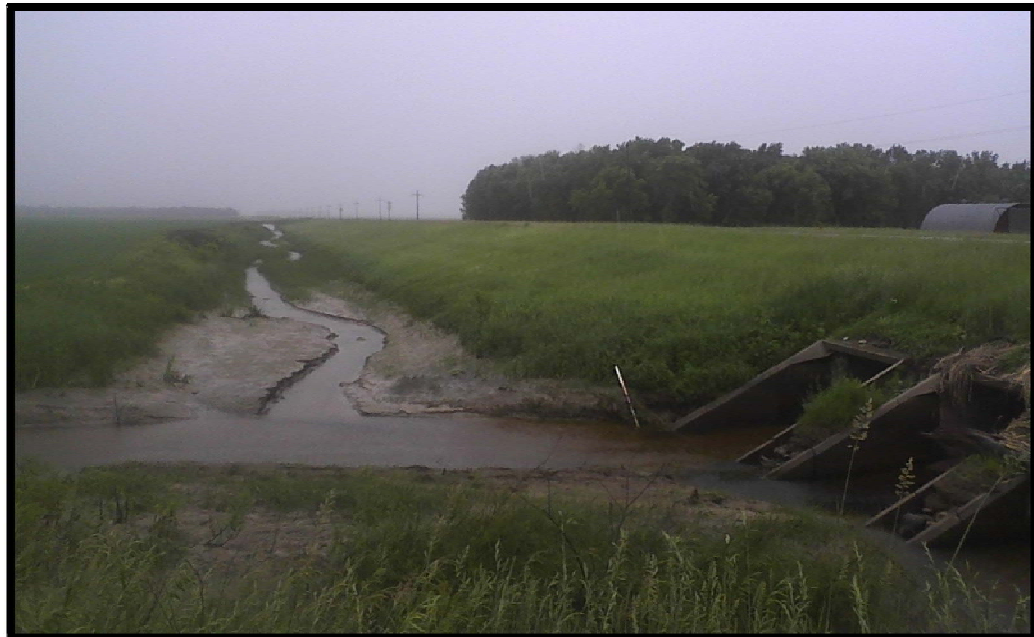
- The erosion that has occurred in Branch 23 of JD21 (east side of Hwy 54, north of Grygla) not only created plumes of suspended sediment in the Moose River, but has also contributed a lot of sediment deposition where Branch 23 of JD21 meets the Moose River (JD21). The sediment deposition is visible during the low water in the following photo. You can see that water has cut a meandering channel through the mud in the ditch at the confluence. The sediment bar in the Moose River also seems to have grown.

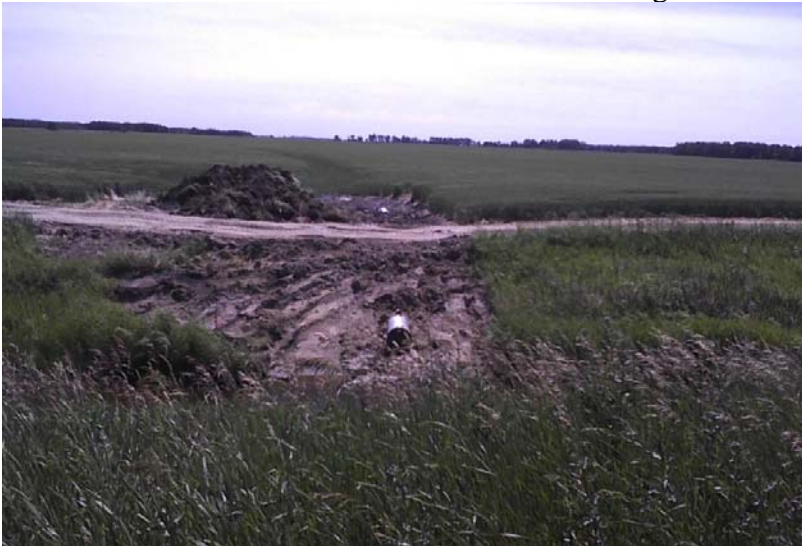
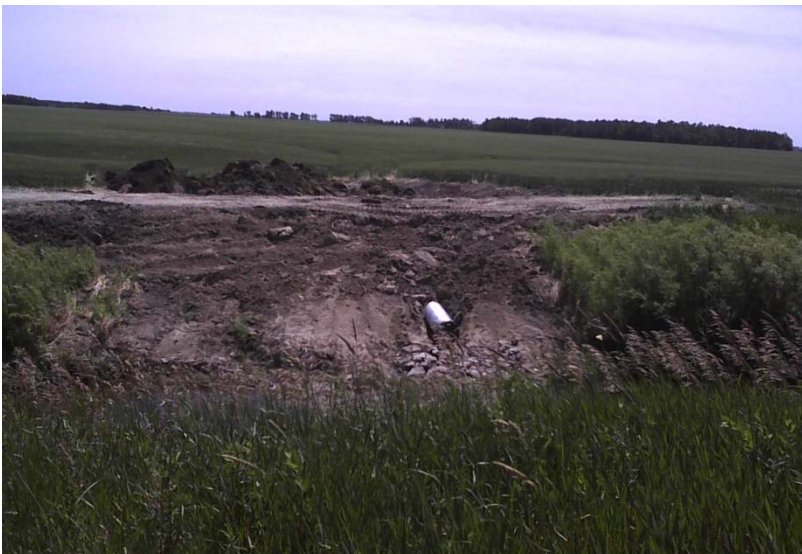
- Meetings were held early in the month to discuss construction plans and the possibility of adding more side water inlets to the project.
- Construction started in late June.
- One of the grade stabilization structures was moved downstream. The original site in the plans happened to be adjacent to a landowner's yard and also on top of the site of a historical crossing of Silver Creek (a creek that used to flow to the Thief River in the lower part of the CD20 sub-watershed before the ditch was dug) and, later on, CD20.
- 14 side water inlets were installed by Friday June 29<sup>th</sup> (and the 15<sup>th</sup> was going in that day). As the photos show, some touch-up work and re-seeding was still needed. All of the work will likely be completed in July.
- Photos of two of the side water inlets installed along CD20:
