**Thief River Watershed Assessment Project**  
**(Watershed Restoration and Protection - WRAP)**

**Red Lake River Watershed Assessment Project**  
**(Watershed Restoration and Protection - WRAP)**

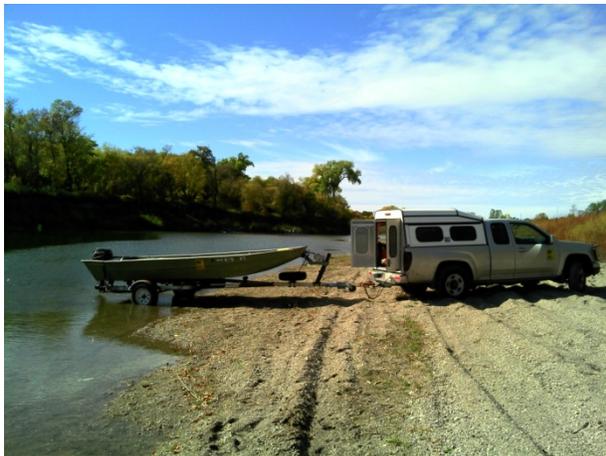
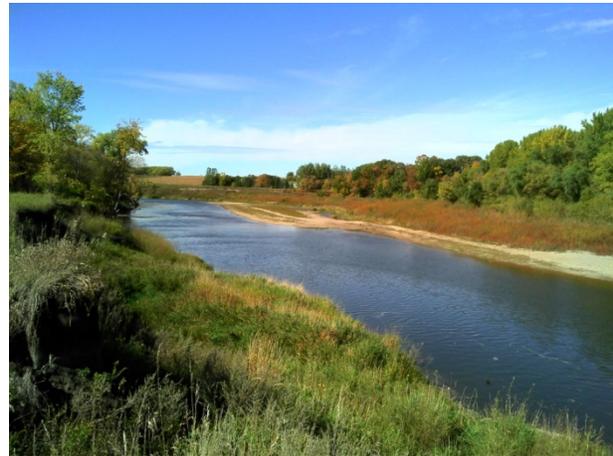
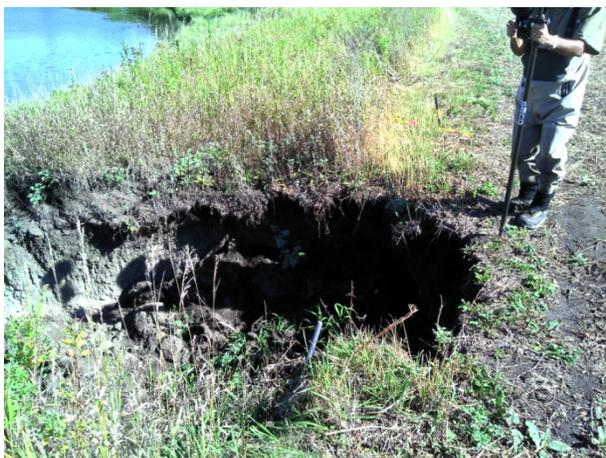
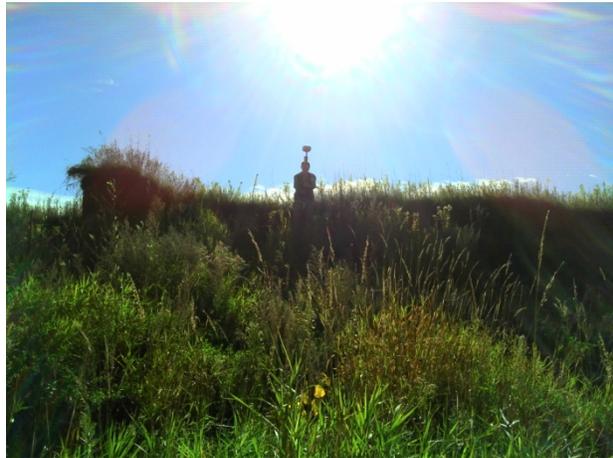
- Task 5 – Stage and Flow Monitoring
  - Flow was measured in the Red Lake River at the CSAH 27 monitoring site.
- Task 6 – Stream Channel Stability Assessment (Geomorphology)
  - Follow-up geomorphology work was conducted at the geomorphology station that was established at the Old Crossing Treaty Park near Huot. This work involved surveyed cross-sections, longitudinal surveys, bank profiles, Pfankuch assessments, and Bank Erosion Hazard Index assessments. These repeated measurements will be used to determine how much erosion has occurred in the last year. The results will be extrapolated to similar reaches of the river. There was some gullying within a field ditch near the site and bank failure at the end of that ditch that could be possibly be addressed with BMPs through an incentive program.

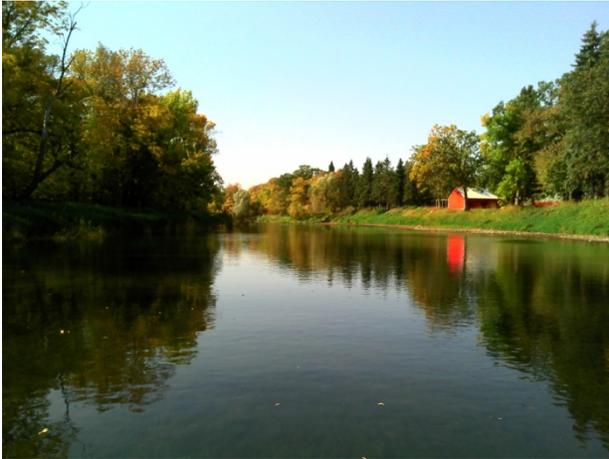
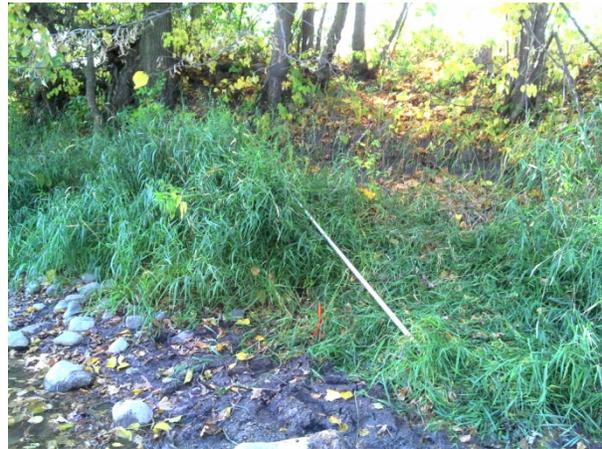
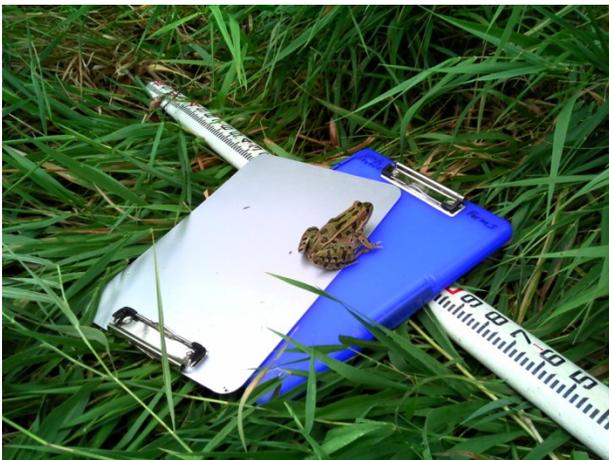
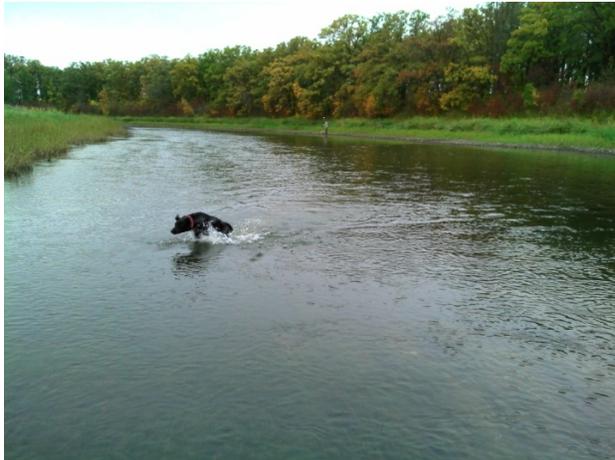
- Follow-up geomorphology measurements were also completed at a site near the lower end of the dredged portion of the upper reach of the river (east of Thief River Falls). Stations were also visited at the Smiley Bridge and St. Hilaire City Park.

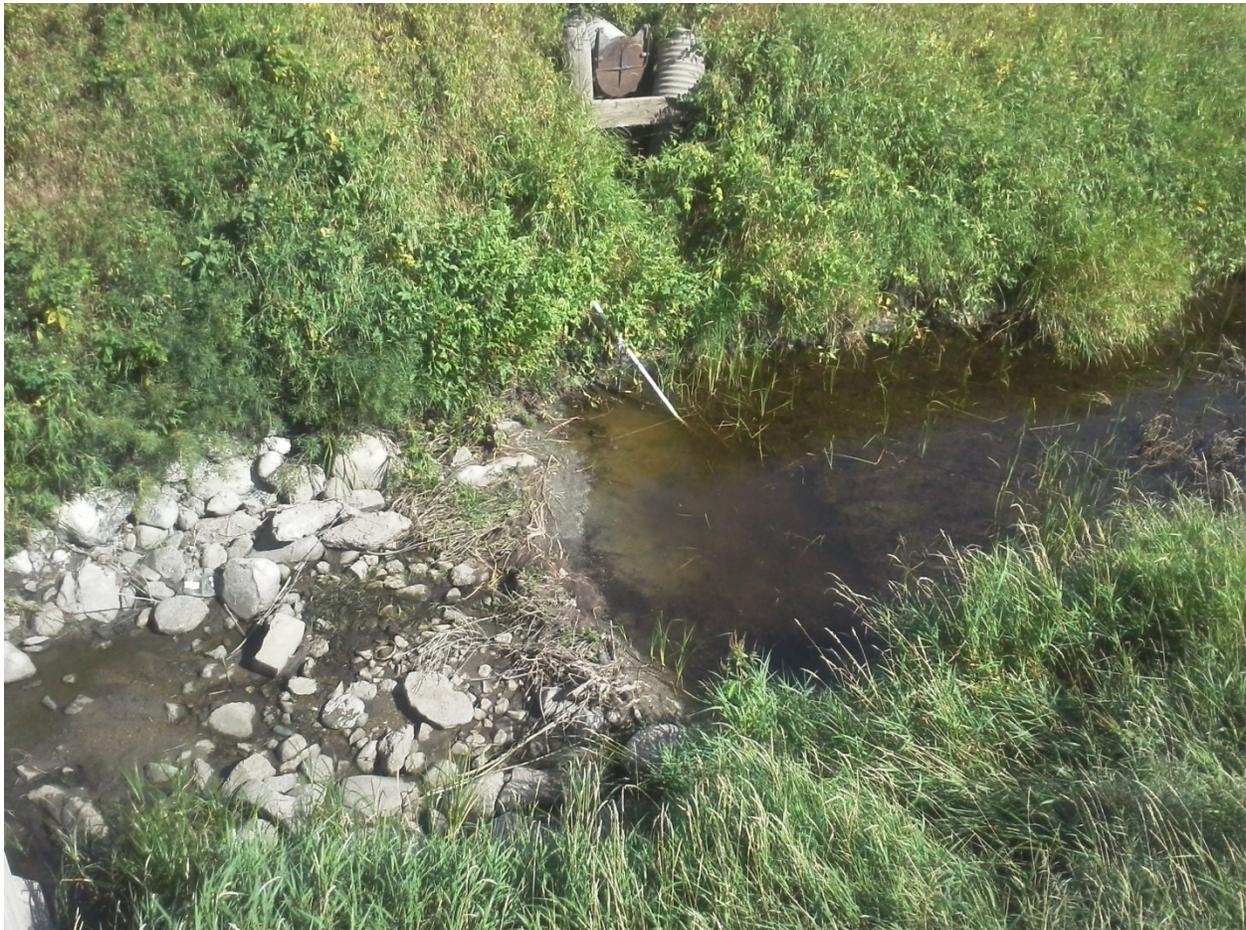
- Water level measurements were made at sites that have water level loggers deployed. Flows are down to zero in JD1 and JD75.

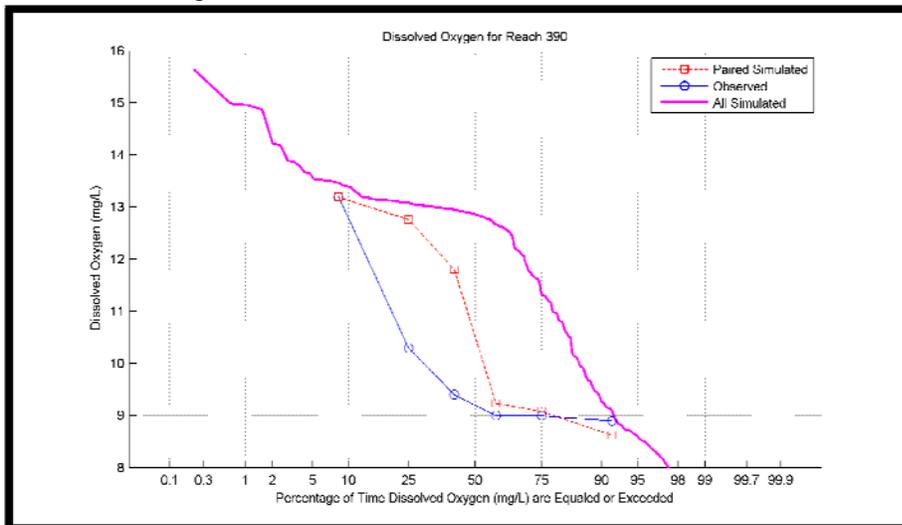
- RLWD staff met with staff from RESPEC that are working on HSPF water quantity/quality models for the Red Lake River, Clearwater River, and Thief River watersheds. RLWD staff provided them with data that can aid with the calibration of the models.
- A review of Clearwater River HSPF modeling results began. The consulting firm, RESPEC, is looking for input on why there is a significant divergence between observed and simulated dissolved oxygen values at some locations. For example, there is a divergence at the Clearwater River monitoring site near Plummer. Observed values were lower than simulated values. At this site (a.k.a. Reach 390, below), the model may not be accounting for the influence of wild rice paddies (pumping water from the river, discharge into the river).

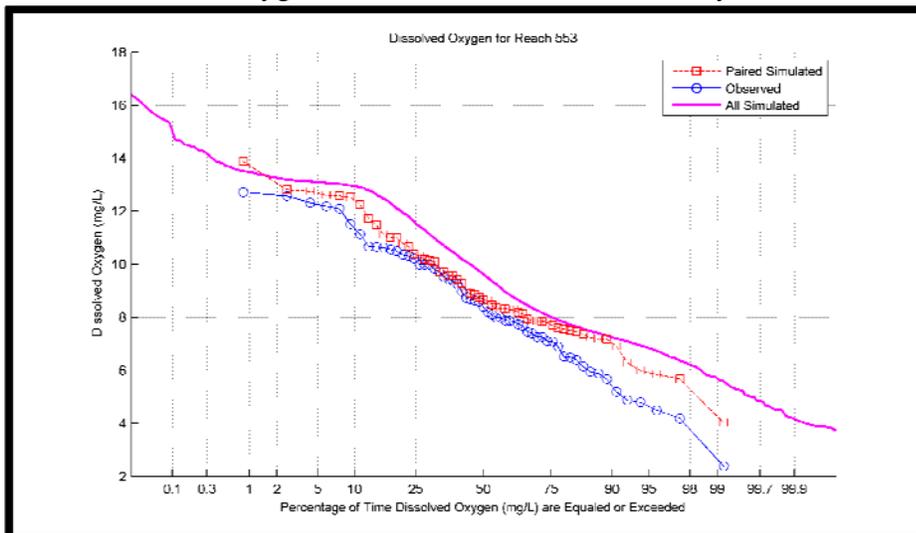
- At some points in the watershed, like this one along the Poplar River, modeled/simulated dissolved oxygen values match the observed very well.
