Long-Term Monitoring Program

RED LAKE WATERSHED DISTRICT MONTHLY WATER QUALITY REPORT

May 2014

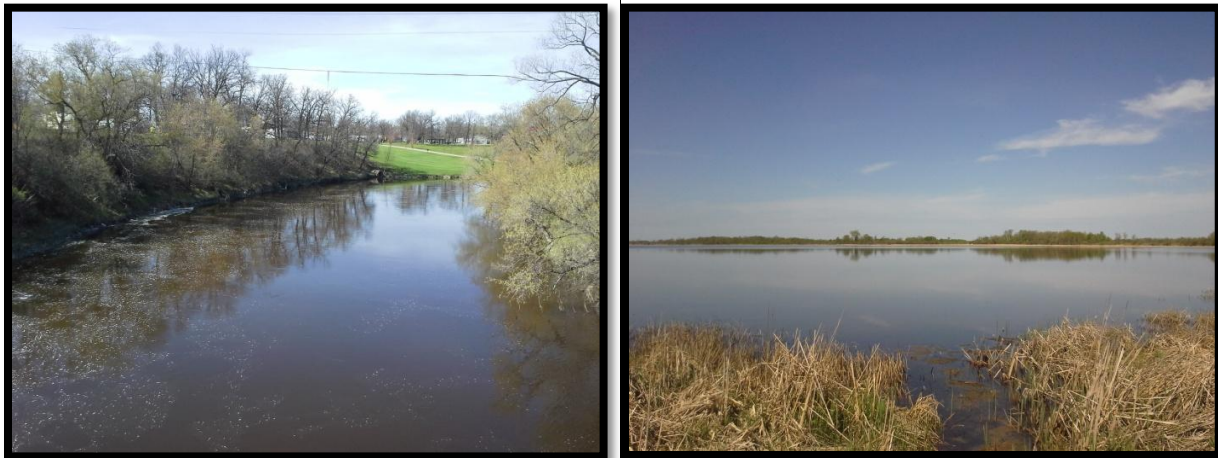
High E. coli concentrations were again found in the Beltrami County monitoring sites on Darrigan's Creek and the North Cormorant River (CSAH 36).

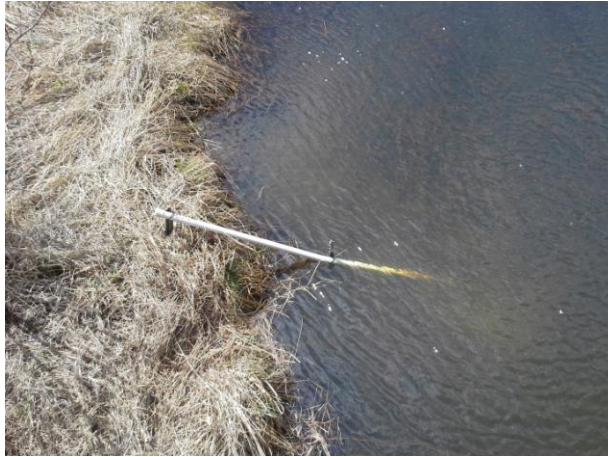
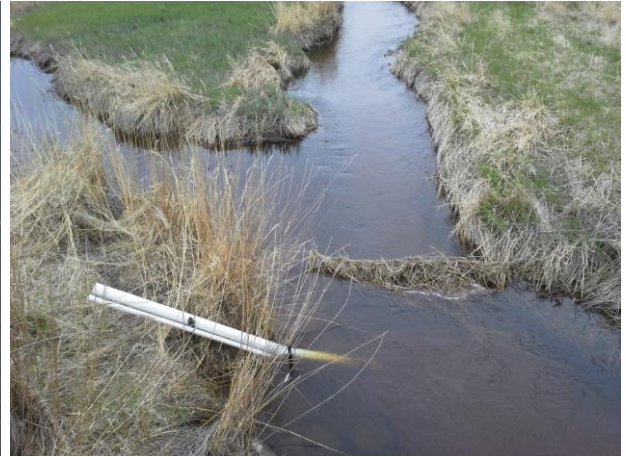
- Objective 3 – Flow Monitoring
 - Gopher One calls were made in preparation for the installation of water level logger deployment pipes at new flow monitoring sties.
 - A research permit application was submitted in order to get permission to install continuous monitoring equipment in Judicial Ditch 73 within the boundaries of Rydell National Wildlife Refuge. The permit was approved.
 - HOBO water level loggers were deployed.

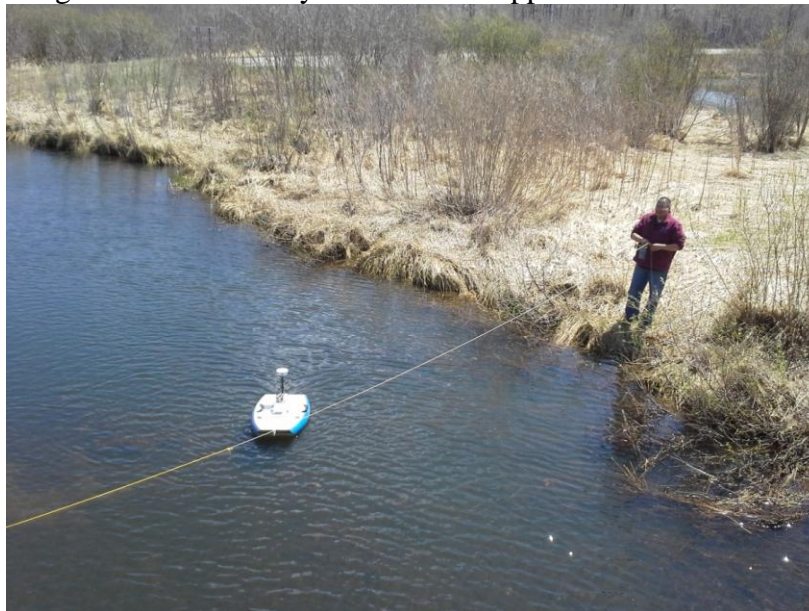
- Red Lake Department of Natural Resources staff conducted flow measurements using their River Surveyor Acoustic Doppler flow meter.

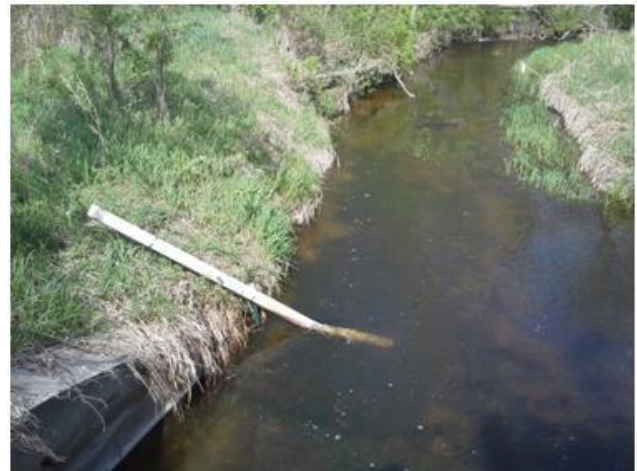
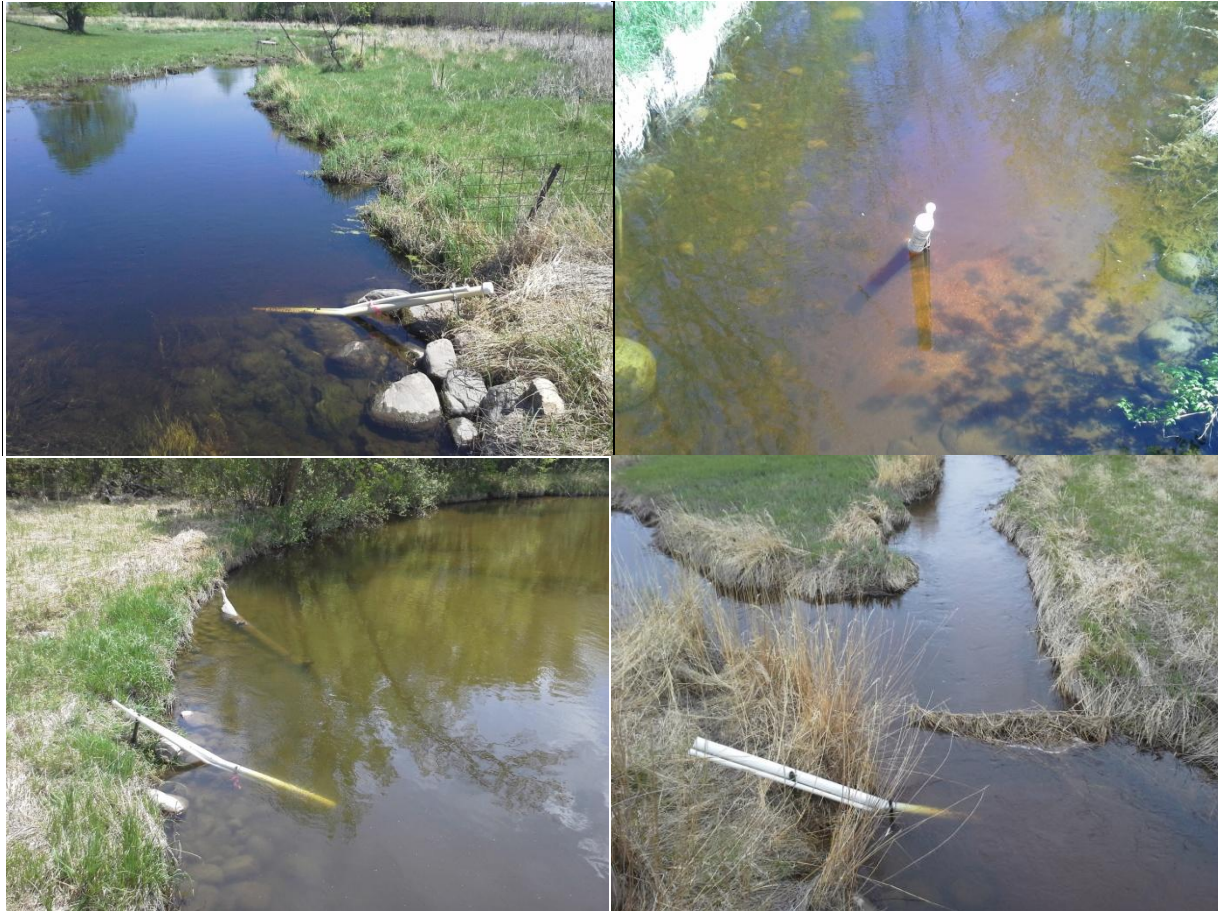
- Objective 4 – Continuous Dissolved Oxygen Monitoring
 - Supplies were purchased for deploying dissolved oxygen loggers.
 - Deployment pipes for dissolved oxygen loggers were installed.

The first 2014 deployments of Clearwater River dissolved oxygen loggers began on May 27th.

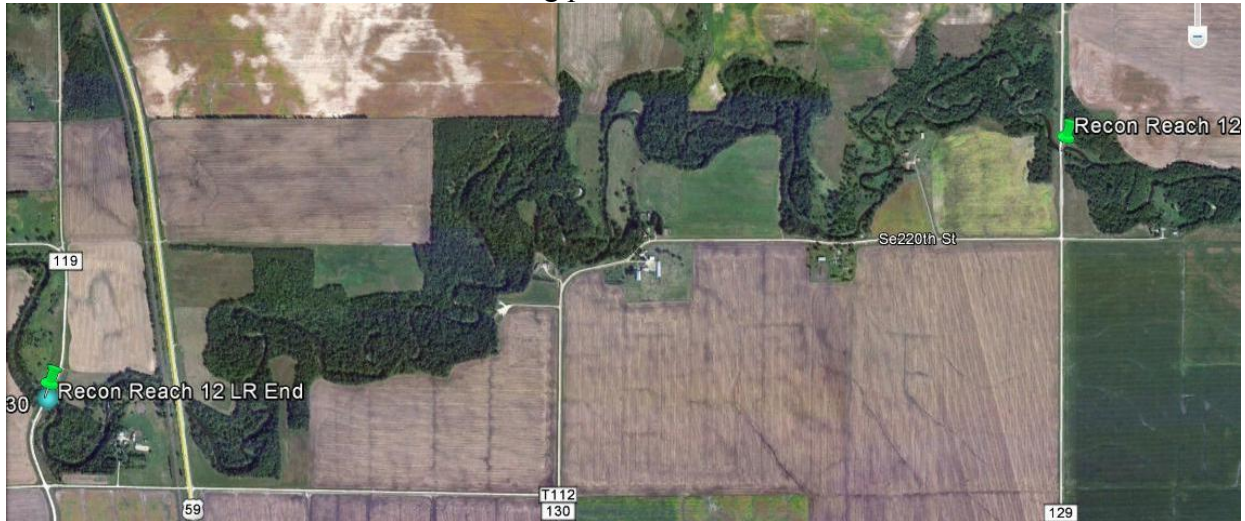
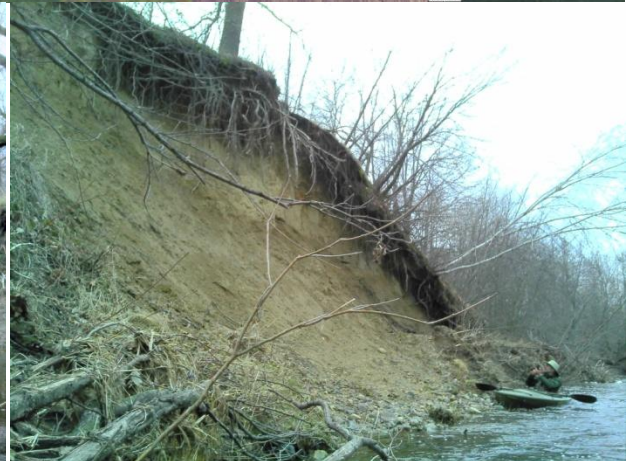
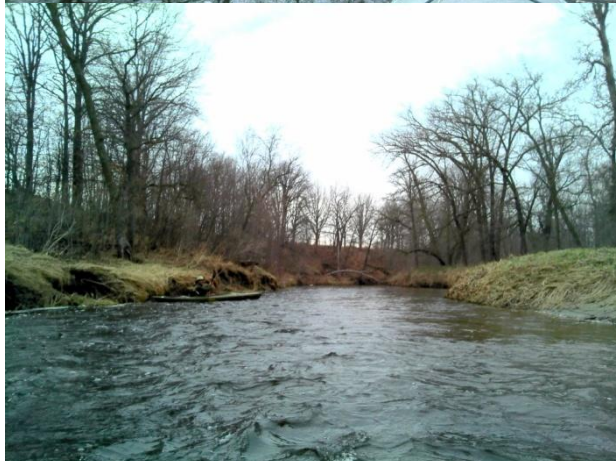
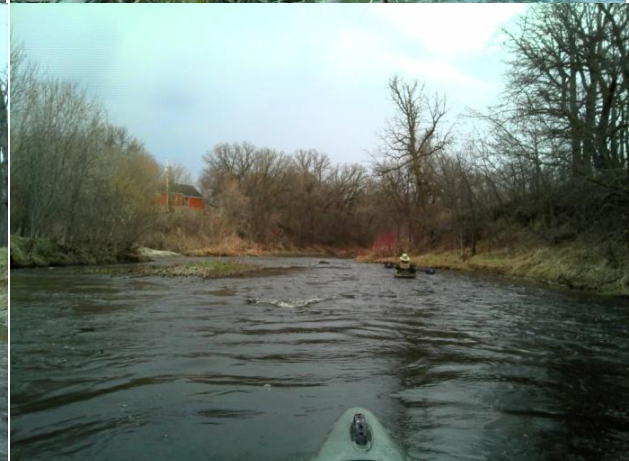
- A reach of the Lost River from CR 129 to CR 119 (Reach 12) was paddled and Bank Erosion Hazard Index ratings, depths, bankfull widths, photos, and more were recorded along the trip. This winding section of the river provided many outside banks to assess. It was a longer trip because of all of the bends. We traveled over 1.6 miles along the river before we had traveled 0.5 miles “as the crow flies” from our starting point.

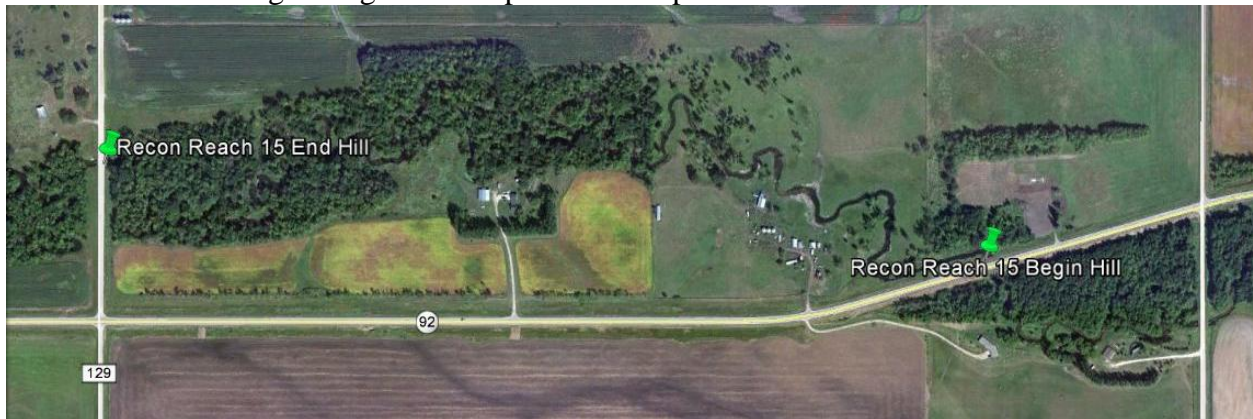
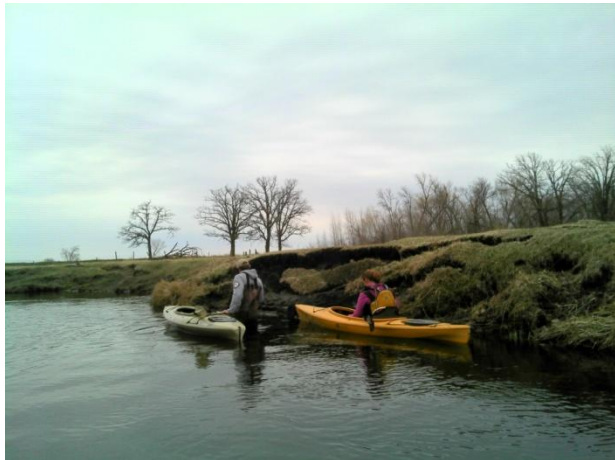
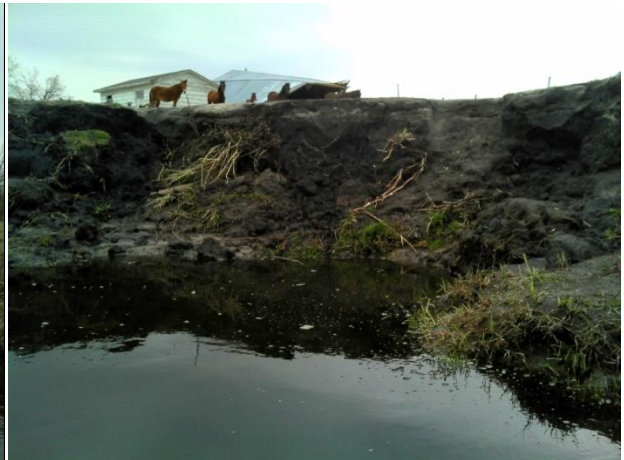
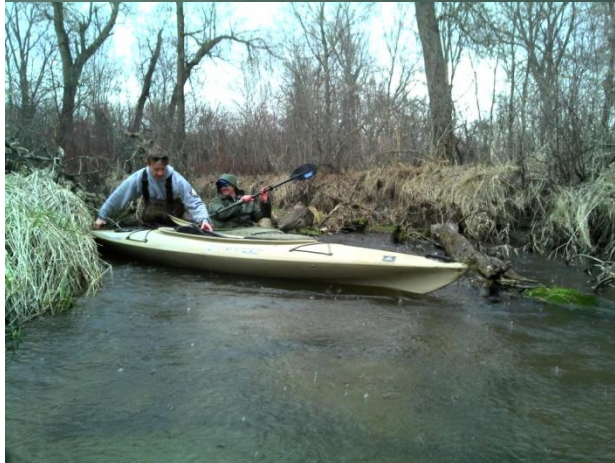
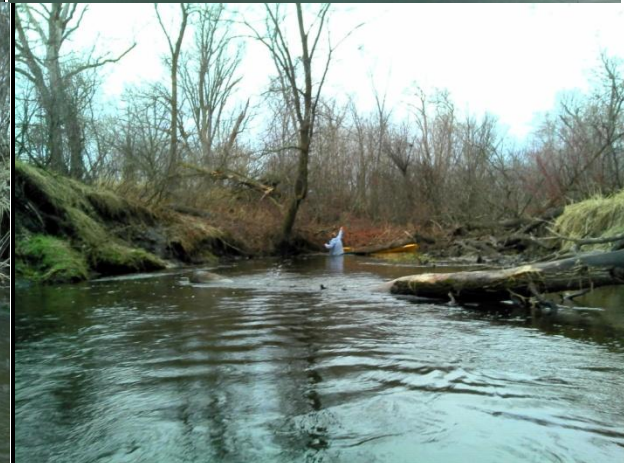
- A reach of the Hill River was inspected via kayak on May 7th for the purpose of conducting Bank Erosion Hazard Index ratings and other measurements. There are a lot of log jams in the lower end of this reach that required a number of portages and made travel along the reach difficult. A livestock operation downstream of Highway 92 has created some streambank instability problems. Stream banks appeared to be more stable within the wooded reach. It also started raining during the latter part of the trip.

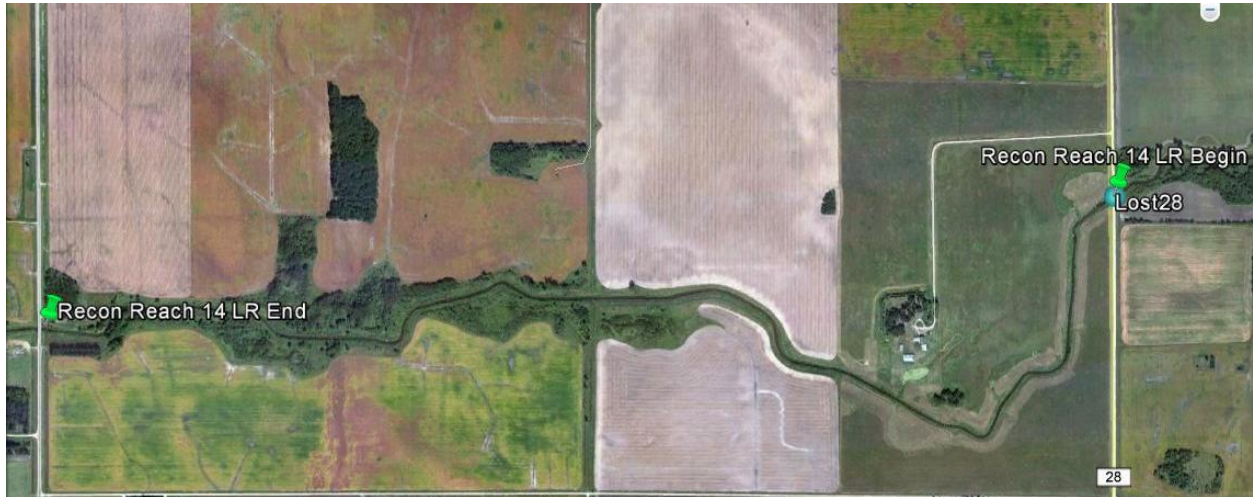
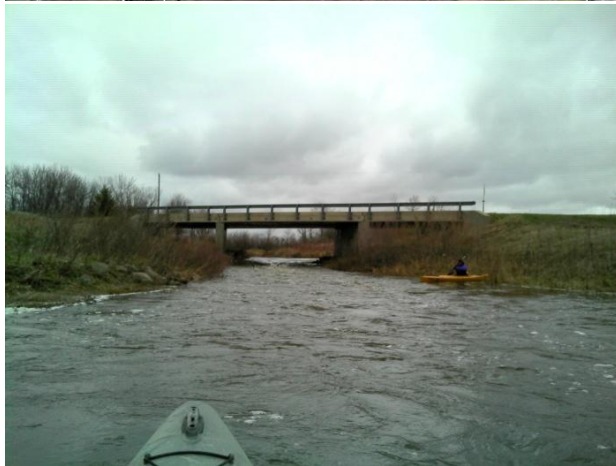
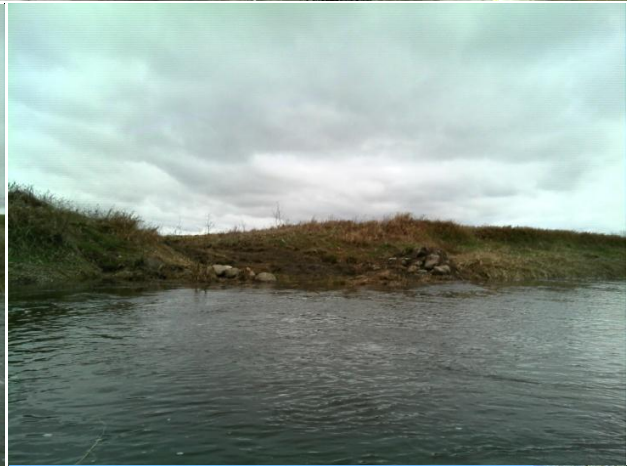
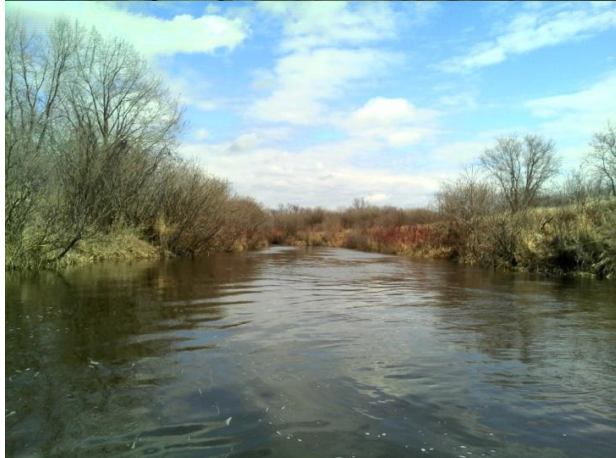
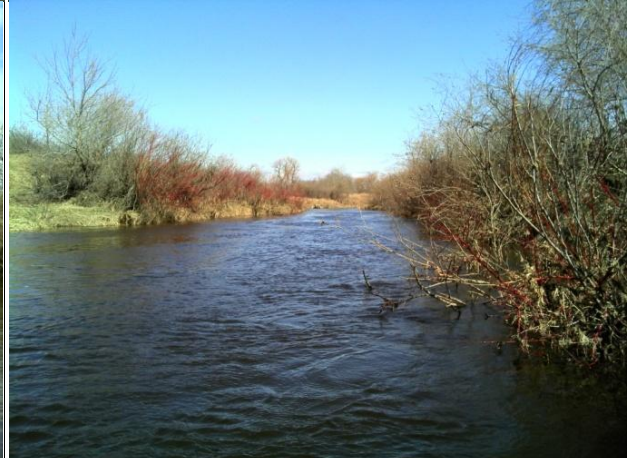
- A reach of the channelized portion of the Lost River between CSAH 28 and CSAH 6, north of the town of Trail was kayaked for the purpose of Bank Erosion Hazard Index ratings, Pfankuch ratings, and other measurements. Despite being channelized, this reach was fairly stable. One of the bank stabilization structures that the District installed downstream of CSAH 28 had been damaged by some excavation.

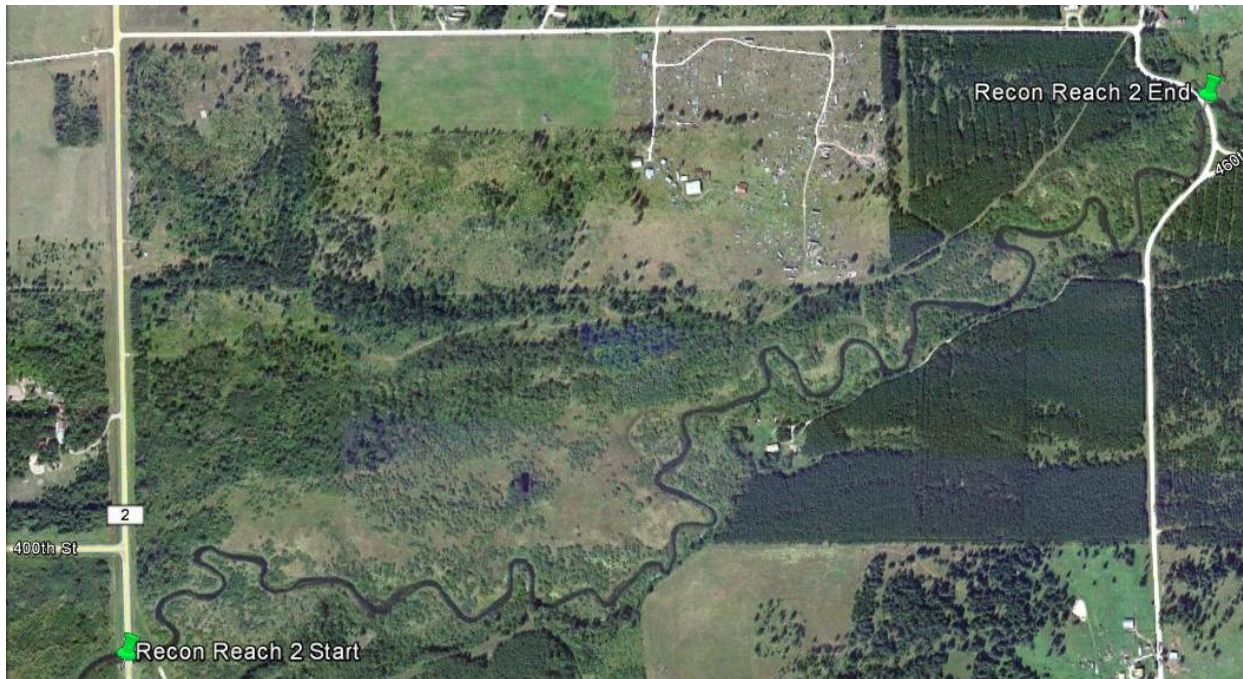
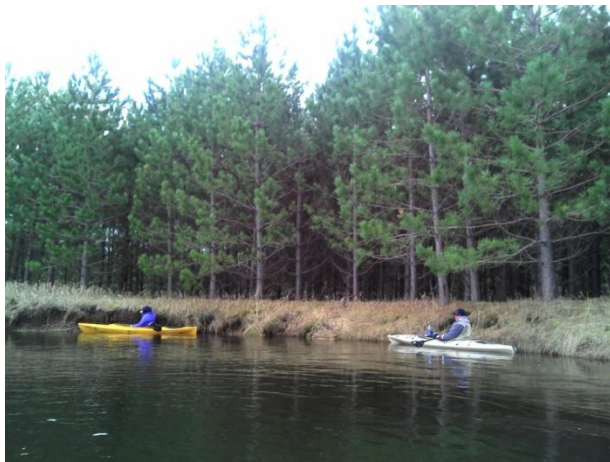
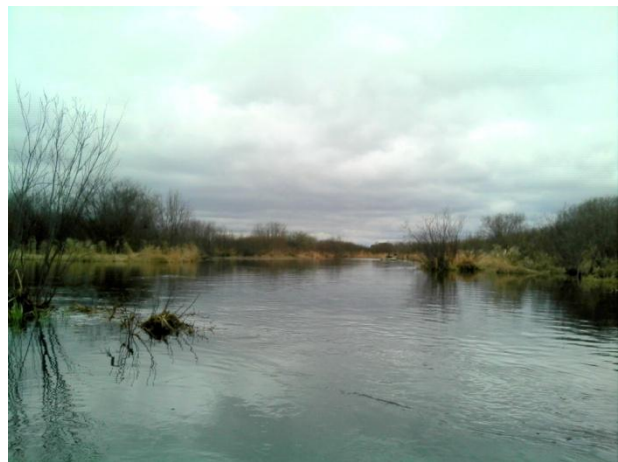
- The Reach of the Clearwater River between CSAH 2 and 253rd Ave was inspected via kayak on May 14th. Bank Erosion Hazard Index ratings, bankfull widths, depths, photos, and Pfankuch ratings were also collected along the reach. There was only one bank along this reach that had an active erosion with much of a bare bank. The rest of the reach was fairly stable. The river's gradient hasn't quite transitioned to that of the steeper trout stream reach yet at this point.

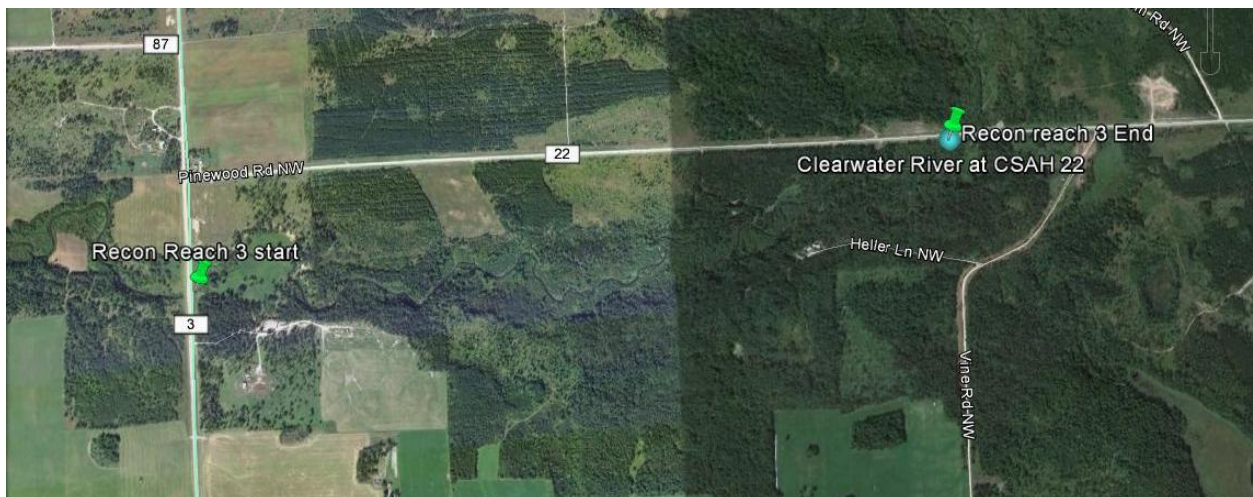
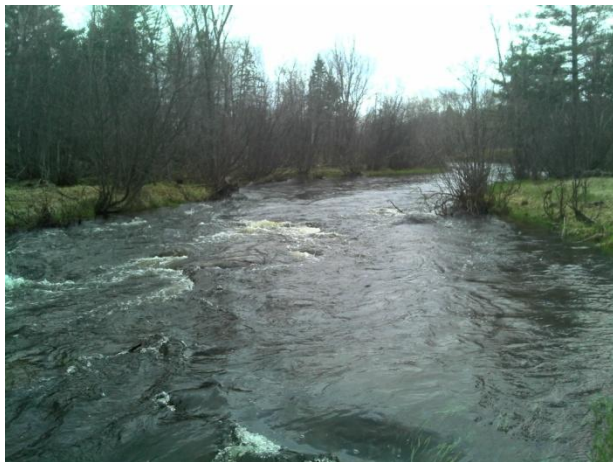
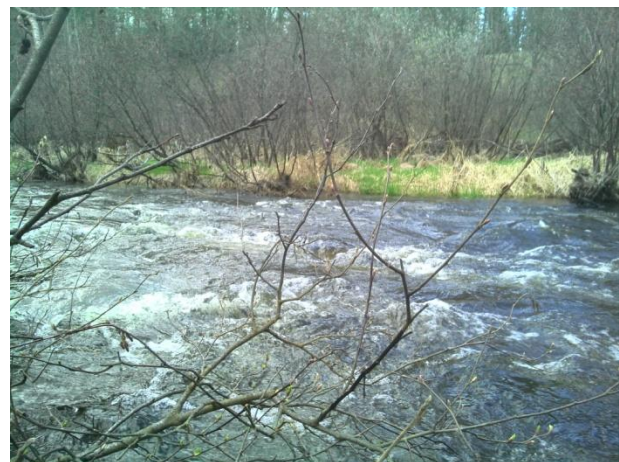
- A reach of the trout stream portion of the Clearwater River between CSAH 3 and CSAH 22 (Pinewood Road) was inspected via kayak on May 15th. Bank Erosion Hazard Index ratings, bankfull widths, depths, photos, and Pfankuch ratings were also collected along the reach. There was a lot of significant erosion and bank instability in the upper, pastured section of this reach. As soon as we passed the pastured area, the banks became much more stable. One of the key factors in the stability of this reach is the presence/absence of brush/shrubs along the edge of the river. There were a couple of cabins/residences along the reach which demonstrated the importance leaving vegetation near the river. The yards were mowed in both circumstances. The one that left brush, grass, and shrubs along the river had a stable bank. The other residence had mowed right up to the edge of the banks and the bank was very actively eroding. The current was swift through this section, which made stopping to take measurements a little more difficult, but we got it done. The river has recently cut a new channel around an old weir just upstream of CSAH 22. The new channel was newer and had a lot of low overhanging brush to get through, which made paddling through there a bit more of a challenge than the old channel would have been.

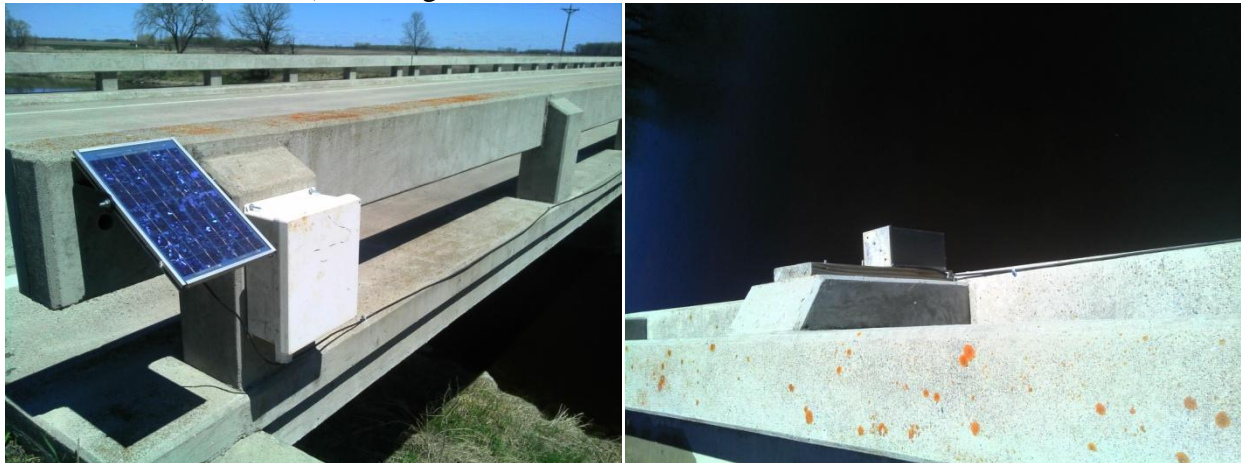
- Task 5 – Flow monitoring
 - Flow was measured in Judicial Ditch 60, Cyr Creek, and County Ditch 96.
 - The MPCA installed an ultrasonic stage monitoring gage on the Smiley Bridge (CSAH 7) crossing of the Red Lake River.

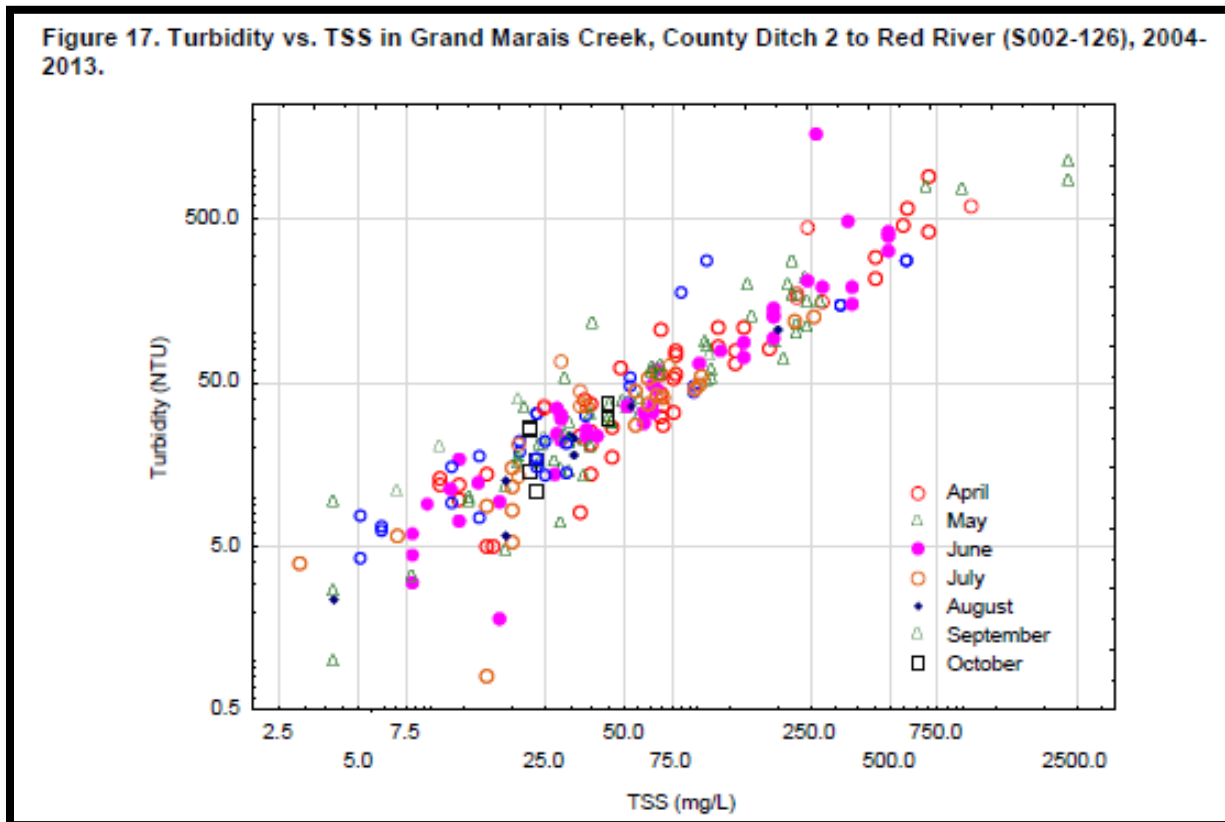
Figure 17. Turbidity vs. TSS in Grand Marais Creek, County Ditch 2 to Red River (S002-126), 2004-2013.

Turbidity concentrations in excess of the (soon to be former) water quality standard of 25 NTU were frequent in the watershed. 58% of the measurements made at the Grand Marais Creek cut-off channel monitoring site exceeded the standard. Turbidity has a strong, positive correlation with total suspended solids in the Grand Marais Creek watershed.

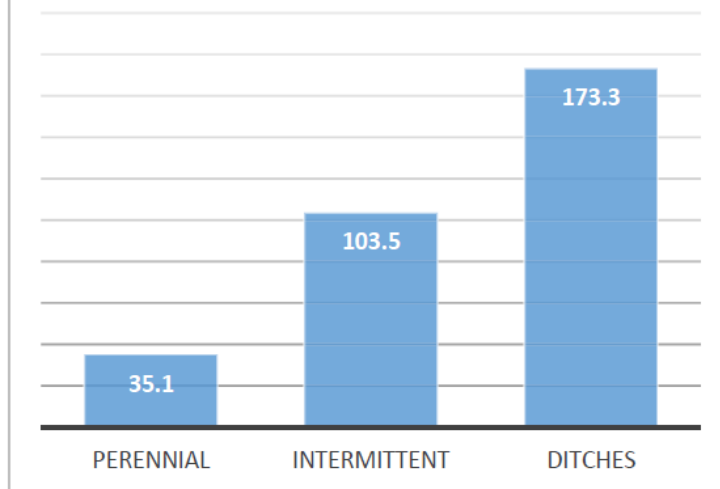
Miles of stream by type in Grand Marais/Red River region

Miles of perennial, intermittent and ditched streams in the Grand Marais / Red River HUC (09030206).

EOR staff also completed a report on the geomorphology work that was done in the watershed entitled “Geomorphic and Hydrologic Influences on TMDL Impairments in the Grand Marais Creek Watershed.” Not surprisingly, the report states that channelization is the most widespread stream impact in the region and has many direct impacts on aquatic biota. Connectivity is also an important impact on aquatic biota that may be affected by stream geomorphology. Many, if not most, of the streams in this watershed are ephemeral. Without perennial streamflow, fish would need to migrate to refuge areas and deeper water areas during periods of low flow. The vast majority of the stream network is either ditched natural streams or channels that were created for surface water drainage.

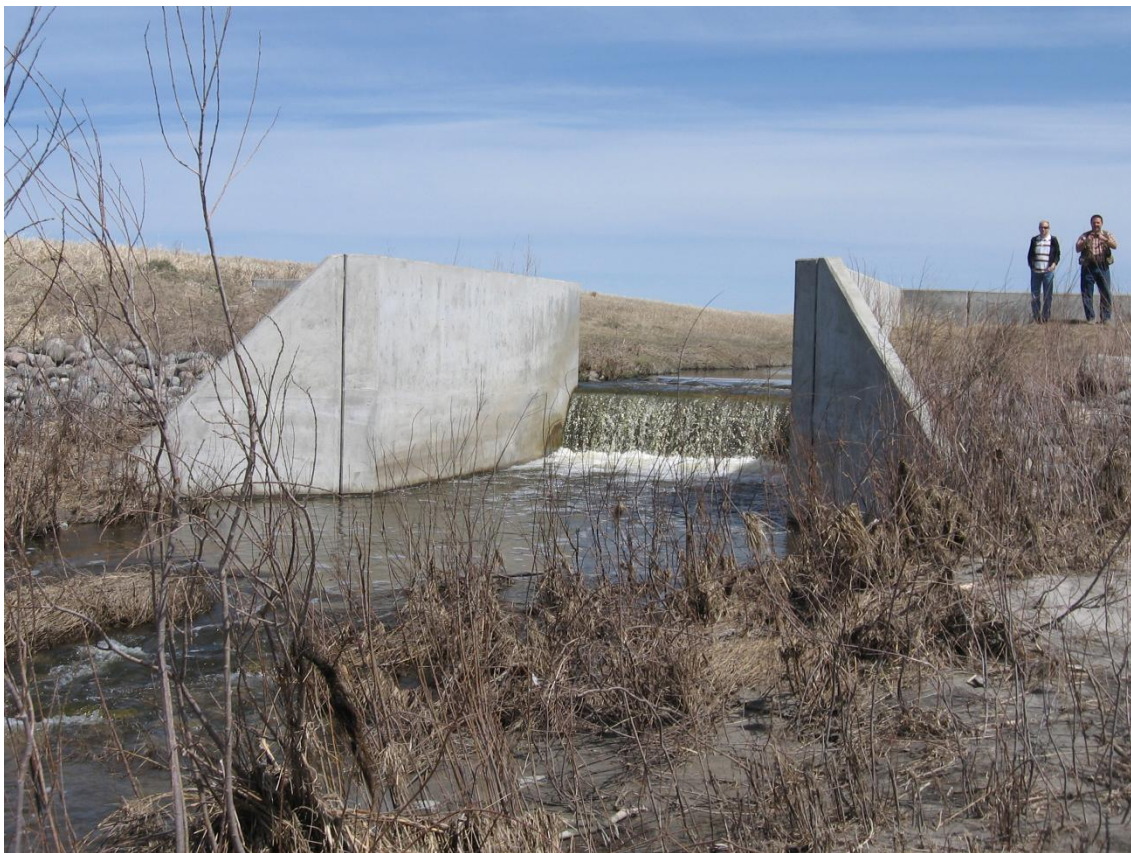
- Permit applications have been submitted for the Burnham Creek Watershed Restoration project.
- Phase I of this project will be channel maintenance (excavation and turf establishment along the legal ditch system).
- In Phase II of this project, grade stabilization structures will be installed to reduce headcutting (downward erosion in the channel). These rock structures will be designed to allow fish passage.
- In Phase III, rock structures will be built downstream of a large NRCS grade stabilization weir to allow fish passage past that point.

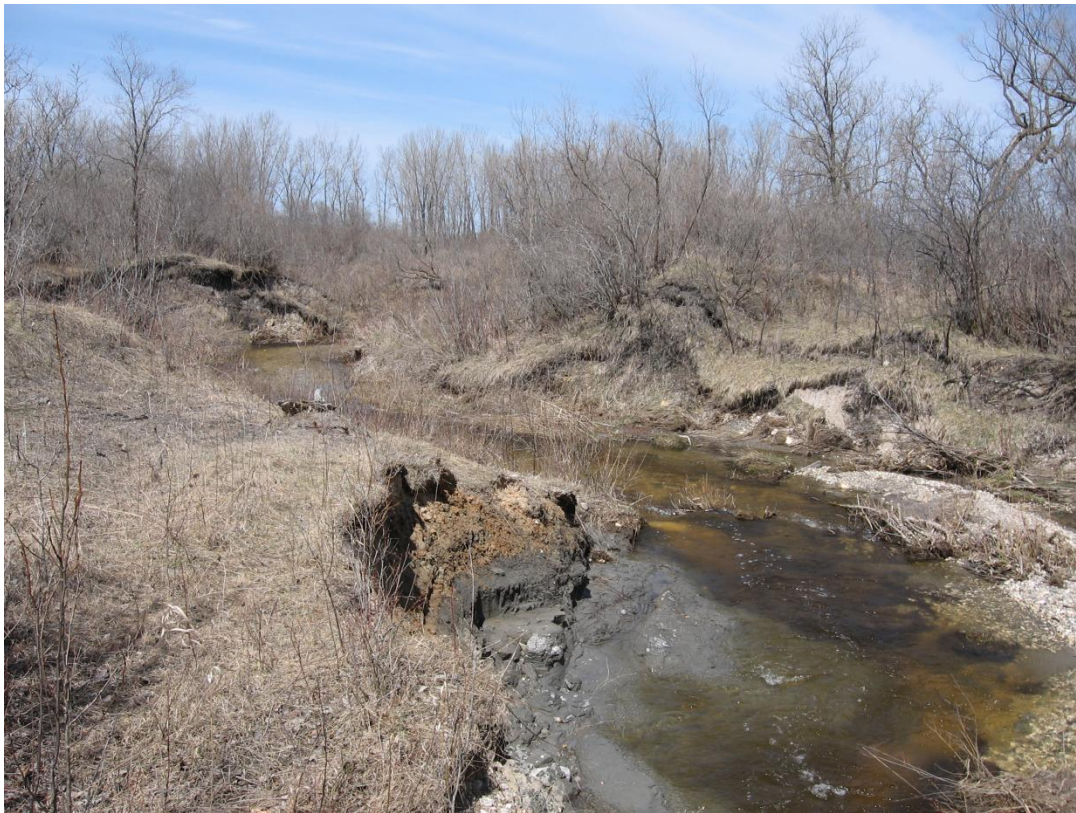
- Phase IV is the portion of the project in which the area around the Spring Gravel Dam washout will be stabilized and restored. Eroding stream banks will be stabilized using the toe wood – sod mat technique. The old sheet pile dam and an old bridge will be removed from the flood plain.
