RED LAKE WATERSHED DISTRICT MONTHLY WATER QUALITY REPORT

June 2014

Red Lake Watershed District Long-Term Monitoring Program

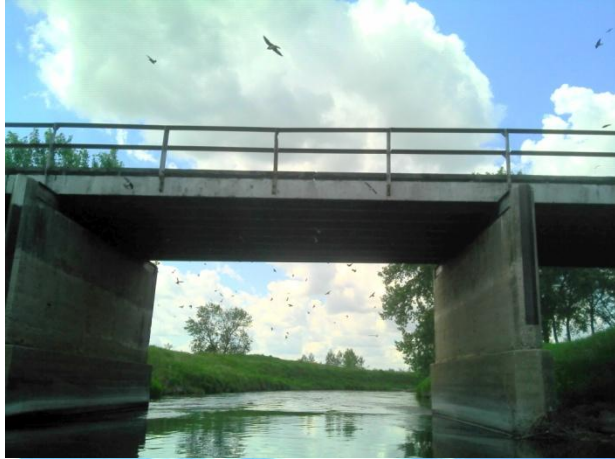
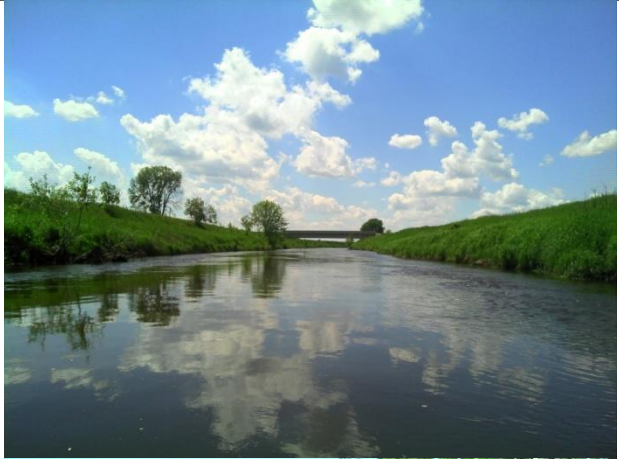
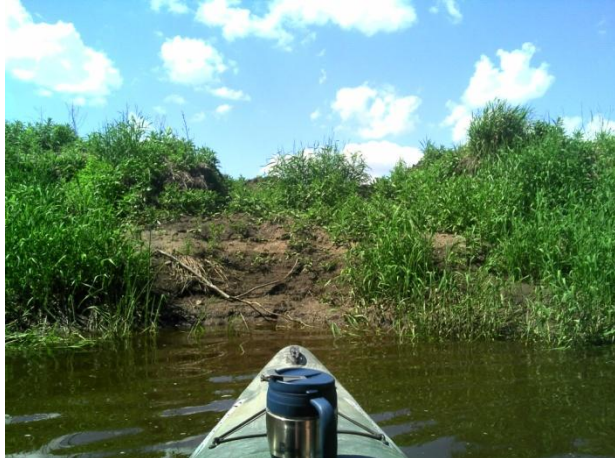
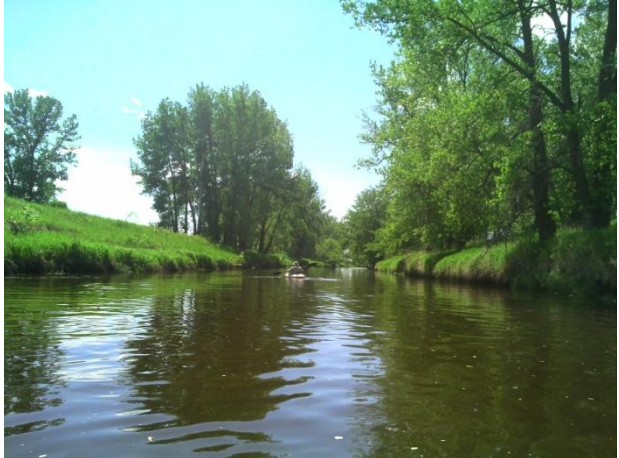
- RLWD staff made phone calls to landowners to get access permission for getting in or out of the rivers.
- The Clearwater River between CSAH 10 and CSAH 5 was inspected via kayak on 6/9/14. Bank erosion hazard ratings (BEHIs), Pfankuck ratings, depth measurements, georeferenced photos, and bank full width measurements were collected along the reach. This reach is part of the channelized portion of the Clearwater River. Banks were undercut a bit, but seemed to be relatively stable. There were few major erosion problems. There is a definite lack of buffer and shading of the river, so that could be negatively affecting dissolved oxygen levels by increasing temperatures in the water. Many cliff swallows were living under the bridges (potential source of E. coli).

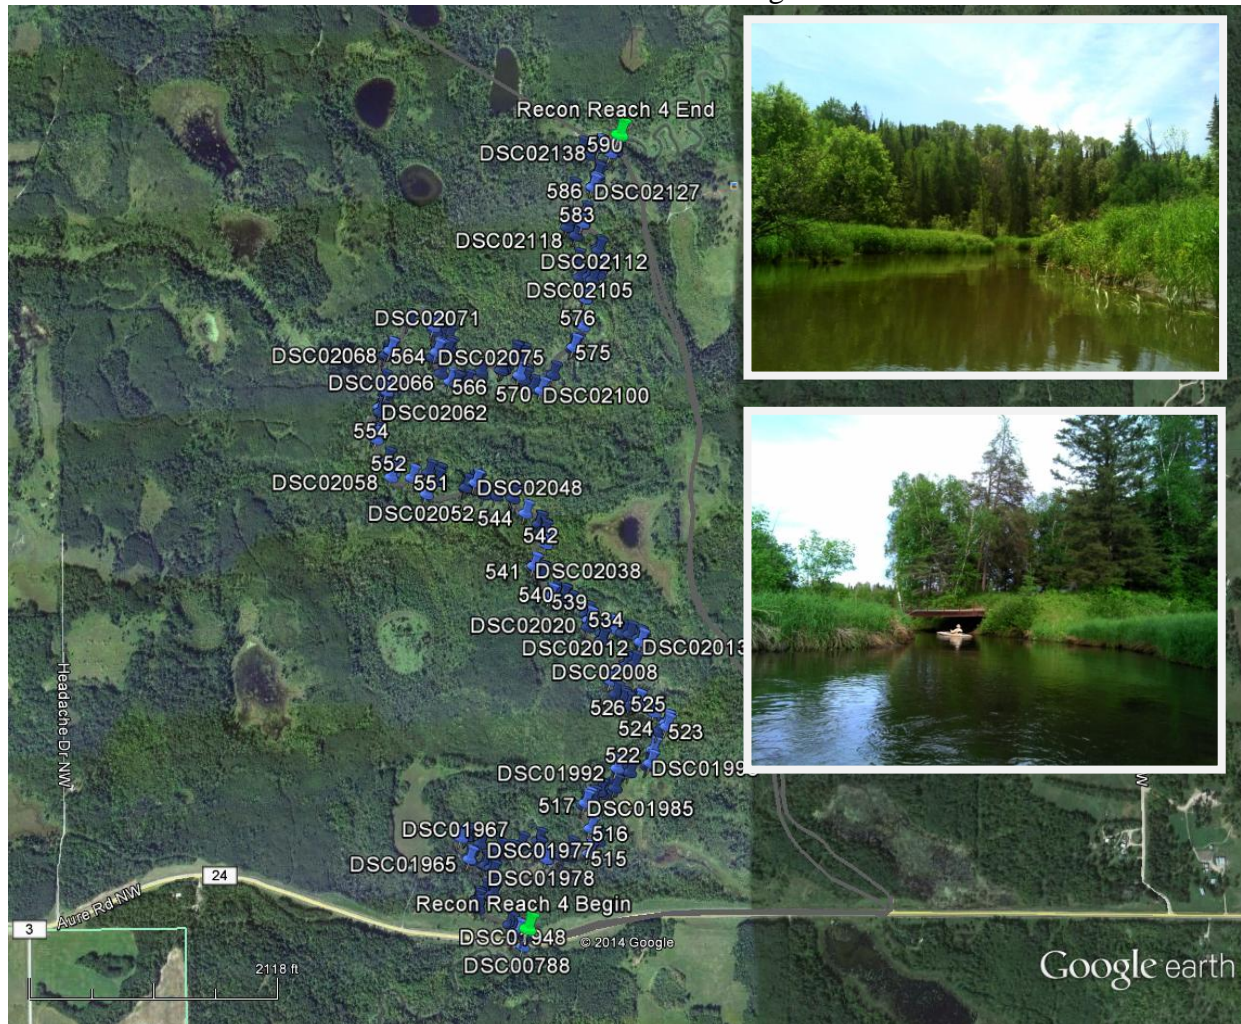
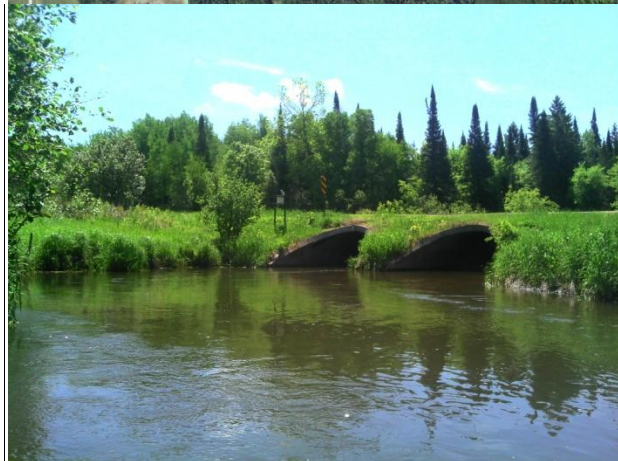
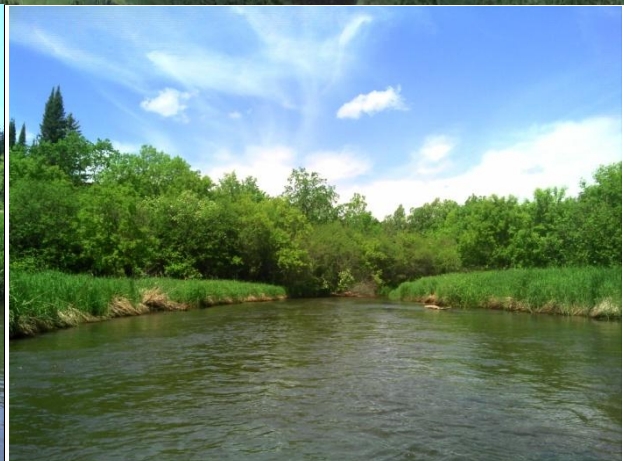
- The Clearwater River, upstream of Clearwater Lake, between CSAH 24 and an ATV trail bridge was inspected via kayak on 6/9/14. Bank erosion hazard ratings (BEHIs), Pfankuck ratings, depth measurements, georeferenced photos, and bank full width measurements were collected along the reach.

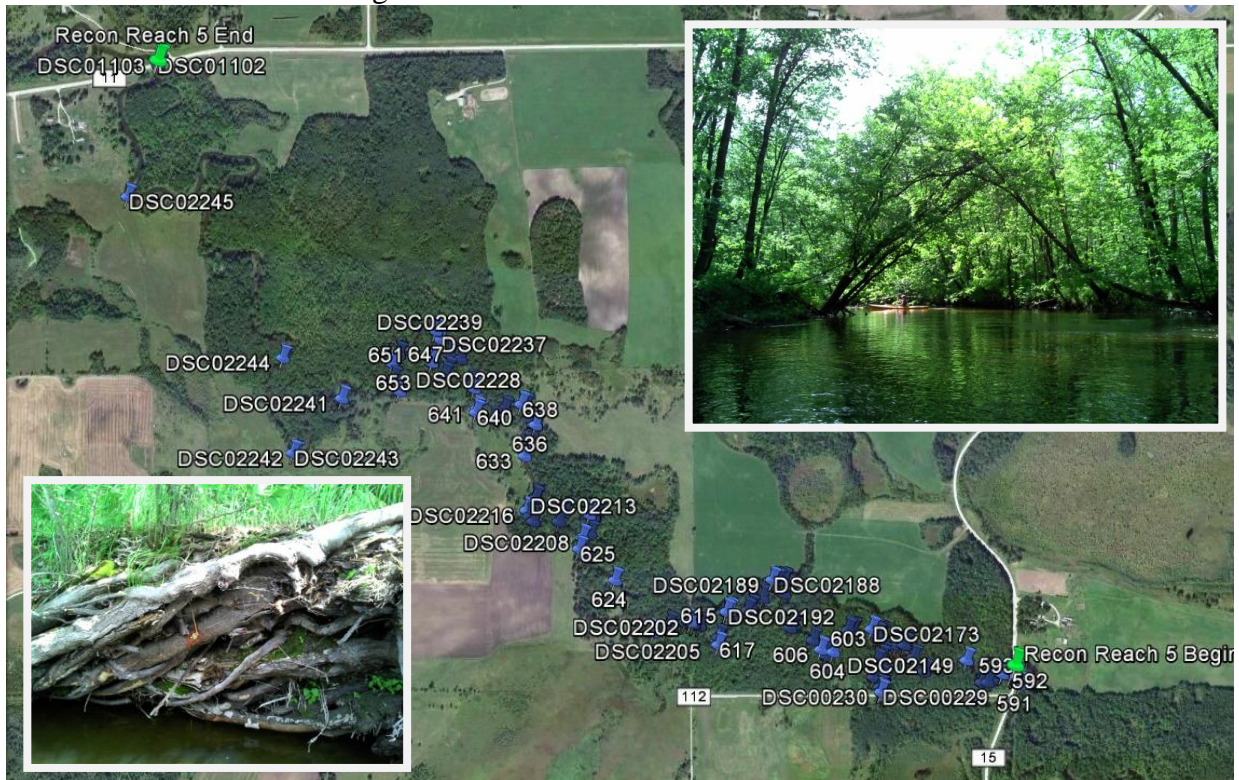
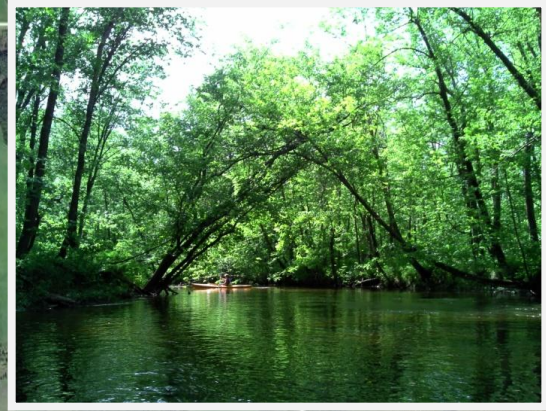
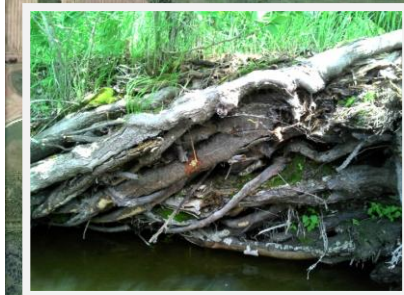
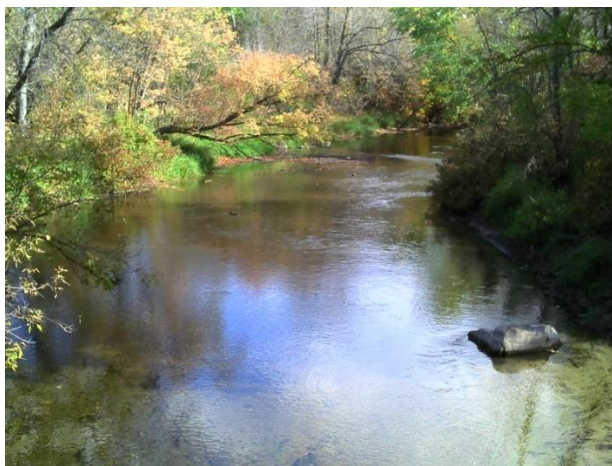
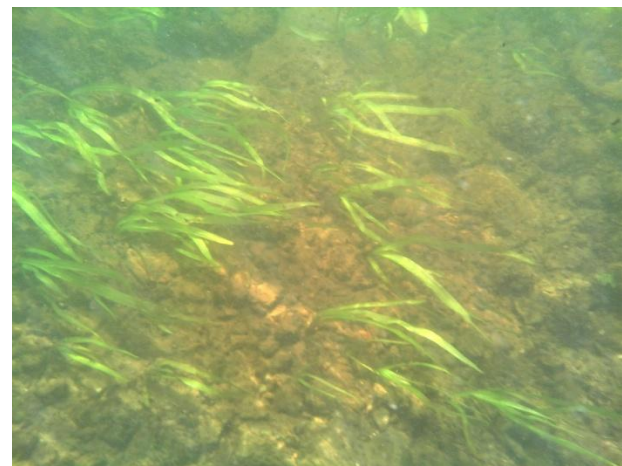
- The Clearwater River between CR 15 and CSAH 11 was inspected via kayak on 6/12/14. Bank erosion hazard ratings (BEHIs), Pfankuck ratings, depth measurements, georeferenced photos, and bank full width measurements were collected along the reach.

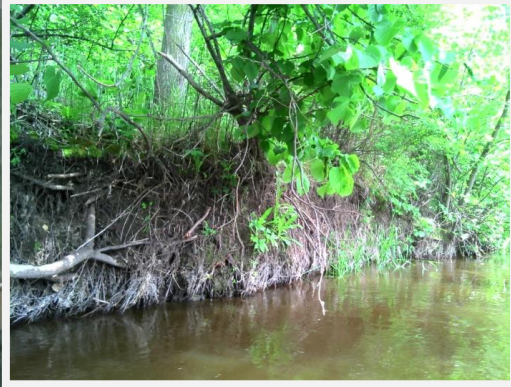
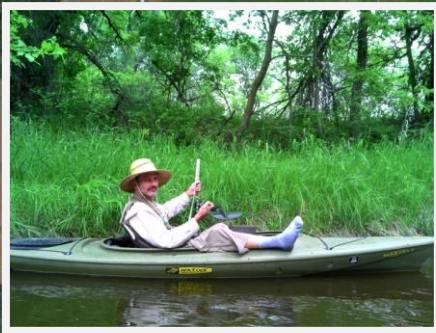
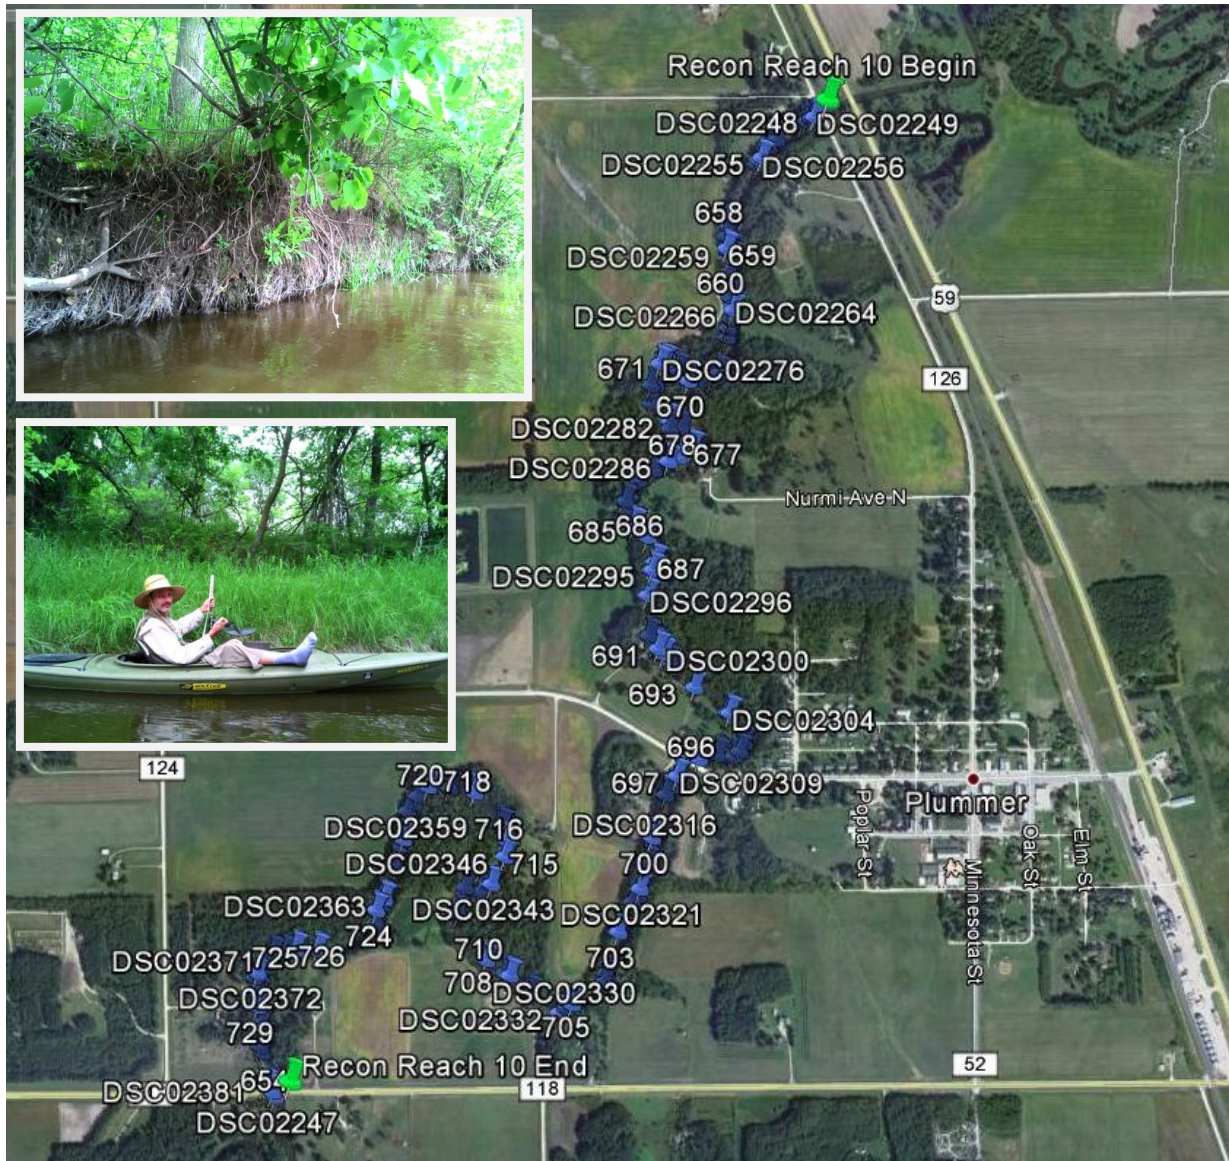
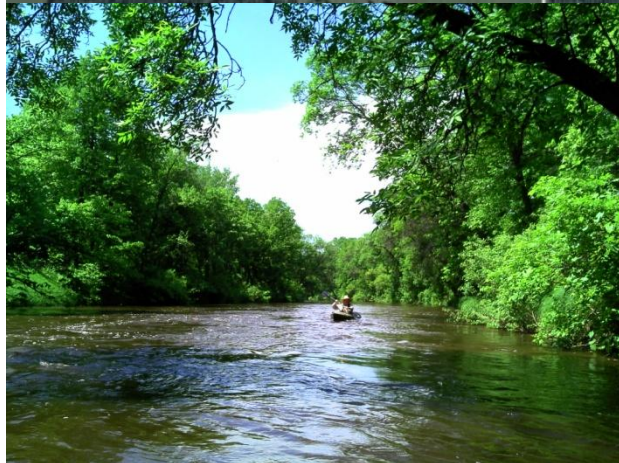
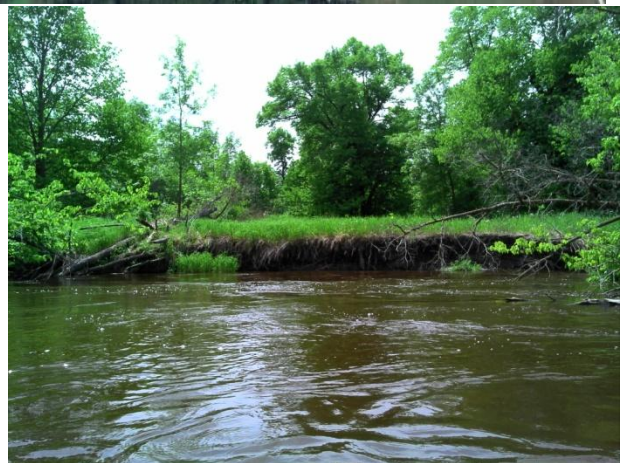
- The Clearwater River by Plummer (Highway 59 to CSAH 1) was inspected via kayak on 6/13/14. Due to recent rain, flows ended up being too high for full BEHI ratings because the water was higher than the bank full depth. Study bank heights, depths, channel widths, some bank angles, and georeferenced photos were still collected.

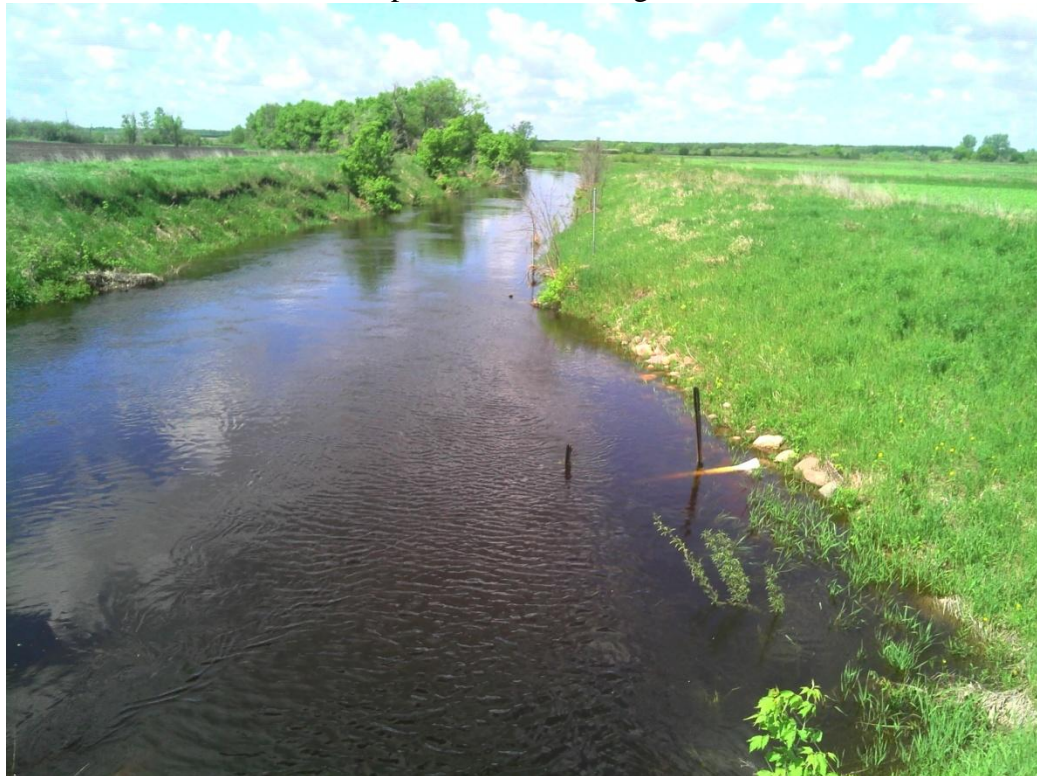
- Task 3 – Continuous Dissolved Oxygen Monitoring
 - The United States Fish and Wildlife Service at Agassiz national Wildlife Refuge has installed water quality logging equipment around the refuge. Here, equipment is installed in the Mud River upstream of the refuge:

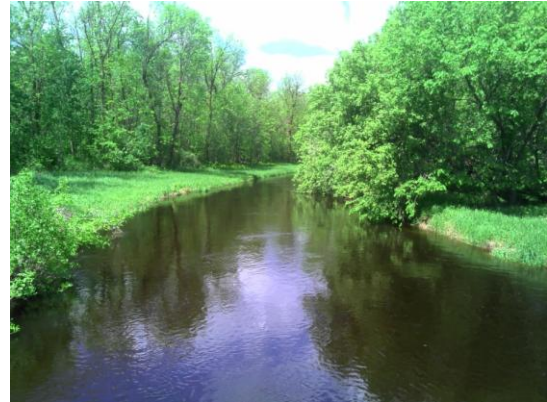
- Longitudinal water quality samples were collected along the Mud River on June 3, 2014 following a runoff event. Field measurements of dissolved oxygen, turbidity, pH, conductivity, and temperature were collected. Samples were analyzed for chemical oxygen demand (COD), ammonia nitrogen (NH₃), total Kjeldahl nitrogen (TKN), total phosphorus (TP), total suspended solids (TSS), and E. coli. Despite the recent rain, runoff, and relatively high flows, turbidity and TSS levels were low throughout the reach. TSS ranged from 1 mg/L to 6 mg/L. E. coli concentrations were all below the chronic standard of 126 CFU/100ml. E. coli concentrations did increase from upstream to downstream, though, and there were some points where there were relatively significant increases in E. coli. The lowest bacteria levels were found where near the Mud River (JD11) leaves Moose River impoundment (which was discharging at the time). This indicates that the impoundment is not a likely source of the high E. coli readings that are sometimes found in the river.

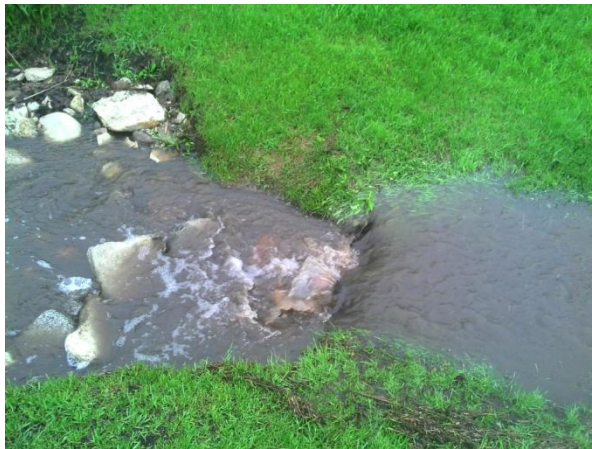
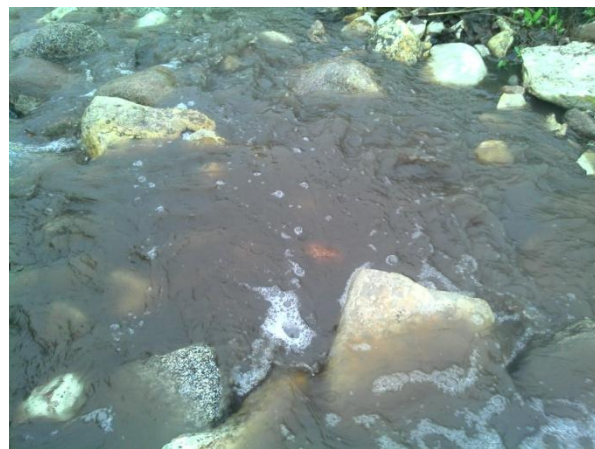
Field measurements of stage, temperature, conductivity, dissolved oxygen, pH, and turbidity were collected. Samples were analyzed for chemical oxygen demand (COD), ammonia nitrogen (NH₃), total Kjeldahl nitrogen (TKN), total phosphorus (TP), total suspended solids (TSS), and E. coli. The samples were taken during a heavy rainfall event with significant runoff. At the lower end of the watershed, turbidity, TSS, and E. coli levels were very high. Turbidity, TSS, and E. coli levels were very high in samples collected at the end of a ditch that was flowing north along the east side of CSAH 11.

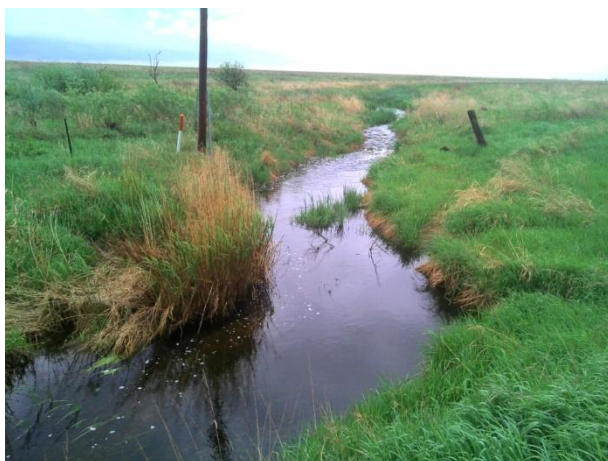
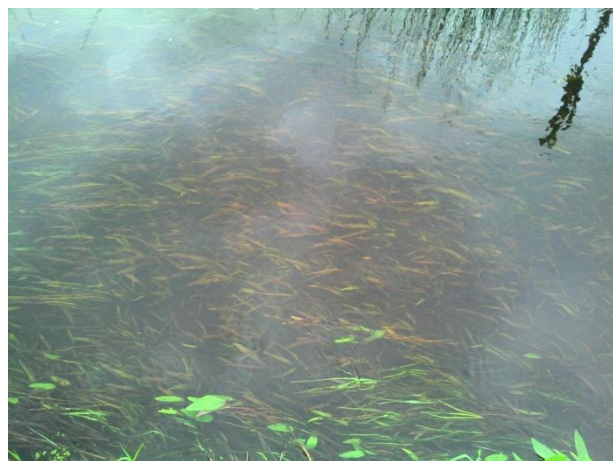
The water was very clean where it was leaving Glacial Ridge National Wildlife Refuge at Highway 2.

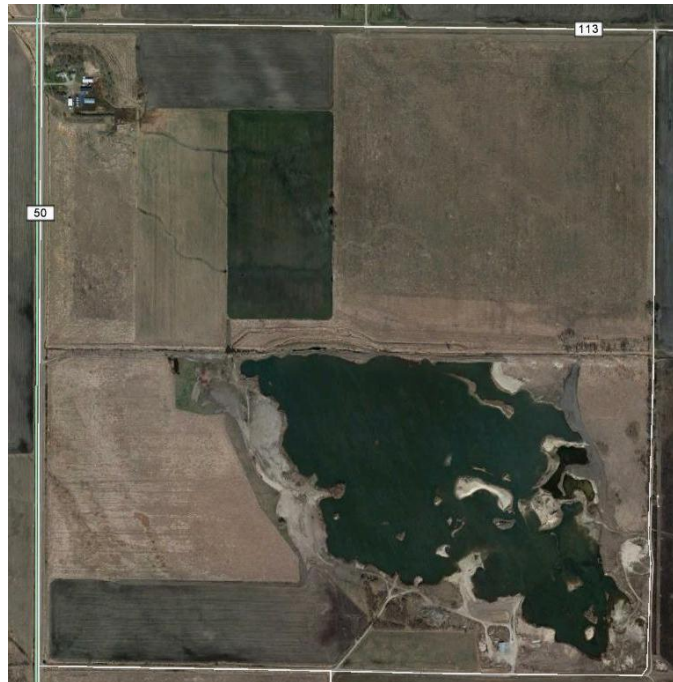
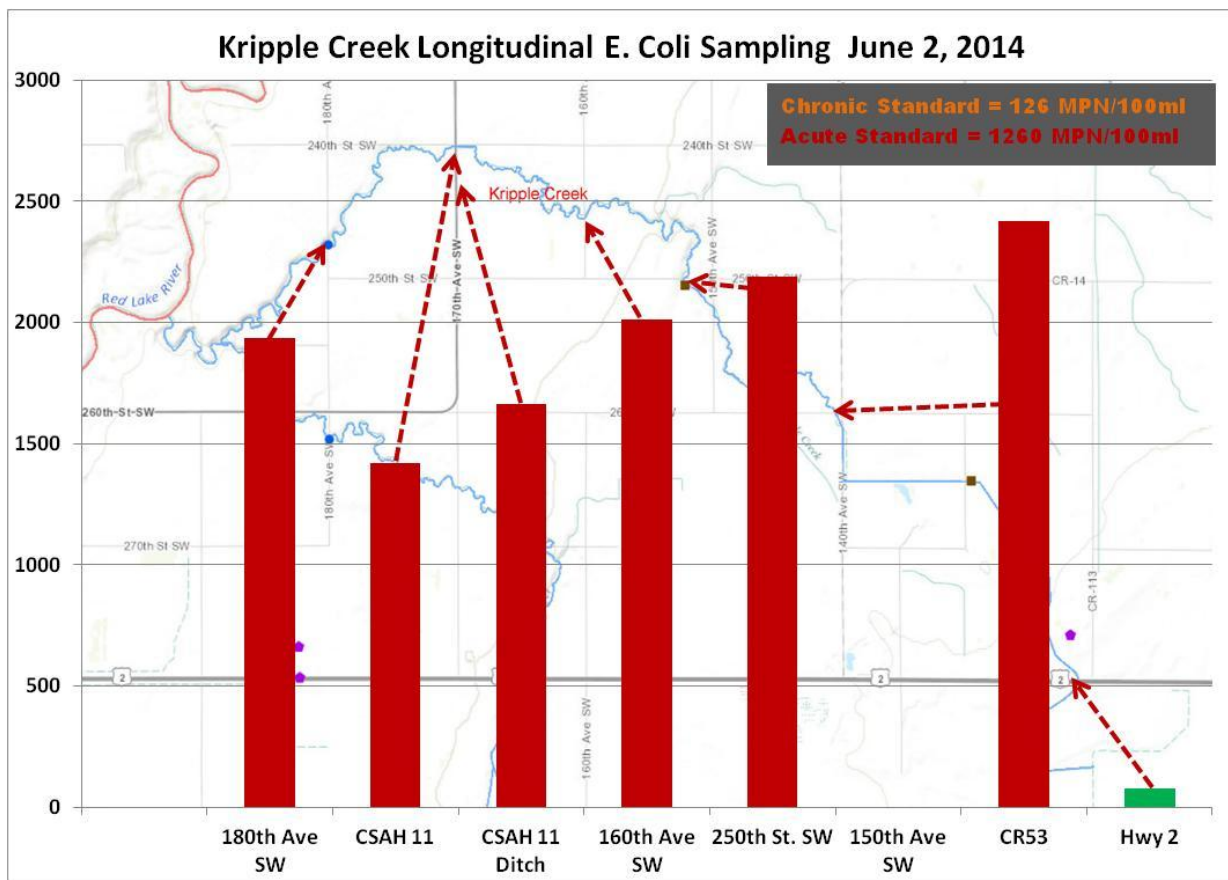
There was a significant increase in turbidity/TSS and a very large increase in E. coli between Highway 2 and CR 53. E. coli went from 77.6 CFU/100ml at Highway 2 to a concentration that was higher than the laboratory's maximum reporting limit at >2419.6 CFU/100ml at CR53. Primary suspected sources of this E. coli are livestock operations in Section 30 of Pleasant Township in Red Lake County.

E. coli actually decreased at each of the next three crossings that were sampled and then increased again downstream of CSAH 11 (where there are some horses along the stream).

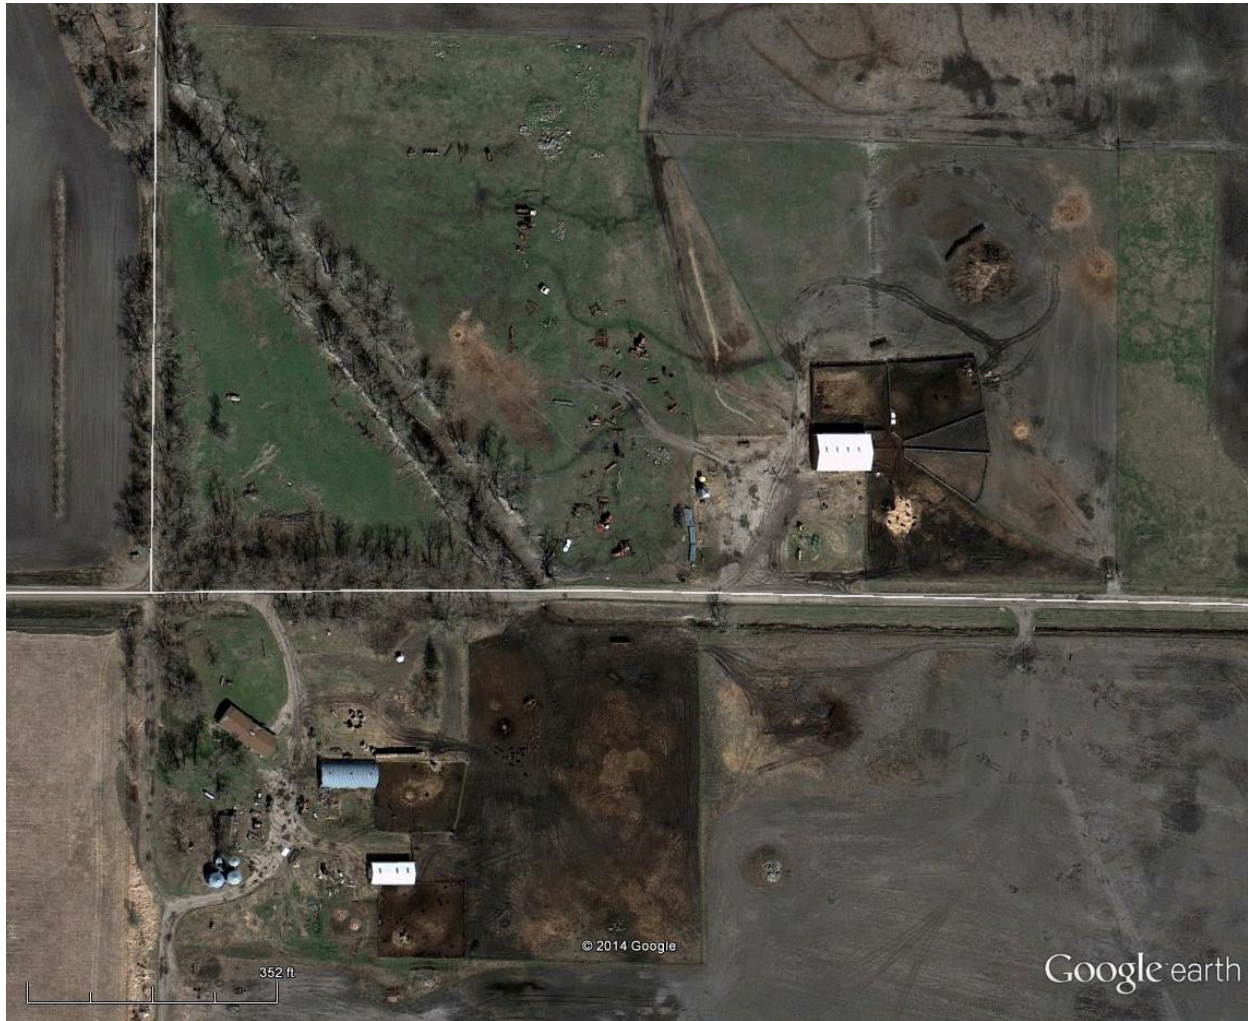
Longitudinal samples were collected along Gentilly Creek on June 5th, 2014. The samples were collected after several days of rain in the area, including the day of collection. E. coli concentration and turbidity levels spike where the Polk County Ditch 140 portion of the Gentilly Creek watershed crosses CR44 and 300th St. SW. There is a definite livestock operation east of CR44 that drains to both branches of CD 140 that could be contributing to high E. coli levels.

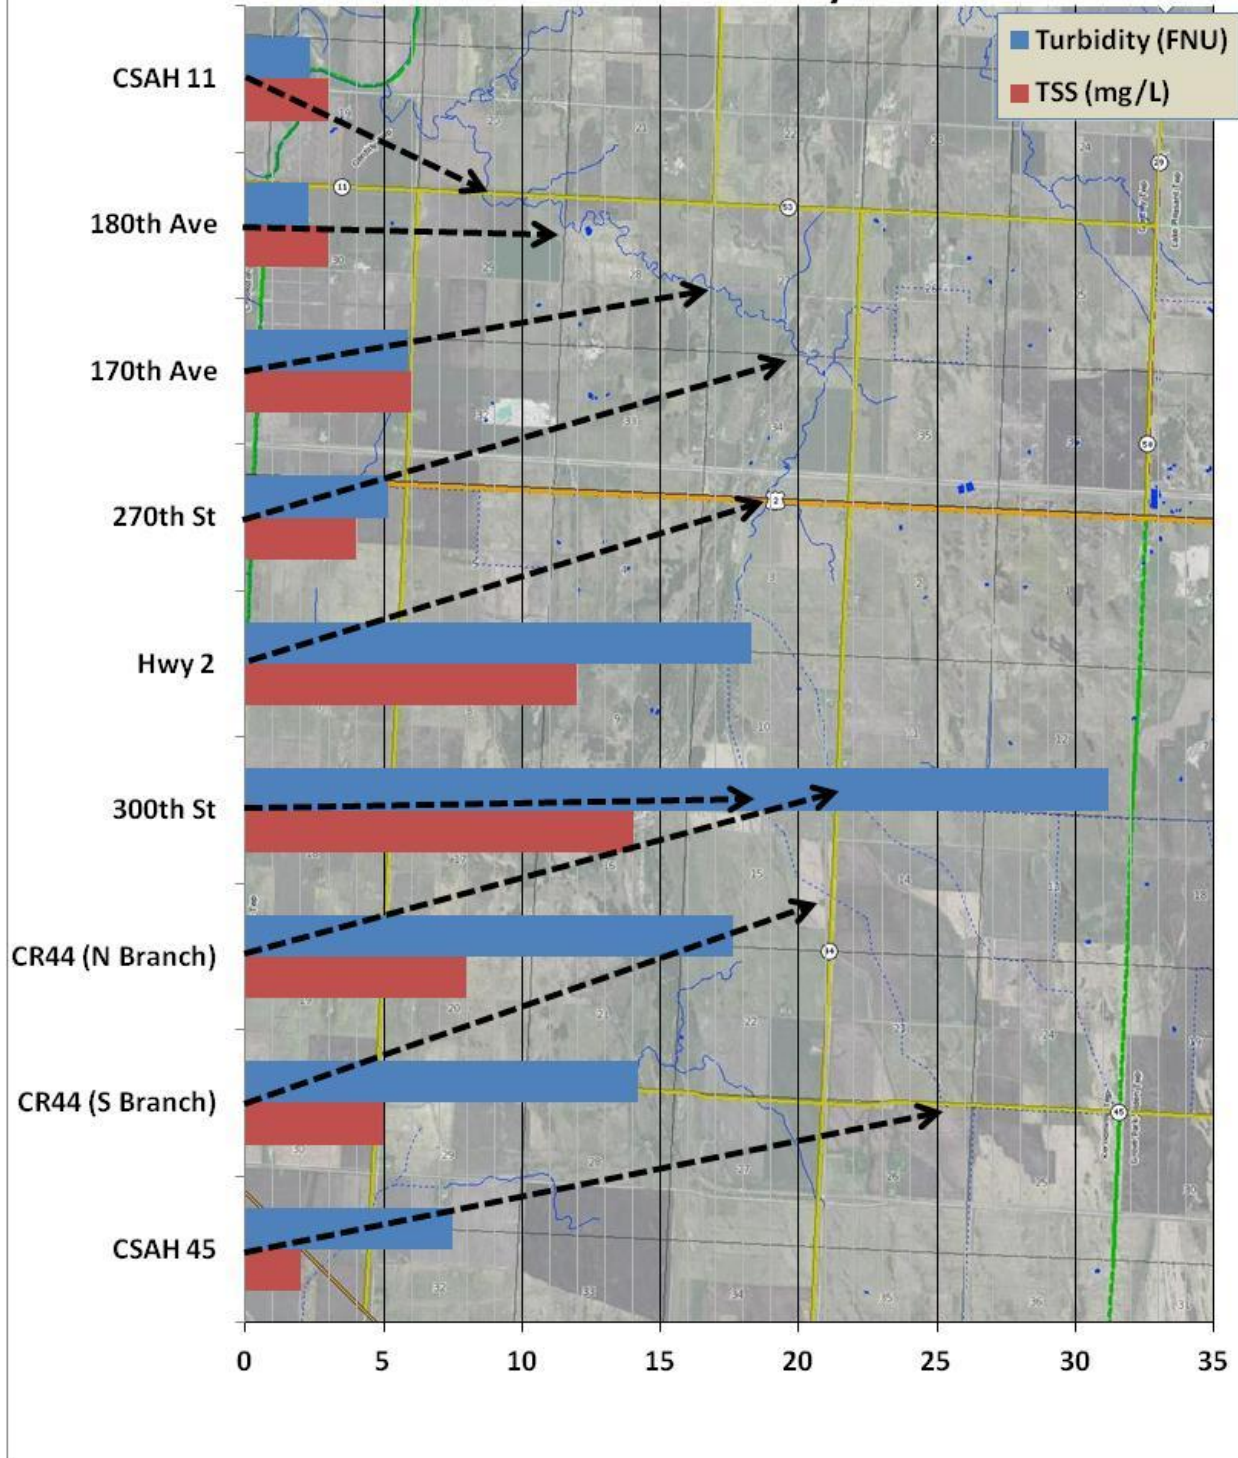
**Gentilly River Longitudinal Sampling - June 5, 2014
Sediment and Turbidity**

Total suspended solids and turbidity also increase dramatically at the lower end of the watershed. Erosion control projects will be needed in the lower part of the watershed. These could include structural projects in the channel to fix eroding banks and best management practices to reduce overland erosion. Based on preliminary observations during the geomorphologic analysis of the Black River, lowering peak flow rates would reduce stress on stream banks and would be an important part of reducing erosion in the lower reach of the Black River.

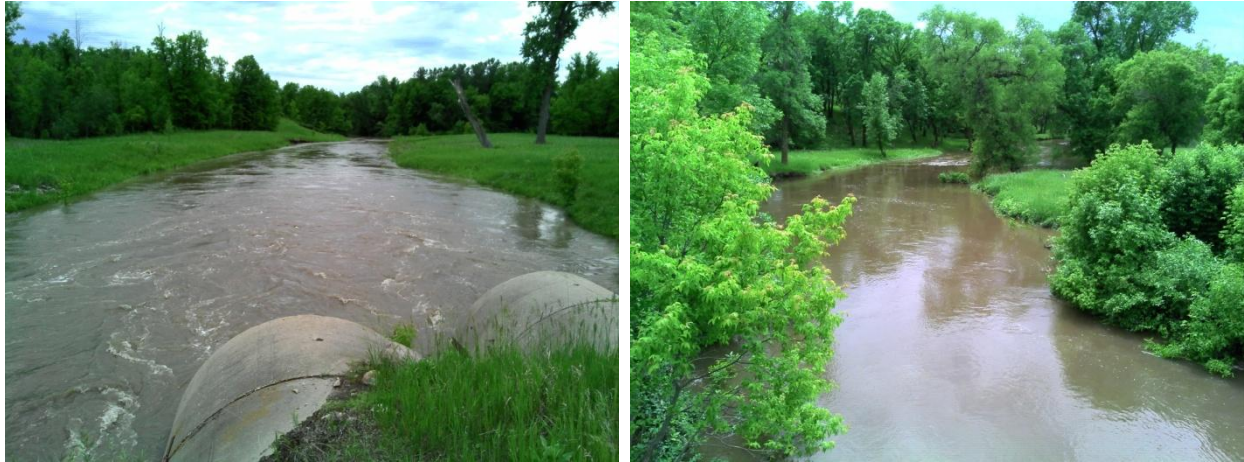
On June 16, 2014, longitudinal samples were collected at sites along the Black River and at the pour points of two of its main tributaries (Little Black River and Browns Creek). The samples were taken after a rain event to help identify specific areas in the watershed in which runoff is significantly increasing pollutant concentrations in the river. These areas can be targeted for project implementation.

Very high E. coli concentrations were found at the lower end of the watershed. E. coli concentrations still exceeded the chronic standard (126 MPN/100ml) at the upper end of the sampled reach. Time was a factor in why sampling wasn't extended further upstream.
