**Red Lake Watershed District Long-Term Monitoring Program**

### **Clearwater River Watershed Restoration and Protection (WRAP) Project**

# RED LAKE WATERSHED DISTRICT MONTHLY WATER QUALITY REPORT

July 2014

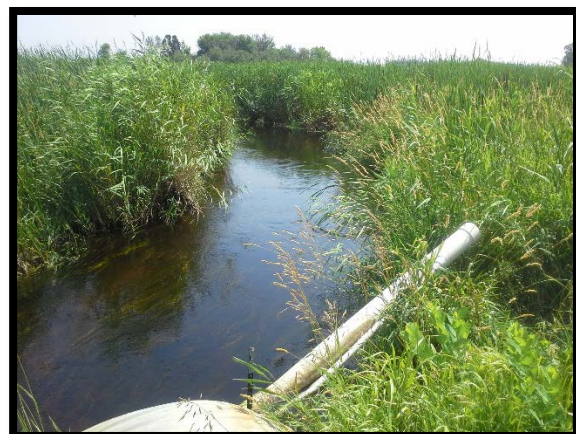
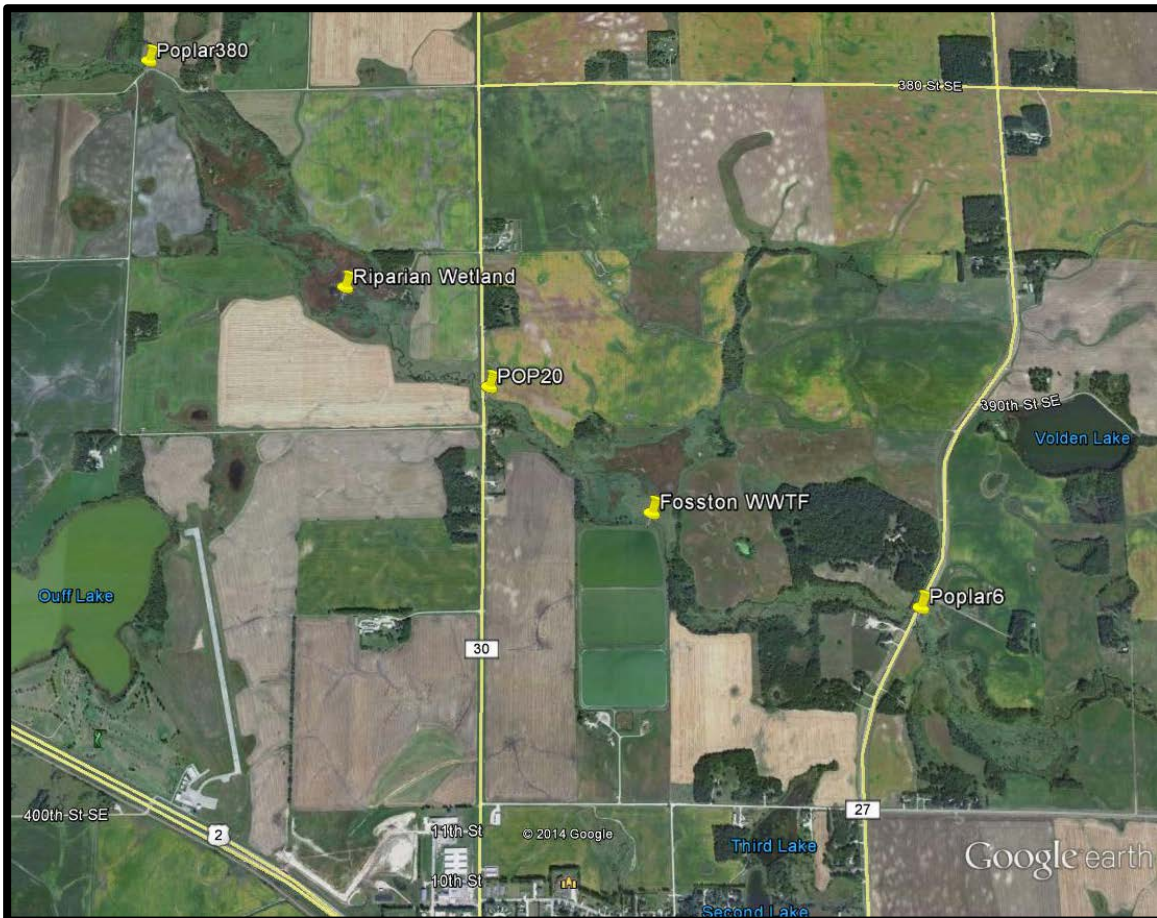
- Objective 2 – Water Quality Sampling
  - Deployment pipes for dissolved oxygen loggers and HOBO water level loggers were installed at the CSAH 6 and 380<sup>th</sup> St. SE crossings of the Poplar River in preparation for an intensive examination of a reach of the Poplar River that has been influenced by past discharge from the Fosston wastewater treatment facility lagoons. Three crossings in a row will be continuously monitored for stage and dissolved oxygen and will be intensively sampled. This will occur in two separate 2-week periods.

- Eureka Manta sondes with optical dissolved oxygen probes were deployed at the CSAH 6 (Poplar6) and 380<sup>th</sup> Street (Poplar380) sites in late July.

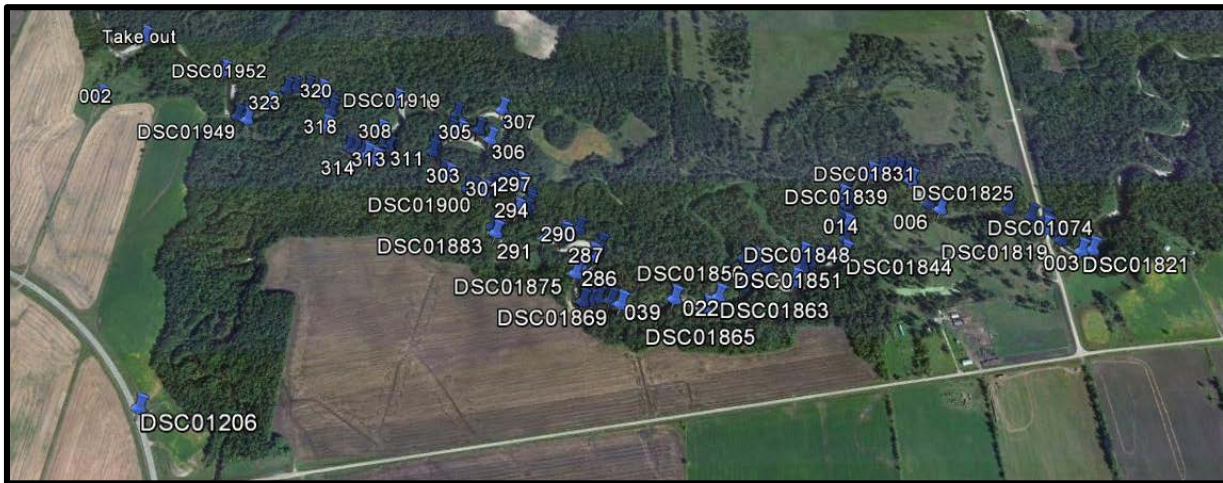
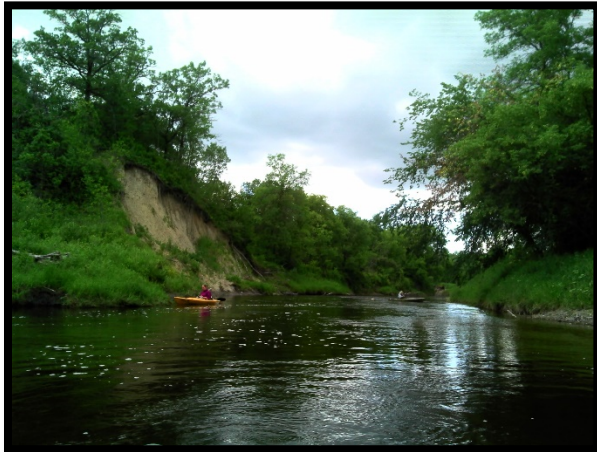
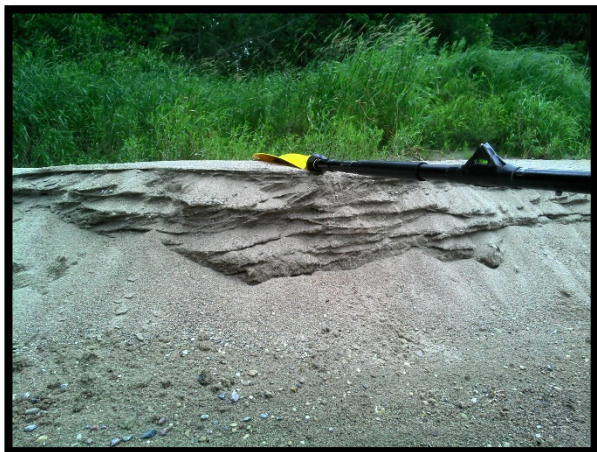
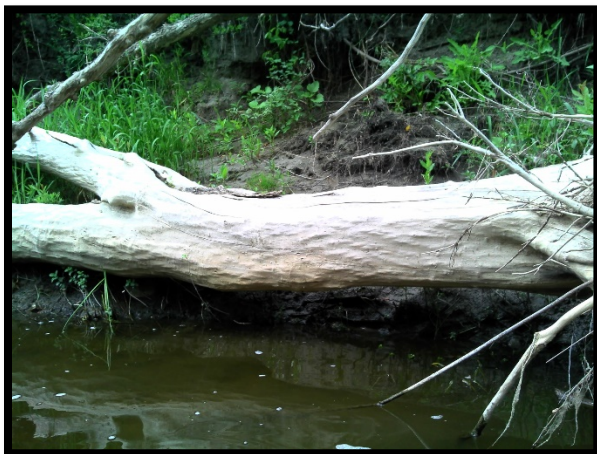
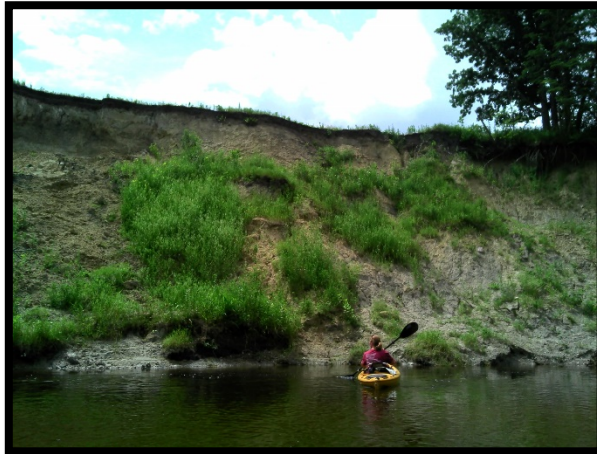
- RLWD staff contacted landowners to get access permission for geomorphology intensive station work.
  - The Lost River between CSAH 10 and CSAH 5 was inspected via kayak on 7/14/14. Bank erosion hazard ratings (BEHIs), Pfankuch ratings, depth measurements, georeferenced photos, and bank full width measurements were collected along the reach. There is a lot of sand moving through this reach. Sand bars were relatively large. There was a lot of woody debris along this reach. Some tree trunks and woody debris had a unique, sandblasted look to them.

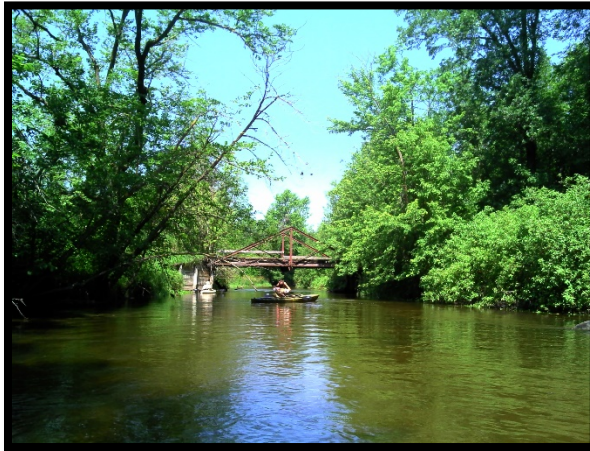
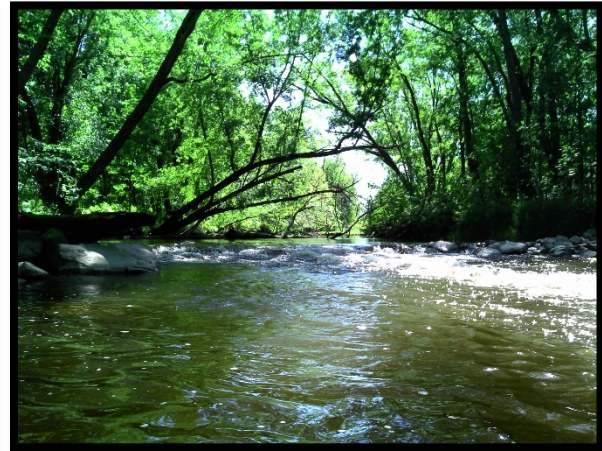
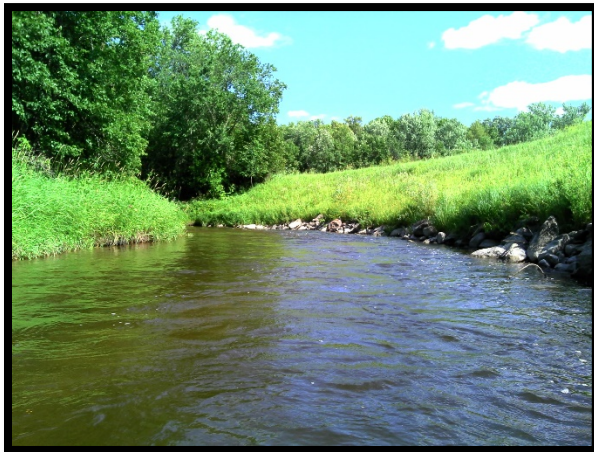
- The Clearwater River in Greenwood Township between CSAH 11 and CSAH 5 was inspected via kayak on 7/22/14. Bank erosion hazard ratings (BEHIs),
  - Pfankuch ratings, depth measurements, georeferenced photos, and bank full width measurements were collected along the reach. This trip collected data that is upstream and downstream of the start of the channelization of the Clearwater River.

- Stream bank condition data from upstream of the grade stabilization structures constructed by the Red Lake Watershed District can be compared with data from downstream of the lower structure. The grade control structures are working very well and are doing a good job of keeping the channel stable upstream of their location. There is a contrast between the stability of the river upstream of the grade control structure project and the stability of the river and its banks downstream of the grade stabilization project. There are noticeable headcuts in the channel bottom and many failing banks downstream of the structures. The grade control structures were fun to go float through in a kayak.

- One of the floodplain restoration structures (rock dams plugging channels that are crossing the floodplain) has been washed-out and will have to be repaired. There are some log jams along this reach that require portaging.

- The bank stabilization work that was done as part of the same Greenwood 27 project that created the grade stabilization and floodplain restoration structures is still holding up. The willow plantings that survived are sparse, but there are still some willows growing along those banks.

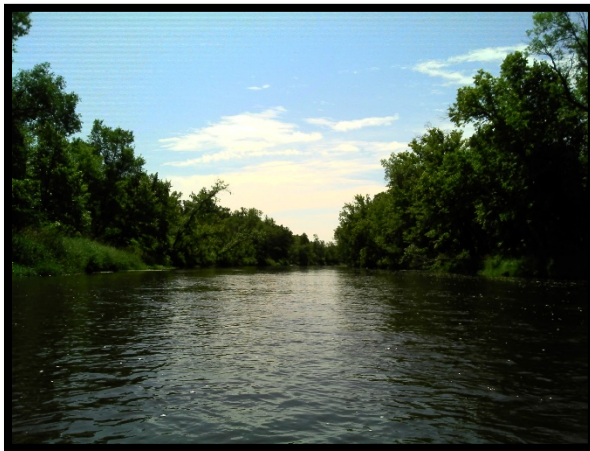
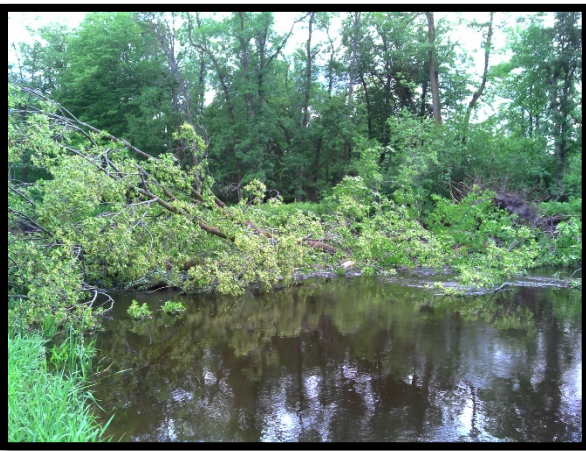
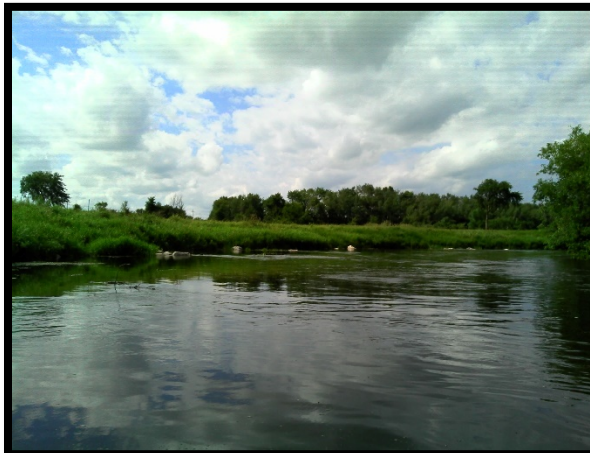
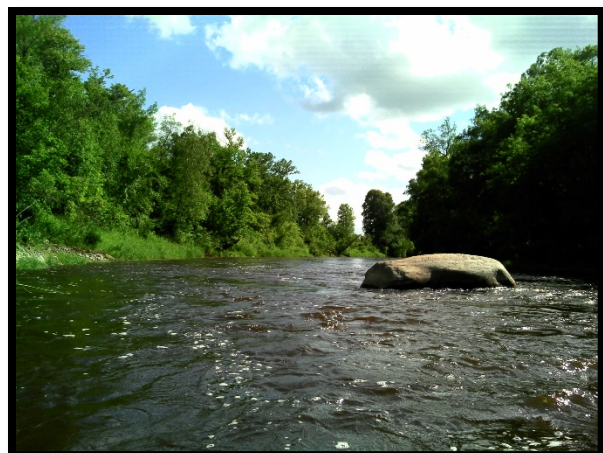
- The Clearwater River near Terrebonne, between CSAH 20 and CSAH 12, was inspected via kayak on 7/23/14. Bank erosion hazard ratings (BEHIs), Pfankuch ratings, depth measurements, georeferenced photos, and bank full width measurements were collected along the reach.

- This was one of the nicest reaches we paddled. There was only one tree down across the river. The portage around that tree was pretty easy due to a sand bar that made exiting and re-entering the river easy.

- Right before those rapids, we passed a stream bank stabilization project that the Red Lake Watershed District completed in the late 90s. The toe protection and stream barbs are still keeping the bank stable.

- A lot of trees had been knocked down along the river by the tornado that went through the area July 21, 2014.

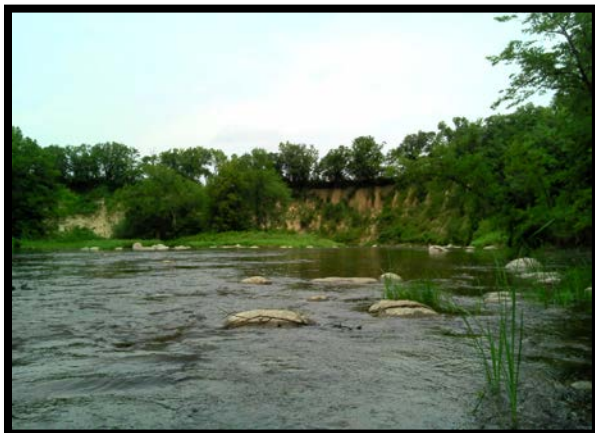
- Seven miles of the Clearwater River by Red Lake Falls, between CSAH 20 and CSAH 12, were inspected via kayak on 7/24/14. Bank erosion hazard ratings (BEHIs), Pfankuch ratings, depth measurements, georeferenced photos, and bank full width measurements were collected along the reach.
  - There were some high bluffs along this reach and a lot of rapids. The rapids just downstream of the Highway 32 crossing were tricky and it might be a good idea to portage around them during low water.

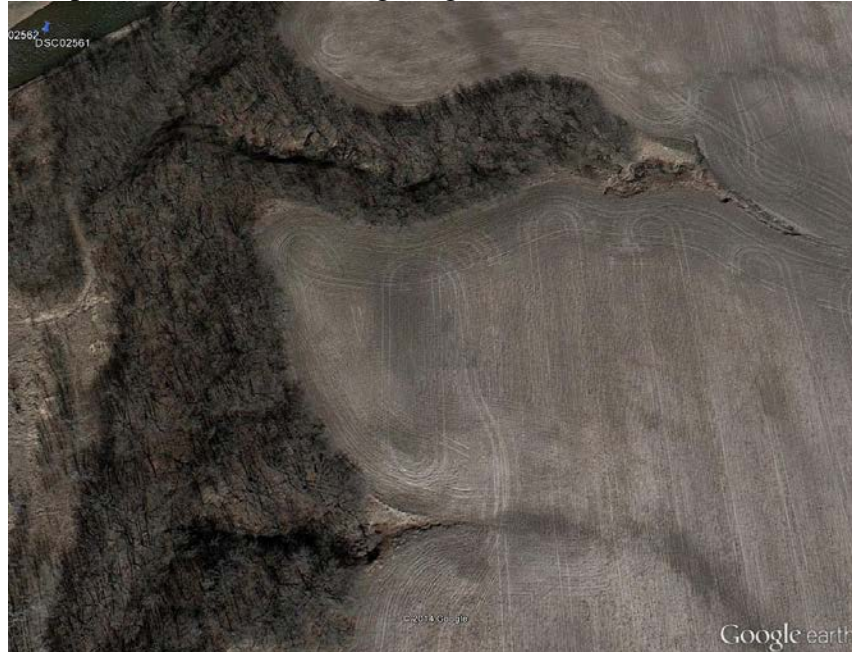
- Significant gully erosion is occurring along smaller waterways that flow into this lower reach of the Clearwater River. There is a steep drop from the uplands where the drainage begins down to the Clearwater River.

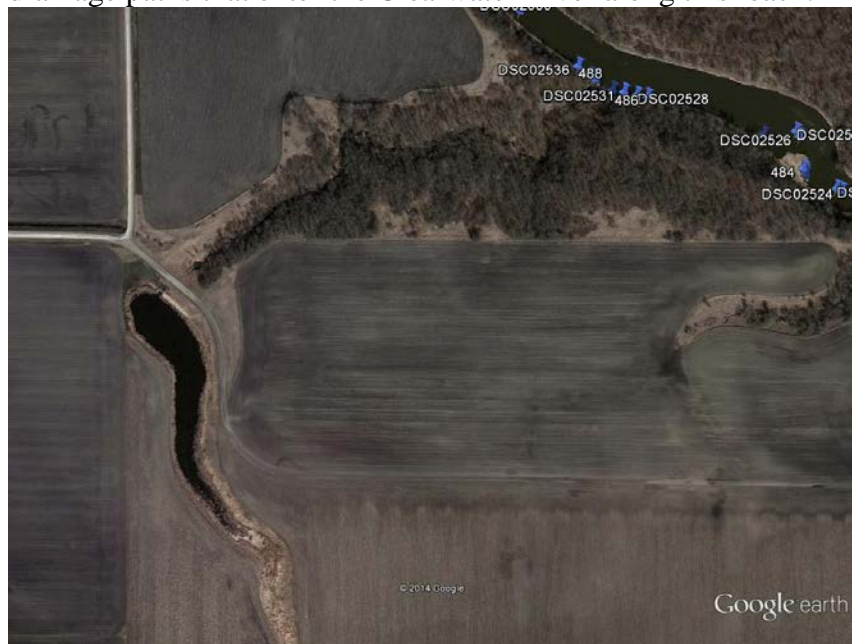
- There is at least one case where grade has been stabilized along one of these drainage-ways. An SCS water control structure south of Red Lake Falls has kept gully erosion from creeping upstream along one of small drainage paths that enter the Clearwater River along this reach.
