By Corey Hanson, Red Lake Watershed District Water Quality Coordinator. 2/21/2018.

### **Red Lake Watershed District Long-Term Monitoring Program**

# RED LAKE WATERSHED DISTRICT MONTHLY WATER QUALITY REPORT

**September -  
October 2017**

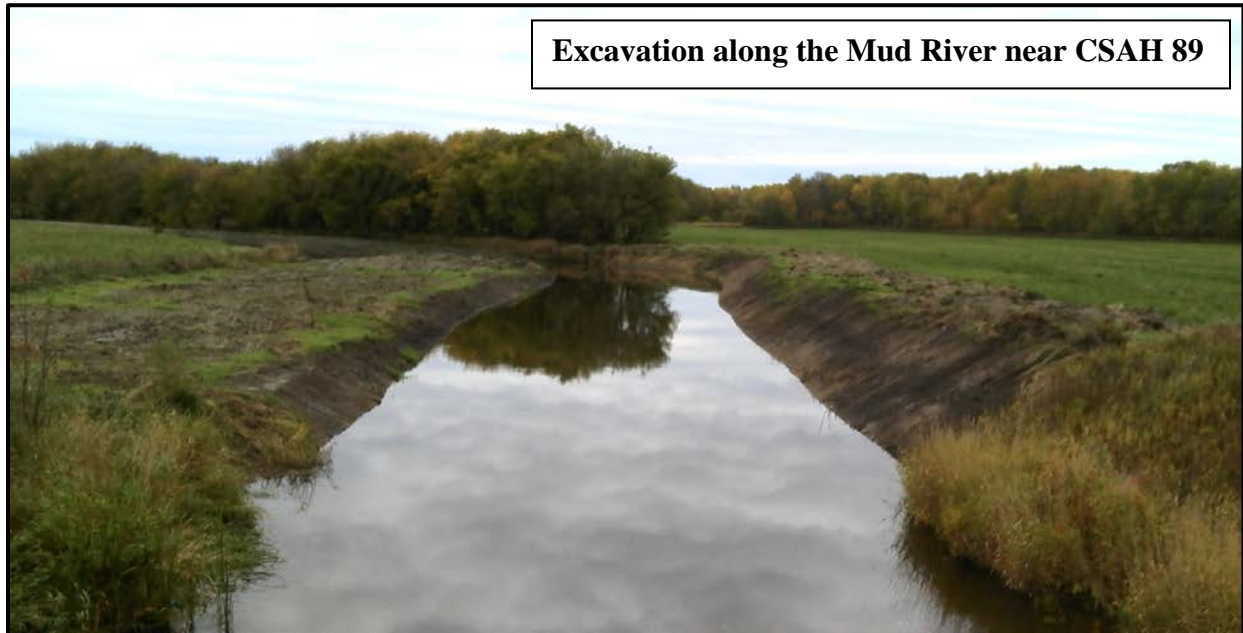
- A ditch along the Wapiti WMA that was being cleaned during a runoff event, sending muddy water downstream to the Mud River.
- Mud River at Highway 89 (18 mg/L, runoff event, recent "cleaning")
- Thief River at CSAH 7 (38 mg/L)
  - The concentration was lower (8 mg/L) downstream at 140<sup>th</sup> Ave NE

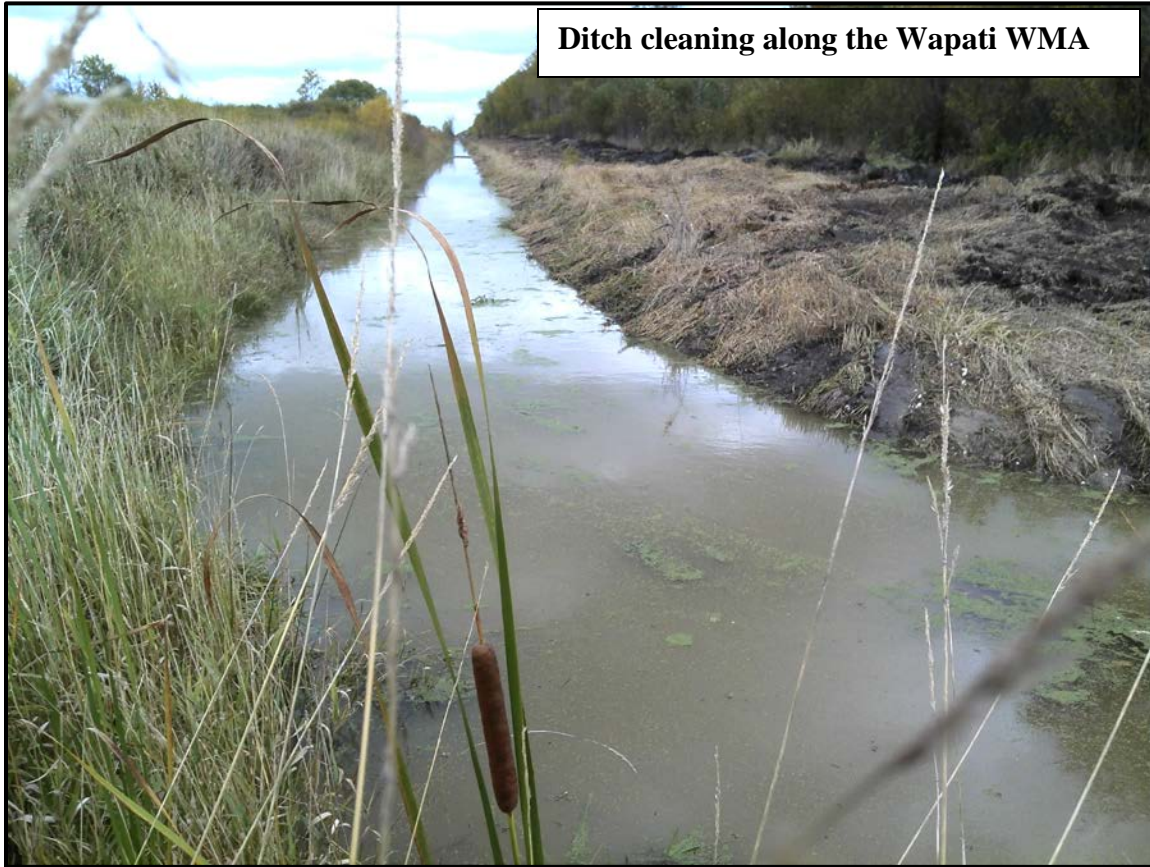
**Ditch cleaning along the Wapati WMA**

During early-October sampling, there was a lot of standing water and runoff in the Grygla area after a large rainfall event. A ditch cleanout was in progress along the border of the Wapiti WMA while the Thief River watershed was being sampled in early October. This ditch flows to Branch 55 of Judicial Ditch 11, north of Grygla along CSAH 54. That ditch flows into other branches of JD 11 before emptying into the Mud River. The water in the ditch was very muddy near the cleanout. Before reaching the Mud River, the muddy water in this ditch was diluted by cleaner water from downstream tile drainage systems that were rapidly discharging after the recent rainfall event.

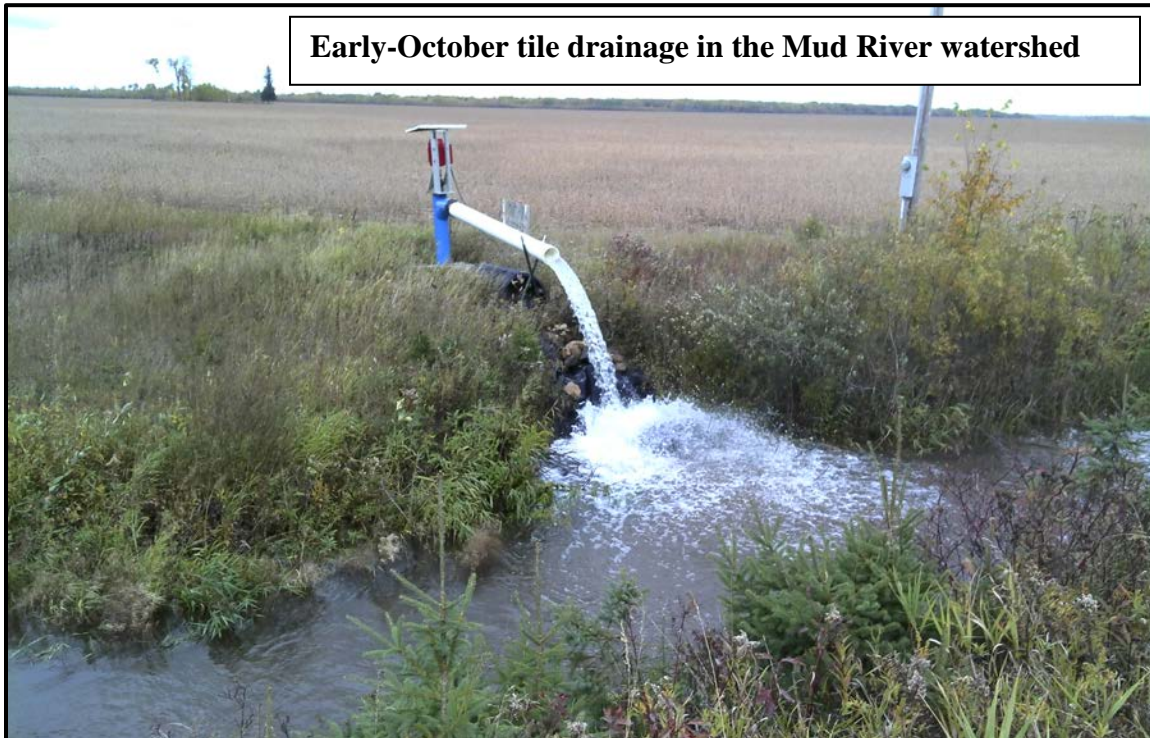
**Early-October tile drainage in the Mud River watershed**

A very high (13.2 mg/L) nitrate + nitrite concentration was found in Lower Badger Creek on October 11, 2017. A relatively high nitrate + nitrite concentration was found in the Mud River on October 3, 2017. All tile drainage in that watershed was flowing after a rainfall event. Relatively high nitrates and nitrites concentrations were also found in Beau Gerlot Creek and Terrebonne Creek.

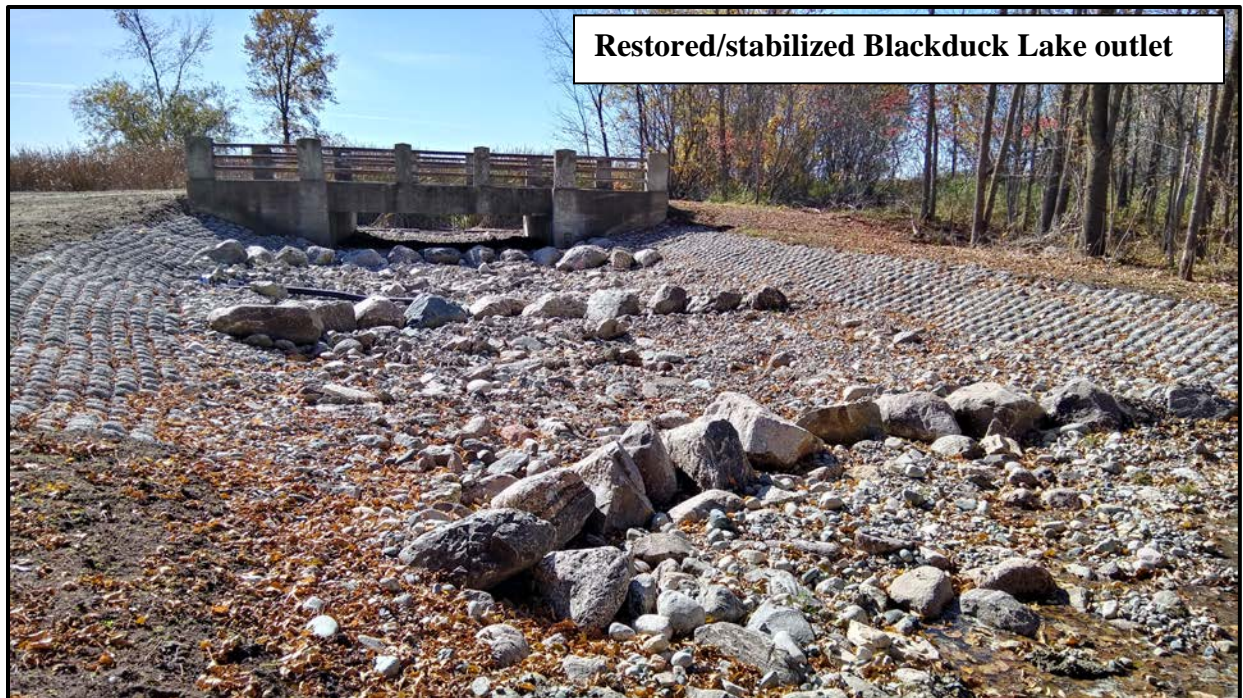
The recently completed restoration of the Blackduck Lake outlet was photographed during the Upper/Lower Red Lakes area sampling trip.

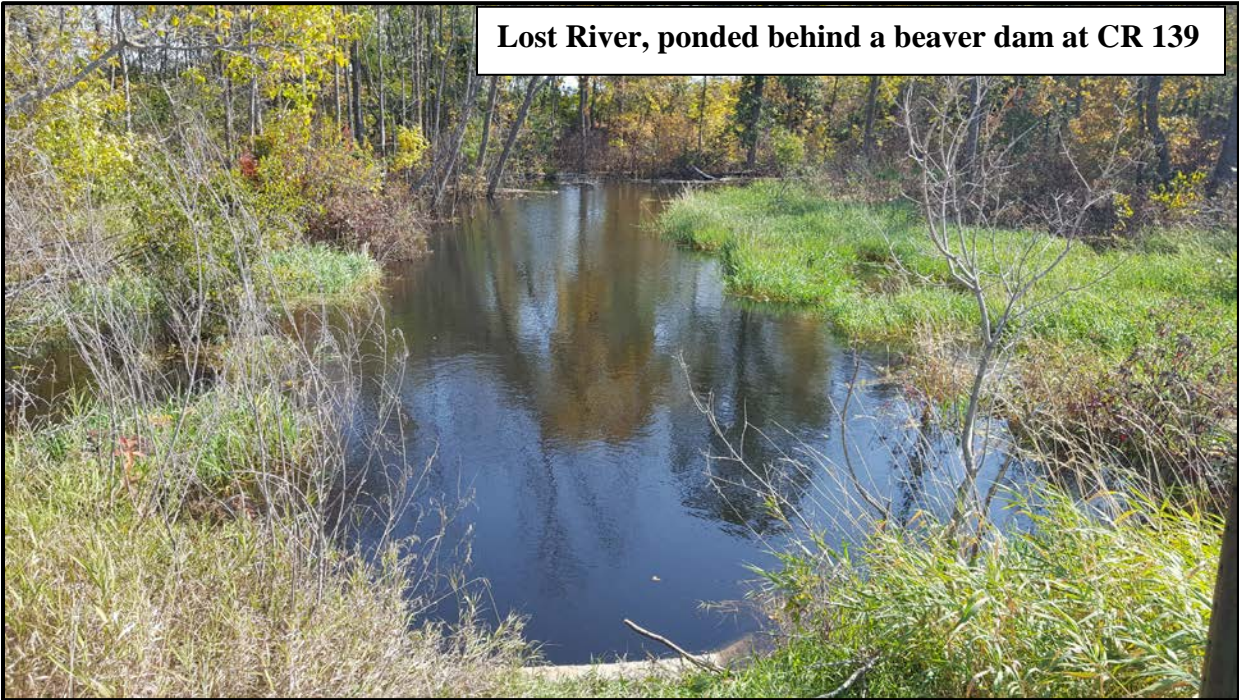
**Lost River, ponded behind a beaver dam at CR 139**

- Little Black River at County Road 102
- Lost River at County Road 139 (ponded behind a beaver dam)
- Walker Brook at CSAH 19

Beaver dams in the Lost River were blocking flow near the County Road 139 crossing near Anderson Lake. Beaver dams downstream of the crossing have been a common occurrence. However, on September 12, 2018, a beaver dam had also been built within the culvert. The culvert was plugged from top to bottom, causing flooding upstream.
