By Corey Hanson, Red Lake Watershed District Water Quality Coordinator. 12/11/2018.

**RED LAKE WATERSHED DISTRICT
MONTHLY WATER QUALITY REPORT**

June 2018

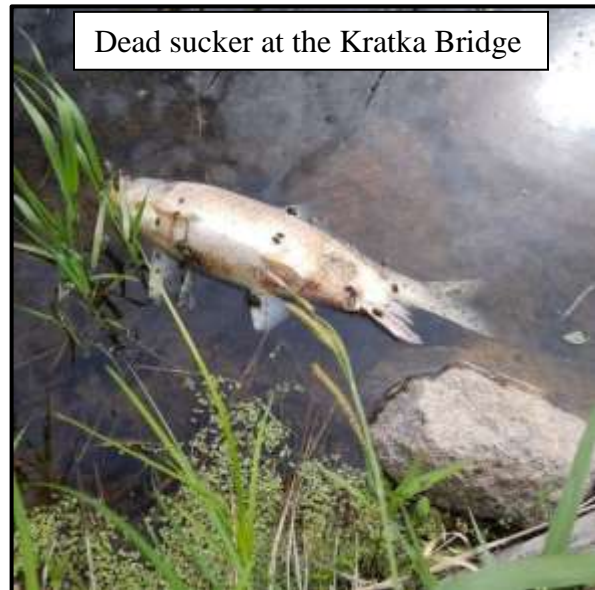
Dead sucker at the Kratka Bridge

A fish kill was reported in the Red Lake River east of Thief River Falls. A resident reported that he found around 100 dead suckers in the river while fishing and noticed big chunks of dried algae floating down the river near the Highlanding and Smiley Bridges in either late May/early June. The most common cause of fish kills is a lack of dissolved oxygen in the water, but they may also be caused by extreme temperatures, diseases, parasites, or toxins. District staff collected longitudinal water quality samples along the Red Lake River in an effort to discover a potential cause of this particular fish kill. There were still some dead white suckers at the Kratka Bridge. Dissolved oxygen levels were sufficient (>5 mg/L). Flow wasn't exceptionally high at the time. There were no signs of extreme flow in ditches. Some ditches weren't even flowing. The water coming from Good Lake Impoundment was clean and clear. There were live suckers in the river at 420th Ave SE.

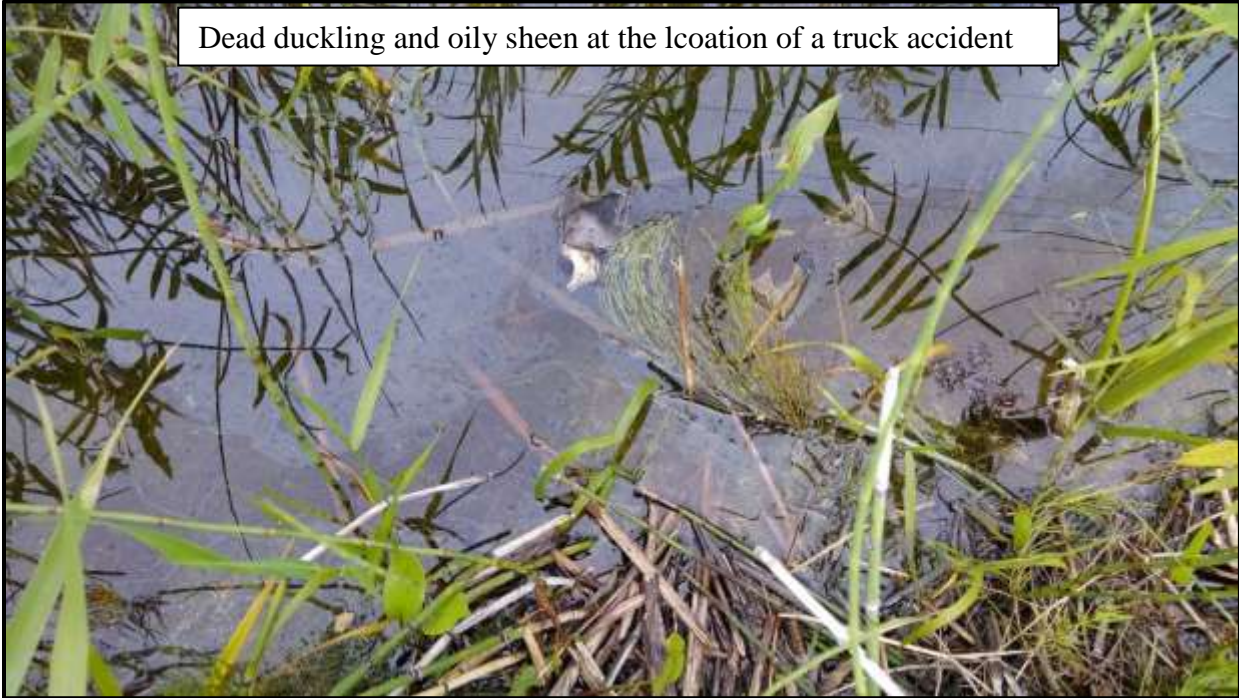
Dead duckling and oily sheen at the location of a truck accident

At the "River Valley" Bridge (CSAH 3), District staff notices a metallic smell in the air, an oily sheen on the water, and a large floating mat of something that looked and smelled very much like manure. Although that floating, manure-like mat was odd, it was not a likely cause of a fish kill. Another unusual occurrence near the Red Lake River was a collision of two trucks at an intersection north of the Kratka Bridge. One of those trucks was hauling fertilizer and there was some evidence of spillage – brown, chemically "burnt" grass, oil in the road ditch. There was a strong diesel/chemical odor at the crash site. It looked like both trucks went into a ditch that flows to the Red Lake River (CD 59) less than a mile downstream. The vegetation was discolored near the water line in the ditch near the crash site, there was an oily sheen, and there was a dead duckling in the water. The ditch near the accident connects to the Red Lake River but was stagnant and choked with cattails and other vegetation that likely would have filtered much of any pollutants that might have been spilled into the ditch.

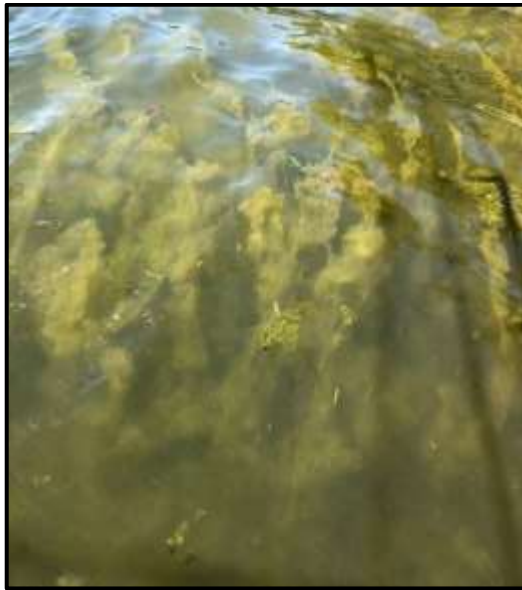
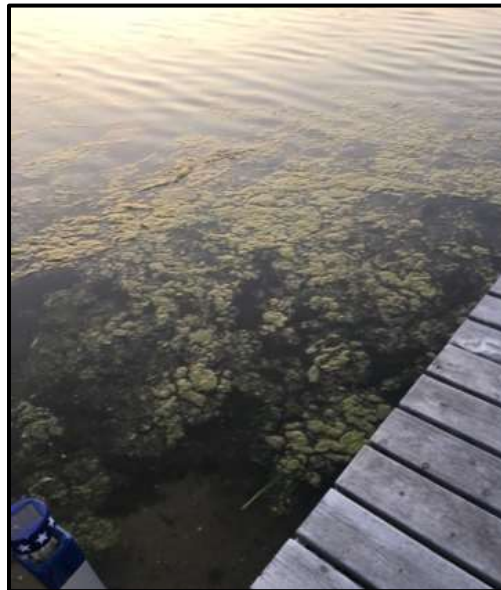
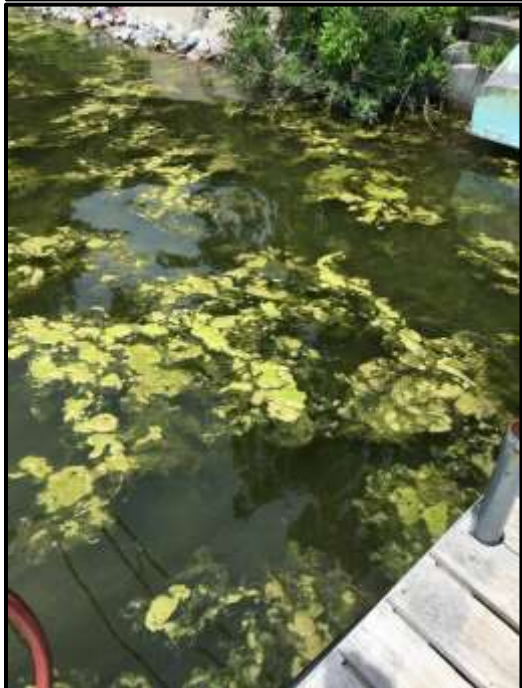
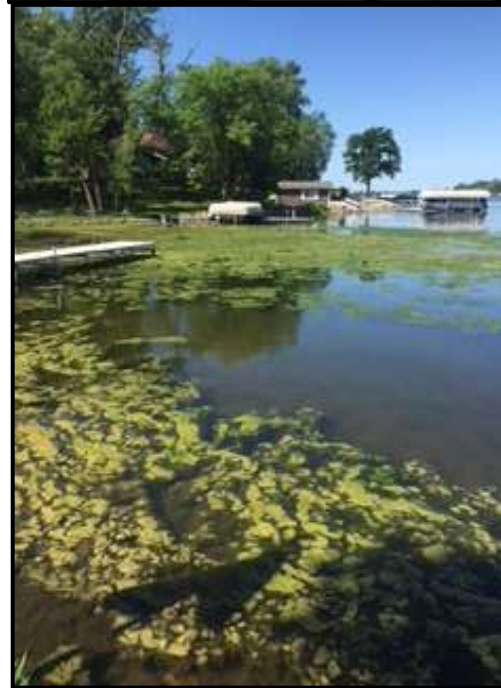
Residents along Maple Lake complained of excess floating mats of algae in mid-to-late June. District staff answered questions from landowners, spoke with members of the Maple Lake Improvement District, and collected samples. Information was shared with East Polk SWCD staff. The visible, nuisance algae were green, filamentous algae (not harmful). However, some blue-green algae were also present in the sample that was sent to RMB Environmental Laboratories for identification. The lab recommended additional sampling.
