By Corey Hanson, Red Lake Watershed District Water Quality Coordinator. 3/23/2020

# RED LAKE WATERSHED DISTRICT MONTHLY WATER QUALITY REPORT

January 2020

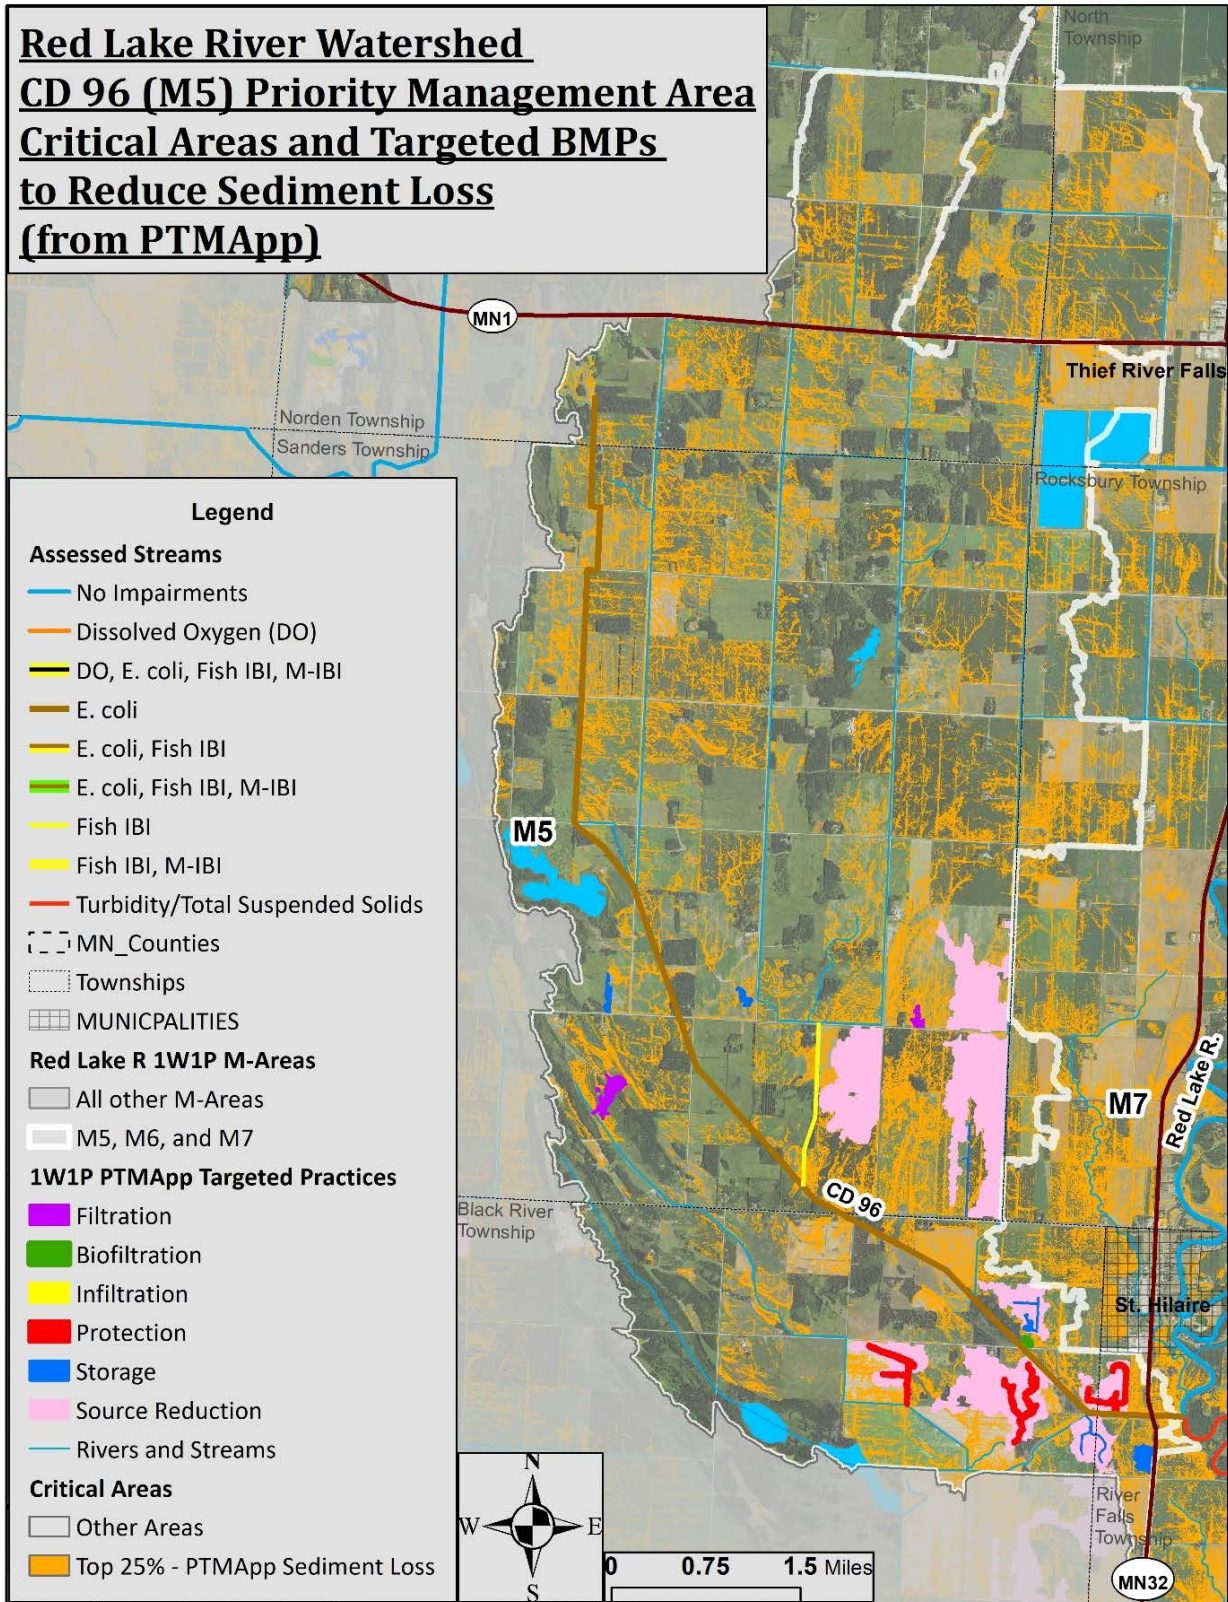
**Red Lake River Watershed**  
**CD 96 (M5) Priority Management Area**  
**Critical Areas and Targeted BMPs**  
**to Reduce Sediment Loss**  
**(from PTMApp)**

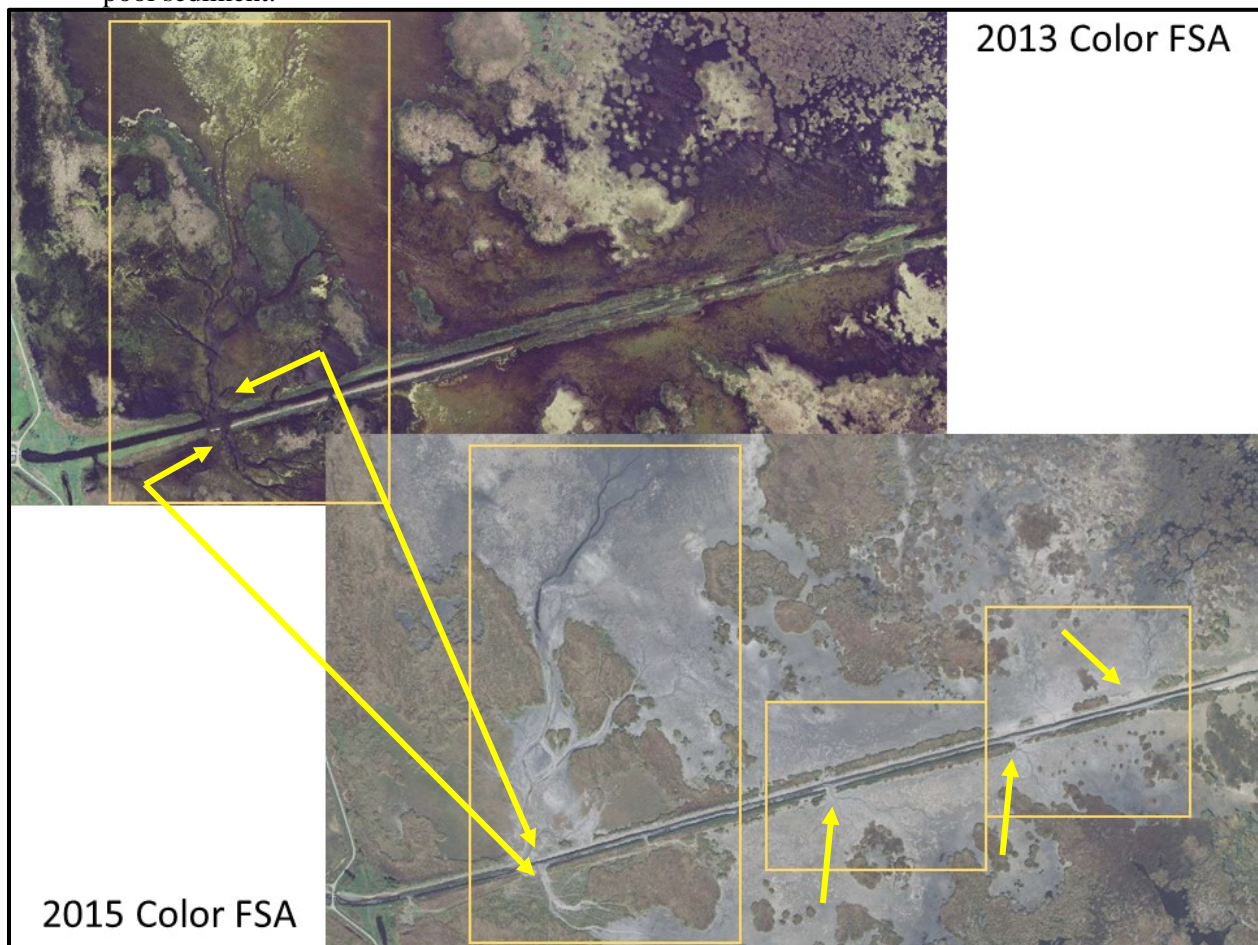
- A comparison of 2013 and 2015 aerial photos of the Judicial Ditch 11 channel within Agassiz Pool (pre/post JD 11 clean-out) confirmed that the excavation and flushing of sediment from the JD 11 was not the only concern with the JD 11 excavation. The breaches in the spoil bank allowed gully erosion to expand into the pool. Gully erosion had been occurring near the radial gate outlet (bottom, left corner of the following aerial photos) prior to the additional cleaning of the JD 11 channel. The gully erosion within the pool was documented in the Assessment of Water Quality Conditions: Agassiz National Wildlife Refuge, 2012 report (<https://ecos.fws.gov/ServCat/DownloadFile/23563?Reference=24863>) that was written by United States Fish and Wildlife staff. Those in-pool gullies were so large that they were given names within the report. Cleaning additional JD 11 channel created more locations in which head differential between the pool and the JD 11 channel encourages extensive erosion of pool sediment.

The United States Fish and Wildlife Service adopted a strategy for removing existing sediment from the Refuge through flushing and scouring from multiple drawdowns and breaches over several years. High TSS concentrations have been recorded during drawdowns, especially while flow rates are receding. The pooled water is relatively low in TSS, but erosion within the pool begins as the water levels drop. The high TSS concentrations occurred after much of the pooled water had drained and flow became concentrated within the ditch channel and gullies that formed at breaches in the Judicial Ditch 11 spoil bank.

A 2012 study by the United States Fish and Wildlife Service examined the effects of a drawdown and reported that “the drawdown within the pool caused significant disturbance to emergent wetland vegetation and substrate in the immediate vicinity of the Ditch-11 Outlet. The head differential created between water surface elevations in the main ditch system extending upstream of the Ditch-11 Outlet and water surface elevations within Agassiz Pool appear to have created velocities sufficient to flatten vegetation and scour multiple networks of channels.
