By Corey Hanson, Red Lake Watershed District Water Quality Coordinator. 4/3/2017.

### **Clearwater River Watershed Restoration and Protection Strategy (WRAPS) Project**

RED LAKE WATERSHED DISTRICT  
MONTHLY WATER QUALITY REPORT

February 2017

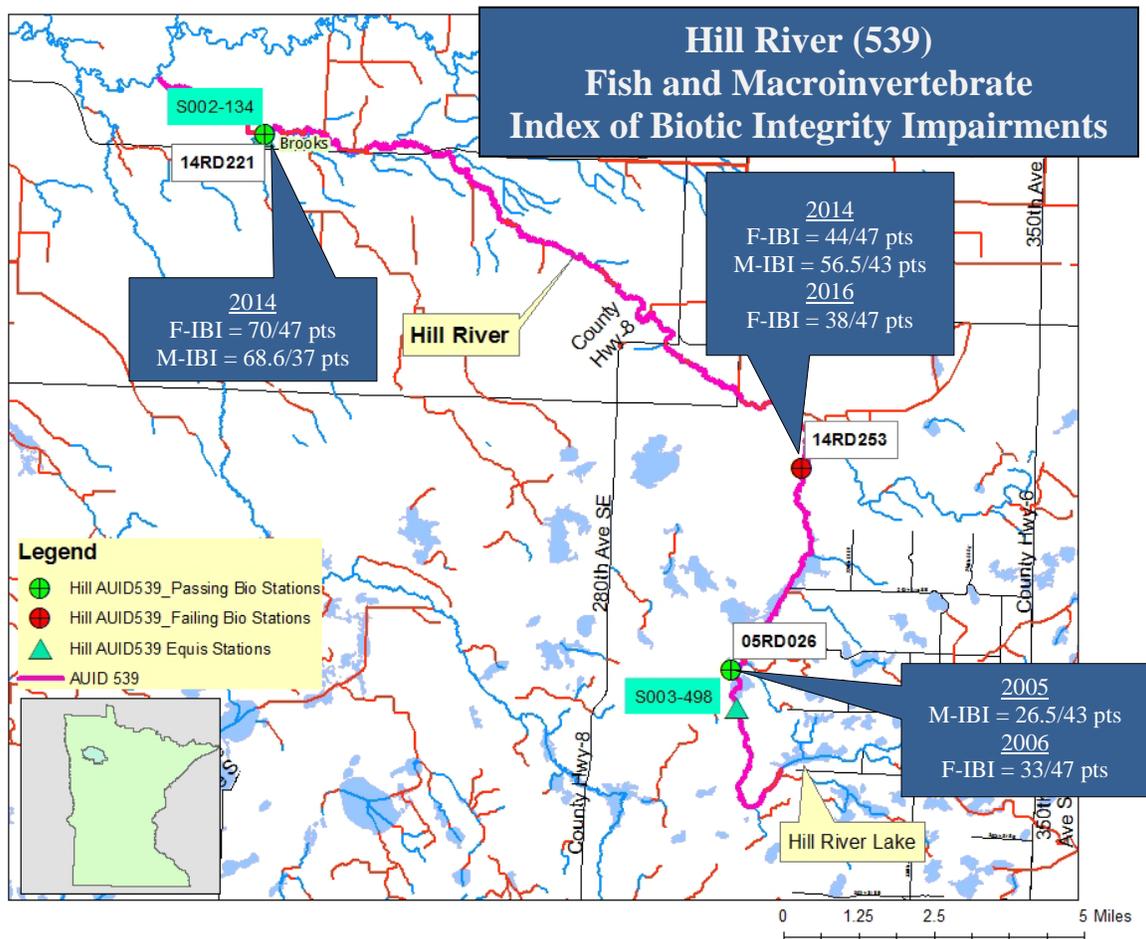
Upstream end of AUID 539, at CSAH 35

The **Hill River** (AUID 09020305-539) between Hill River Lake and the Lost River is impaired by low fish and macroinvertebrate IBI scores. Scores were very good at the downstream end of the reach near Brooks, but were poor near the upstream end of the reach near Hill River Lake. The river looks significantly different at either end of this reach. The upstream end has consistently low dissolved oxygen concentrations, a lower gradient, a mucky bottom, stagnant water, and a lot of in-channel vegetation. The downstream end of the Hill River has consistently good dissolved oxygen concentrations, gradient, consistent flow, and a sand/gravel bottom. A LiDAR profile of the reach revealed that there is a change in gradient where the channel begins flowing west toward Brooks (near the 14RD263 site on the following map). Additional continuous dissolved oxygen monitoring is recommended for the summer of 2017 within the portion of the river that changes from a northerly direction to a westerly direction (somewhere between 310<sup>th</sup> Ave SE and CSAH 8). The primary stressors to aquatic life suspected in AUID 539 on the Hill River are most evident at (and upstream of) site 05RD026. Those stressors are lack of connectivity, low DO/daily DO flux, and lack of habitat. Low dissolved oxygen seems to be the primary stressor for aquatic life. DO concentrations are being more greatly affected by physical characteristic of the stream rather than by pollutant concentrations. There is evidence that, despite not being a direct cause of the IBI impairments, there is also room for improvement of the in-stream habitat of this portion of the Hill River.
