# Red Lake River Erosion Site and Assessment Catalog

## Threatening Infrastructure or homes

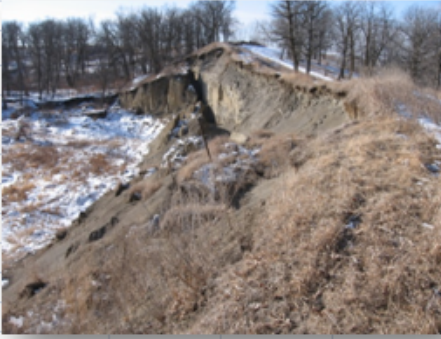
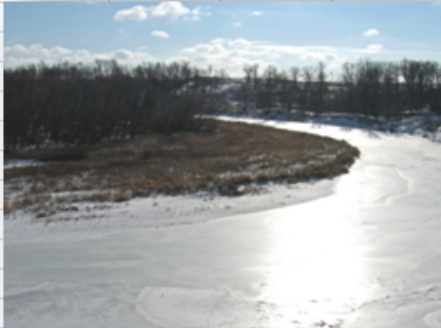
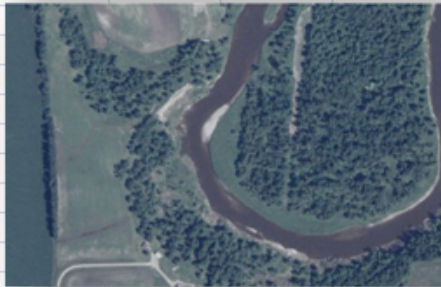
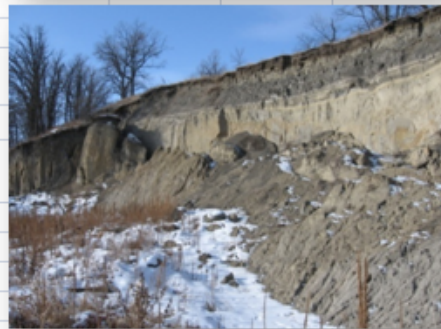
Streambank Erosion Severity Index					
Joe Hanson site upstream of the Highway 32 bridge over the Red Lake River					
First site visit on January 24, 2007					
OBSERVATION		SCORE			
<b>Condition of bank</b>		<b>5</b>

More than 20 ft.	7				
10 to 20 ft.	5				
5 to 10 ft.	3				
Less than 5 ft.	1				
<b>Current</b>		<b>2</b>			
Fast	2		Eventual threat to new Hwy 32 Bridge and the Hwy itself.

Slow	1				
<b>Total Points for site</b>		<b>41</b>	<b>Severe</b>		
0-30	Minor	30-36	Moderate	>36	Severe

Recommendations: remove sed bar, bendway weirs where possible, stabil. may not be feasil

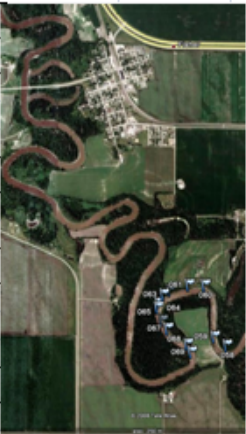
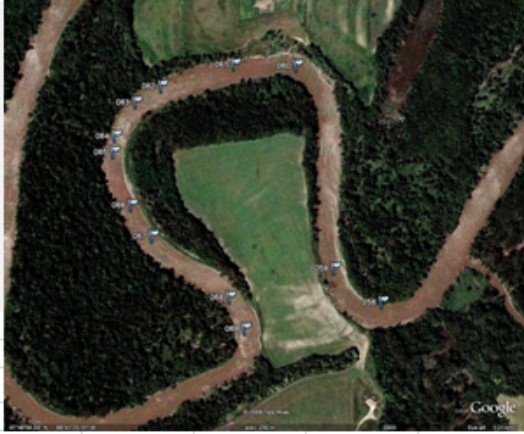
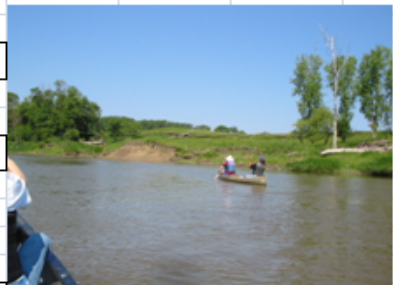
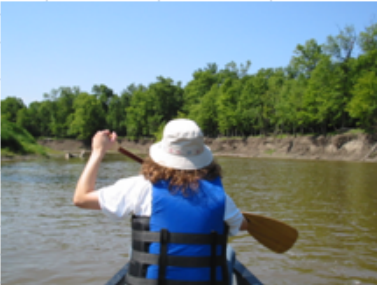
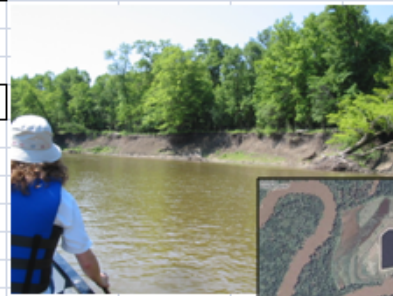
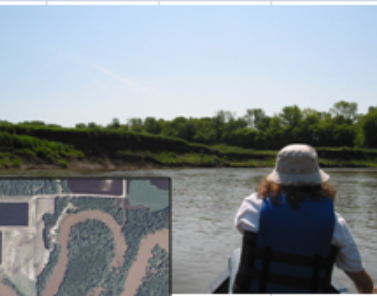
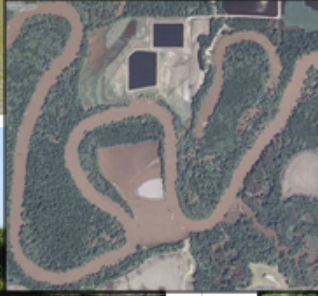
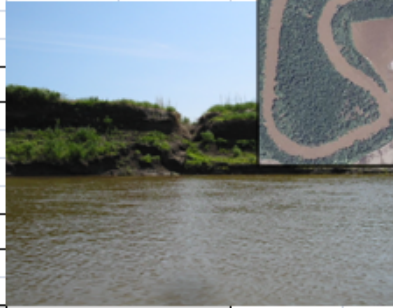
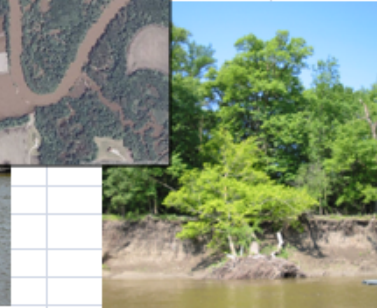
Streambank Erosion Severity Index		Sites 58-69	
Site Description	Badly eroding bend in the river south of Fisher		
Site visits on	6/8/2007 11:10 - 11:24	lat/long:	N47 47.128 W96 46.201
OBSERVATION	SCORE		
<b>Condition of bank</b>	<b>5</b>		
Toe and upper bank eroding	5	x	
Toe undercutting	3		
Toe stable, upper bank eroding	1		
<b>Problem Trend</b>	<b>5</b>		
Increasing	5	x	
Decreasing or stable	1		
<b>Side-slope of bank</b>	<b>5</b>		
Vertical, 1:1	5	x

2:1, 3:1	2		
4:1 or flatter	1		
<b>Length of eroded bank</b>	<b>5</b>		
More than 50 ft.	5	x	
20 to 50 ft.	3		
Less than 20 ft.	1		
<b>Depth of river</b>	<b>2</b>		
More than 3 ft.	2	x	
Less than 3 ft.	1		
<b>Soil type or texture</b>	<b>1</b>		
Sand	3		
Gravel	2		
Stratified	2		
Clay, loam	1	x	
<b>Vegetative Cover on bank slope</b>	<b>5</b>		
0-10%	5	x	
10-50%	3		
50-100%	1		
<b>Apparent cause of erosion</b>	<b>2</b>		
Light access traffic	1		
Obstruction in river	1		
Bank seepage	1	x	
Gully by side channels	1	x	
Bend in river	2	x	
Wave action (impoundments)	2		
Road-stream crossing;	3		
Moderate access traffic	3		
Heavy access (foot, horse, etc.)	5		
<b>Mean height of eroded bank</b>	<b>5</b>		
More than 20 ft.	7		
10 to 20 ft.	5	x	
5 to 10 ft.	3		
Less than 5 ft.	1		
<b>Current</b>	<b>2</b>		
Fast	2		
Slow	1	x	
<b>Total Points for site</b>	<b>37</b>	<b>Severe</b>	
0-30	Minor	30-36	Moderate
		>36	Severe
This mile long reach is immediately downstream of the confluence of Burnham Creek. There also are newly constructed lagoons near the apex of this bend. These could add weight and moisture to the already unstable banks.

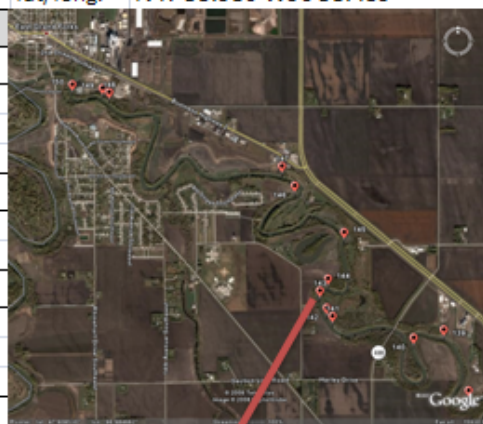
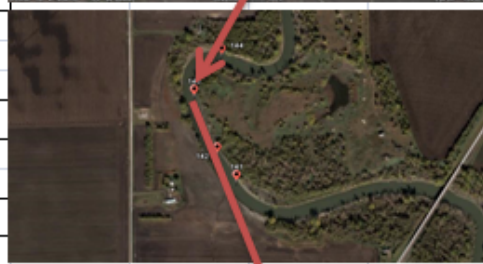
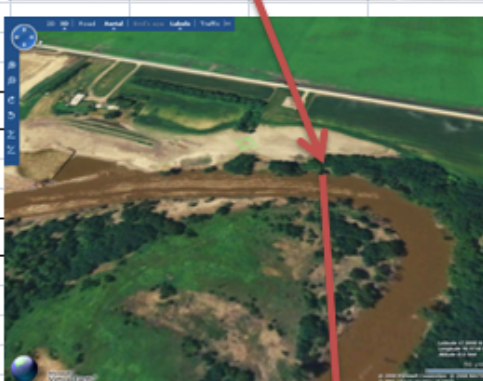
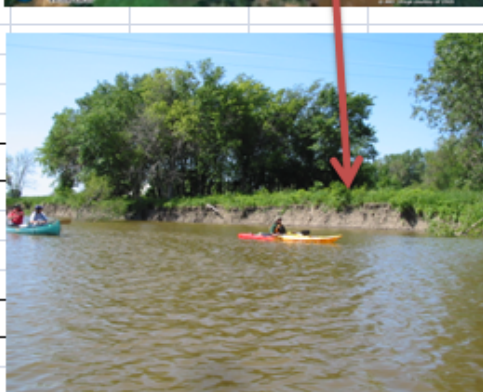
Streambank Erosion Severity Index			
Site Description	Eroding bank downstream of Hartsville Coulee Diversion structure		
Site visits on	6/10/2007 10:51	lat/long:	N47 53.980 W96 58.439
OBSERVATION		SCORE	
<b>Condition of bank</b>		<b>5</b>	
Toe and upper bank eroding	5	x	
Toe undercutting	3		
Toe stable, upper bank eroding	1		
<b>Problem Trend</b>		<b>5</b>	
Increasing	5	x	
Decreasing or stable	1		
<b>Side-slope of bank</b>		<b>5</b>	
Vertical, 1:1	5	x

2:1, 3:1	2		
4:1 or flatter	1		
<b>Length of eroded bank</b>		<b>5</b>	
More than 50 ft.	5	x	
20 to 50 ft.	3		
Less than 20 ft.	1		
<b>Depth of river</b>		<b>2</b>	
More than 3 ft.	2	x	
Less than 3 ft.	1		
<b>Soil type or texture</b>		<b>1</b>	
Sand	3		
Gravel	2		
Stratified	2		
Clay, loam	1	x	
<b>Vegetative Cover on bank slope</b>		<b>5</b>	
0-10%	5	x	
10-50%	3		
50-100%	1		
<b>Apparent cause of erosion</b>		<b>2</b>	
Light access traffic	1		
Obstruction in river	1		
Bank seepage	1		
Gullying by side channels	1		
Bend in river	2	x	
Wave action (impoundments)	2		
Road-stream crossing;	3		
Moderate access traffic	3		
Heavy access (foot, horse, etc.)	5		
<b>Mean height of eroded bank</b>		<b>3</b>	
More than 20 ft.	7		
10 to 20 ft.	5		
5 to 10 ft.	3	x	
Less than 5 ft.	1		
<b>Current</b>		<b>1</b>	
Fast	2		
Slow	1	x	
<b>Total Points for site</b>		<b>34</b>	<b>Moderate</b>
0-30	Minor	30-36	Moderate
		>36	Severe

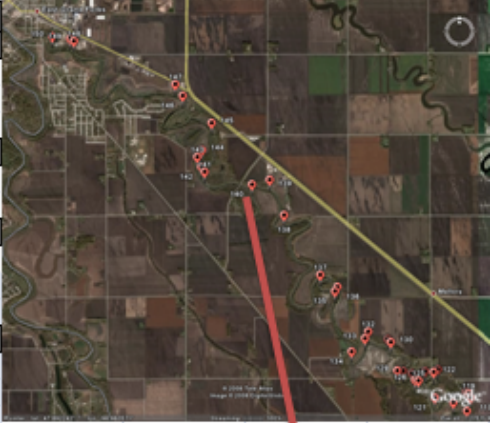
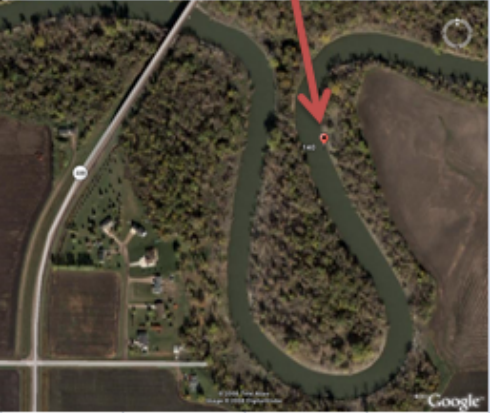
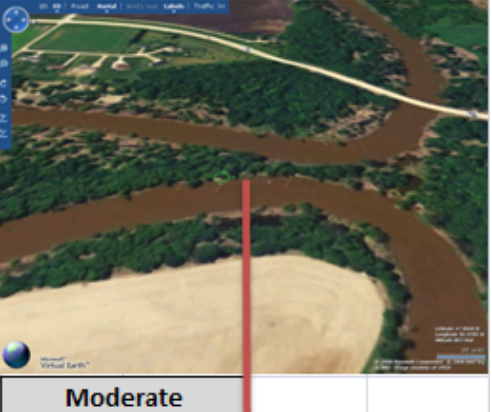
Streambank Erosion Severity Index							
Site Description	Eroding bank threatening to cut across bend in river near Hwy 200 Crossing						
Site visits on	6/10/2007 10:21	lat/long:	N47 53.686 W96 57.565				
OBSERVATION		SCORE

<b>Condition of bank</b>		<b>5</b>					
Toe and upper bank eroding	5	x					
Toe undercutting	3						
Toe stable, upper bank eroding	1						
<b>Problem Trend</b>		<b>1</b>					
Increasing	5						
Decreasing or stable	1	x					
<b>Side-slope of bank</b>		<b>5</b>					
Vertical, 1:1	5	x

2:1, 3:1	2						
4:1 or flatter	1						
<b>Length of eroded bank</b>		<b>5</b>					
More than 50 ft.	5	x					
20 to 50 ft.	3						
Less than 20 ft.	1						
<b>Depth of river</b>		<b>2</b>					
More than 3 ft.	2	x					
Less than 3 ft.	1						
<b>Soil type or texture</b>		<b>1</b>					
Sand	3						
Gravel	2						
Stratified	2						
Clay, loam	1	x					
<b>Vegetative Cover on bank slope</b>		<b>5</b>					
0-10%	5	x					
10-50%	3						
50-100%	1						
<b>Apparent cause of erosion</b>		<b>2</b>					
Light access traffic	1						
Obstruction in river	1						
Bank seepage	1						
Gully by side channels	1						
Bend in river	2	x					
Wave action (impoundments)	2						
Road-stream crossing;	3						
Moderate access traffic	3						
Heavy access (foot, horse, etc.)	5						
<b>Mean height of eroded bank</b>		<b>5</b>					
More than 20 ft.	7						
10 to 20 ft.	5	x					
5 to 10 ft.	3						
Less than 5 ft.	1						
<b>Current</b>		<b>1</b>

Fast	2						
Slow	1	x					
<b>Total Points for site</b>		<b>32</b>	<b>Moderate</b>

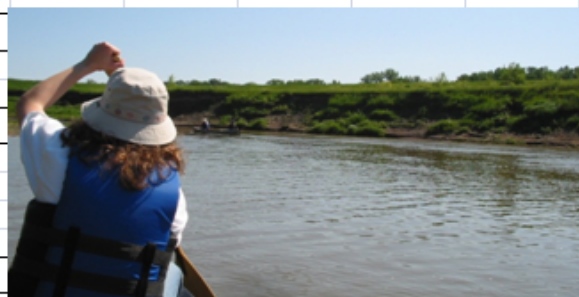
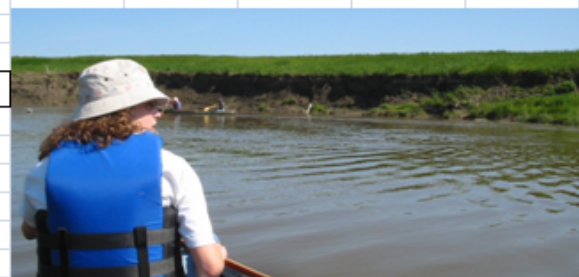
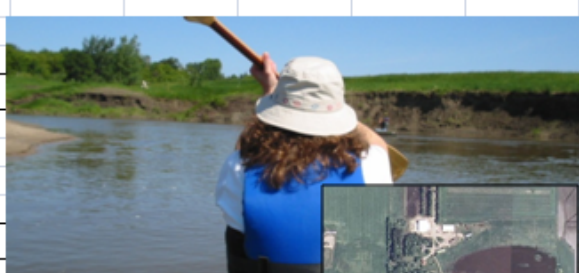
Streambank Erosion Severity Index			Site 49	
Site Description	Eroding cutbank 1.7 miles east of Fisher			
Site visits on	6/8/2007 10:28		lat/long:	N47 47.487 W96 45.400
OBSERVATION			SCORE	
<b>Condition of bank</b>			<b>3</b>	
Toe and upper bank eroding	5			
Toe undercutting	3	x		
Toe stable, upper bank eroding	1			
<b>Problem Trend</b>			<b>5</b>	
Increasing	5	x		
Decreasing or stable	1			
<b>Side-slope of bank</b>			<b>5</b>	
Vertical, 1:1	5	x

2:1, 3:1	2			
4:1 or flatter	1			
<b>Length of eroded bank</b>			<b>5</b>	
More than 50 ft.	5	x		
20 to 50 ft.	3			
Less than 20 ft.	1			
<b>Depth of river</b>			<b>2</b>	
More than 3 ft.	2	x		
Less than 3 ft.	1			
<b>Soil type or texture</b>			<b>1</b>	
Sand	3			
Gravel	2			
Stratified	2			
Clay, loam	1	x		
<b>Vegetative Cover on bank slope</b>			<b>3</b>	
0-10%	5			
10-50%	3	x		
50-100%	1			
<b>Apparent cause of erosion</b>			<b>3</b>	
Light access traffic	1			
Obstruction in river	1			
Bank seepage	1			
Gully by side channels	1			
Bend in river	2	x		
Wave action (impoundments)	2			
Road-stream crossing; grade/shoulder	3			
Moderate access traffic	3	x		
Heavy access (foot, horse, etc.) traffic	5			
<b>Mean height of eroded bank</b>			<b>3</b>	
More than 20 ft.	7			
10 to 20 ft.	5			
5 to 10 ft.	3	x		
Less than 5 ft.	1			
<b>Current</b>			<b>2</b>	
Fast	2			
Slow	1	x		
<b>Total Points for site</b>			<b>32</b>	
			<b>Moderate</b>

0-30	Minor	30-36	Moderate	>36 Severe
There is a road built along the streambank.

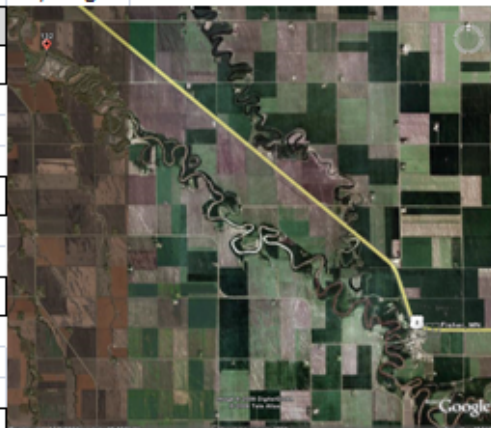
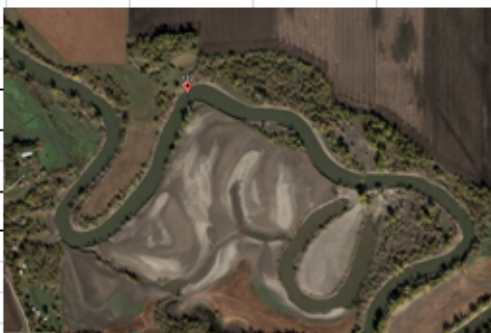
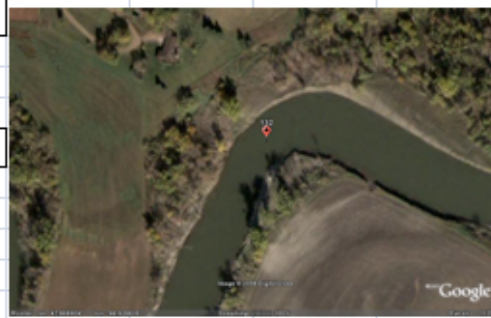
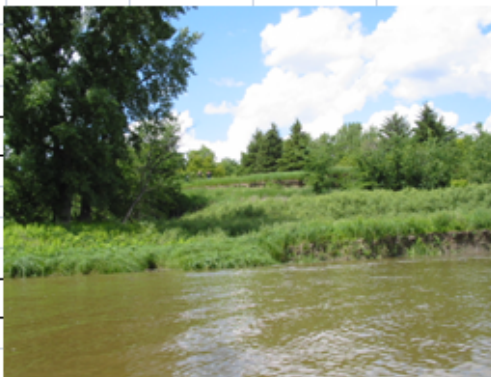
Streambank Erosion Severity Index			
Site Description	Large area of sloughing river bank near residence NW of Fisher.		
Site visits on	6/9/2007 14:24	lat/long:	N47 52.118 W96 55.723
OBSERVATION		SCORE	
<b>Condition of bank</b>		<b>5</b>	
Toe and upper bank eroding	5	x	
Toe undercutting	3		
Toe stable, upper bank eroding	1		
<b>Problem Trend</b>		<b>1</b>	
Increasing	5		
Decreasing or stable	1	x	
<b>Side-slope of bank</b>		<b>1</b>	
Vertical, 1:1	5

2:1, 3:1	2		
4:1 or flatter	1	x	
<b>Length of eroded bank</b>		<b>5</b>	
More than 50 ft.	5	x	
20 to 50 ft.	3		
Less than 20 ft.	1		
<b>Depth of river</b>		<b>2</b>	
More than 3 ft.	2	x	
Less than 3 ft.	1		
<b>Soil type or texture</b>		<b>1</b>	
Sand	3		
Gravel	2		
Stratified	2		
Clay, loam	1	x	
<b>Vegetative Cover on bank slope</b>		<b>1</b>	
0-10%	5		
10-50%	3		
50-100%	1	x	
<b>Apparent cause of erosion</b>		<b>2</b>	
Light access traffic	1		
Obstruction in river	1		
Bank seepage	1		
Gullying by side channels	1		
Bend in river	2	x	
Wave action (impoundments)	2		
Road-stream crossing;	3		
Moderate access traffic	3		
Heavy access (foot, horse, etc.)	5		
<b>Mean height of eroded bank</b>		<b>5</b>	
More than 20 ft.	7		
10 to 20 ft.	5	x	
5 to 10 ft.	3		
Less than 5 ft.	1		
<b>Current</b>		<b>1</b>	
Fast	2		
Slow	1	x	
<b>Total Points for site</b>		<b>24</b>	<b>Minor</b>
0-30	Minor	30-36	Moderate
		>36	Severe

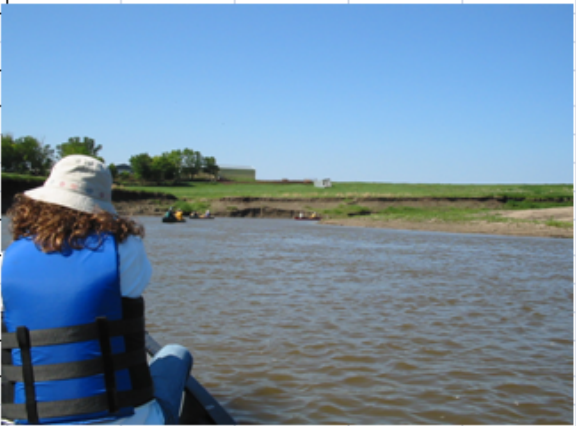
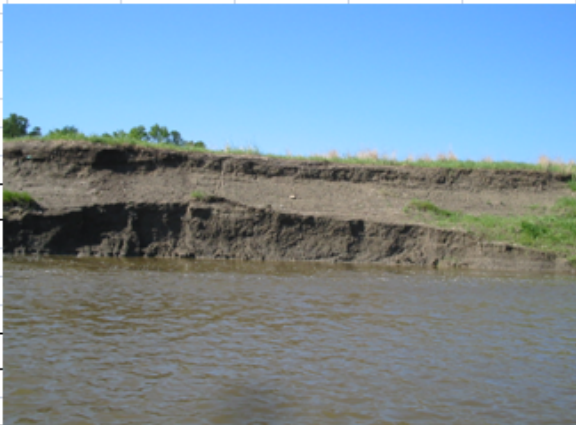
Streambank Erosion Severity Index			Site 43-44	
Site Description		Eroding cutbank 2.6 miles east of Fisher		
Site visits on		6/8/2007 10:02		
		lat/long: N47 46.895 W96 44.469		
OBSERVATION		SCORE		
<b>Condition of bank</b>		<b>5</b>		
Toe and upper bank eroding		5	x	
Toe undercutting		3		
Toe stable, upper bank eroding		1		
<b>Problem Trend</b>		<b>5</b>		
Increasing		5	x	
Decreasing or stable		1		
<b>Side-slope of bank</b>		<b>5</b>		
Vertical, 1:1		5	x

2:1, 3:1		2		
4:1 or flatter		1		
<b>Length of eroded bank</b>		<b>5</b>		
More than 50 ft.		5	x	
20 to 50 ft.		3		
Less than 20 ft.		1		
<b>Depth of river</b>		<b>2</b>		
More than 3 ft.		2	x	
Less than 3 ft.		1		
<b>Soil type or texture</b>		<b>1</b>		
Sand		3		
Gravel		2		
Stratified		2		
Clay, loam		1	x	
<b>Vegetative Cover on bank slope</b>		<b>5</b>		
0-10%		5	x	
10-50%		3		
50-100%		1		
<b>Apparent cause of erosion</b>		<b>2</b>		
Light access traffic		1		
Obstruction in river		1		
Bank seepage		1		
Gully by side channels		1		
Bend in river		2	x	
Wave action (impoundments)		2		
Road-stream crossing; grade/shoulder		3		
Moderate access traffic		3		
Heavy access (foot, horse, etc.) traffic		5		
<b>Mean height of eroded bank</b>		<b>5</b>		
More than 20 ft.		7		
10 to 20 ft.		5	x	
5 to 10 ft.		3		
Less than 5 ft.		1		
<b>Current</b>		<b>2</b>		
Fast		2		
Slow		1	x	
<b>Total Points for site</b>		<b>37</b>		
0-30 Minor		30-36 Moderate		Severe

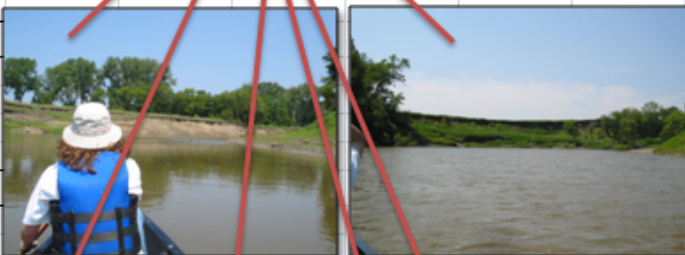
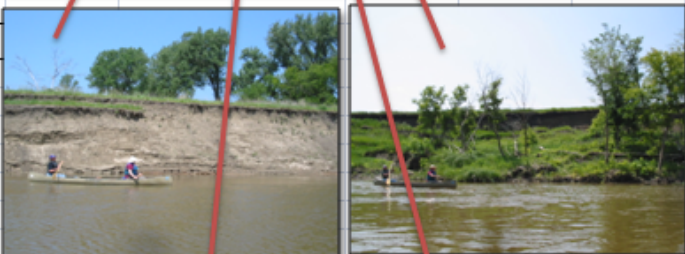
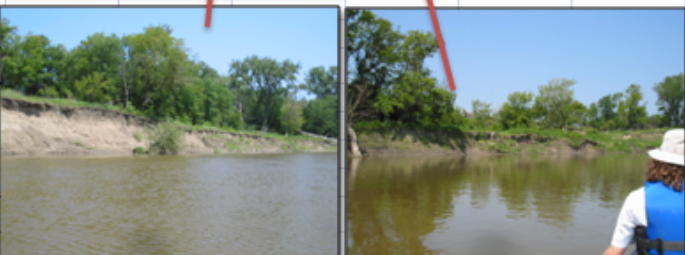
Streambank Erosion Severity Index		Sites 73-79	
Site Description	Cutbank on the Red lake River south of Fisher		
Site visits on	6/8/2007 12:36 - 12:41	lat/long:	N47 47.329 W96 47.891 to N47 47.426 W96 47.986
OBSERVATION		SCORE	
<b>Condition of bank</b>		<b>5</b>	
Toe and upper bank eroding	5	x	
Toe undercutting	3		
Toe stable, upper bank eroding	1		
<b>Problem Trend</b>		<b>5</b>	
Increasing	5	x	
Decreasing or stable	1		
<b>Side-slope of bank</b>		<b>5</b>	
Vertical, 1:1	5	x

2:1, 3:1	2		
4:1 or flatter	1		
<b>Length of eroded bank</b>		<b>5</b>	
More than 50 ft.	5	x	
20 to 50 ft.	3		
Less than 20 ft.	1		
<b>Depth of river</b>		<b>2</b>	
More than 3 ft.	2	x	
Less than 3 ft.	1		
<b>Soil type or texture</b>		<b>1</b>	
Sand	3		
Gravel	2		
Stratified	2		
Clay, loam	1	x	
<b>Vegetative Cover on bank slope</b>		<b>5</b>	
0-10%	5	x	
10-50%	3		
50-100%	1		
<b>Apparent cause of erosion</b>		<b>2</b>	
Light access traffic	1		
Obstruction in river	1		
Bank seepage	1		
Gullyng by side channels	1		
Bend in river	2	x	
Wave action (impoundments)	2		
Road-stream crossing;	3		
Moderate access traffic	3		
Heavy access (foot, horse, etc.)	5		
<b>Mean height of eroded bank</b>		<b>5</b>	
More than 20 ft.	7		
10 to 20 ft.	5	x	
5 to 10 ft.	3		
Less than 5 ft.	1		
<b>Current</b>		<b>2</b>	
Fast	2		
Slow	1	x	
<b>Total Points for site</b>		<b>37</b>	
		<b>Severe</b>	
0-30	Minor	30-36	Moderate
		>36	Severe
<p>Together, these photos show about 1/3 mile of eroding cutbank around the bend of the river</p>

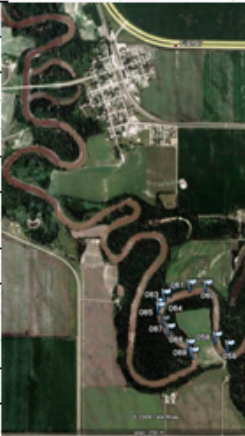
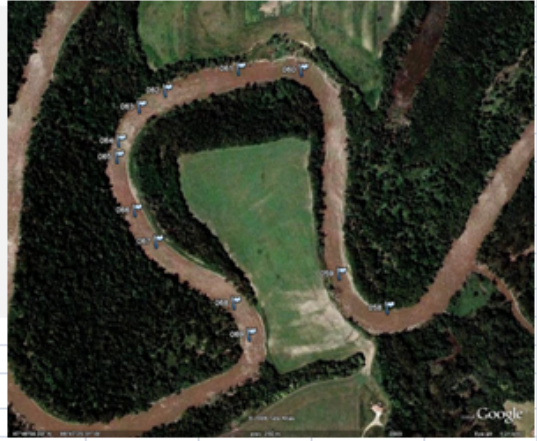
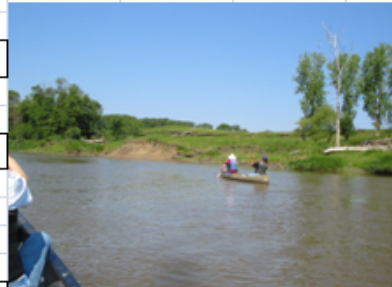
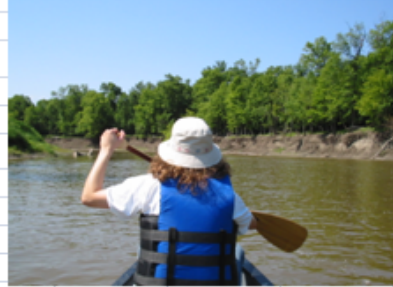
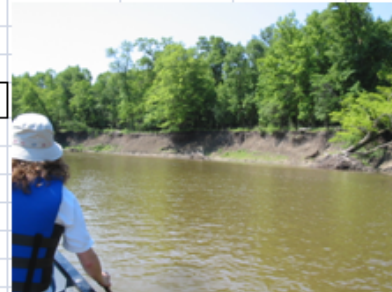
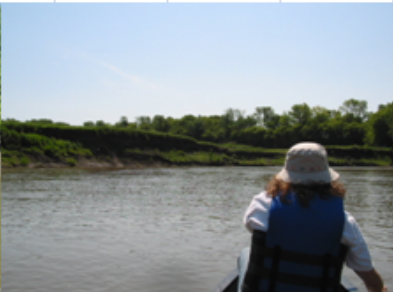
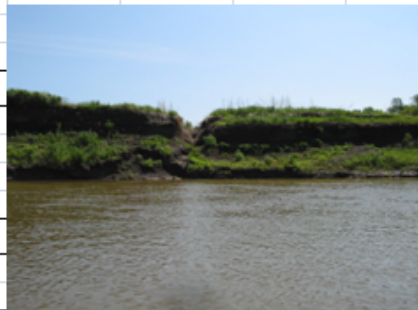
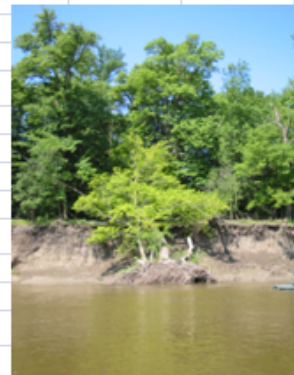
Streambank Erosion Severity Index		Sites 58-69	
Site Description	Badly eroding bend in the river south of Fisher		
Site visits on	6/8/2007 11:10 - 11:24	lat/long:	N47 47.128 W96 46.201
OBSERVATION	SCORE		
<b>Condition of bank</b>	<b>5</b>		
Toe and upper bank eroding	5	x	
Toe undercutting	3		
Toe stable, upper bank eroding	1		
<b>Problem Trend</b>	<b>5</b>		
Increasing	5	x	
Decreasing or stable	1		
<b>Side-slope of bank</b>	<b>5</b>		
Vertical, 1:1	5	x

2:1, 3:1	2		
4:1 or flatter	1		
<b>Length of eroded bank</b>	<b>5</b>		
More than 50 ft.	5	x	
20 to 50 ft.	3		
Less than 20 ft.	1		
<b>Depth of river</b>	<b>2</b>		
More than 3 ft.	2	x	
Less than 3 ft.	1		
<b>Soil type or texture</b>	<b>1</b>		
Sand	3		
Gravel	2		
Stratified	2		
Clay, loam	1	x	
<b>Vegetative Cover on bank slope</b>	<b>5</b>		
0-10%	5	x	
10-50%	3		
50-100%	1		
<b>Apparent cause of erosion</b>	<b>2</b>		
Light access traffic	1		
Obstruction in river	1		
Bank seepage	1	x	
Gullying by side channels	1	x	
Bend in river	2	x	
Wave action (impoundments)	2		
Road-stream crossing;	3		
Moderate access traffic	3		
Heavy access (foot, horse, etc.)	5		
<b>Mean height of eroded bank</b>	<b>5</b>		
More than 20 ft.	7		
10 to 20 ft.	5	x	
5 to 10 ft.	3		
Less than 5 ft.	1		
<b>Current</b>	<b>2</b>		
Fast	2		
Slow	1	x	
<b>Total Points for site</b>	<b>37</b>	<b>Severe</b>	
0-30	Minor	30-36 Moderate	>36 Severe
This mile long reach is immediately downstream of the confluence with Burnham Creek. There also are newly constructed lagoons near the apex of this bend. These could add weight and moisture to the already unstable banks.

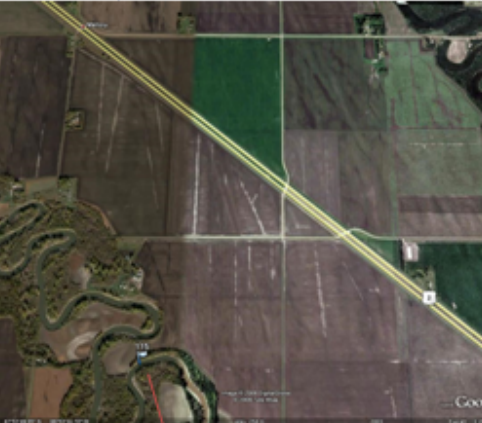
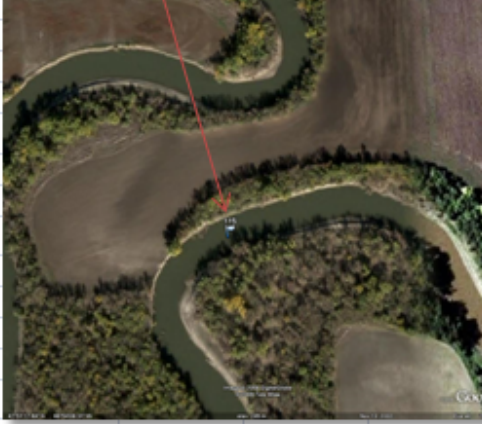
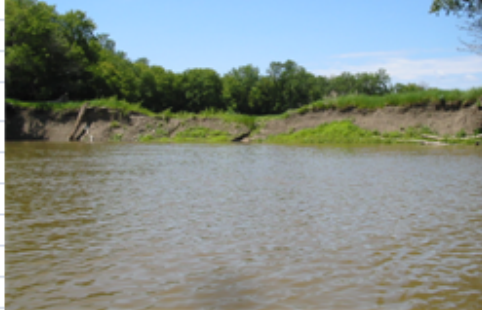
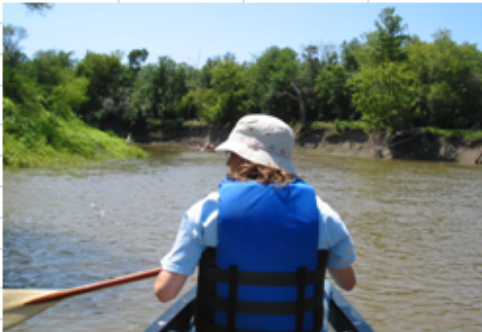
Streambank Erosion Severity Index		Site 115					
Site Description		>1000' stretch of eroded river bank. Some parts unstable with gullies					
Site visits on		6/9/2007 13:15		lat/long:		N47 51.278 W96 54.166	
OBSERVATION		SCORE

<b>Condition of bank</b>		<b>5</b>					
Toe and upper bank eroding	5	x					
Toe undercutting	3						
Toe stable, upper bank eroding	1						
<b>Problem Trend</b>		<b>5</b>					
Increasing	5	x					
Decreasing or stable	1						
<b>Side-slope of bank</b>		<b>5</b>					
Vertical, 1:1	5	x

2:1, 3:1	2						
4:1 or flatter	1						
<b>Length of eroded bank</b>		<b>5</b>					
More than 50 ft.	5	x					
20 to 50 ft.	3						
Less than 20 ft.	1						
<b>Depth of river</b>		<b>2</b>					
More than 3 ft.	2	x					
Less than 3 ft.	1						
<b>Soil type or texture</b>		<b>1</b>					
Sand	3						
Gravel	2						
Stratified	2						
Clay, loam	1	x					
<b>Vegetative Cover on bank slope</b>		<b>5</b>					
0-10%	5	x					
10-50%	3						
50-100%	1						
<b>Apparent cause of erosion</b>		<b>2</b>					
Light access traffic	1						
Obstruction in river	1						
Bank seepage	1						
Gully by side channels	1	x					
Bend in river	2	x					
Wave action (impoundments)	2						
Road-stream crossing;	3						
Moderate access traffic	3						
Heavy access (foot, horse, etc.)	5						
<b>Mean height of eroded bank</b>		<b>5</b>					
More than 20 ft.	7						
10 to 20 ft.	5	x					
5 to 10 ft.	3						
Less than 5 ft.	1						
<b>Current</b>		<b>1</b>

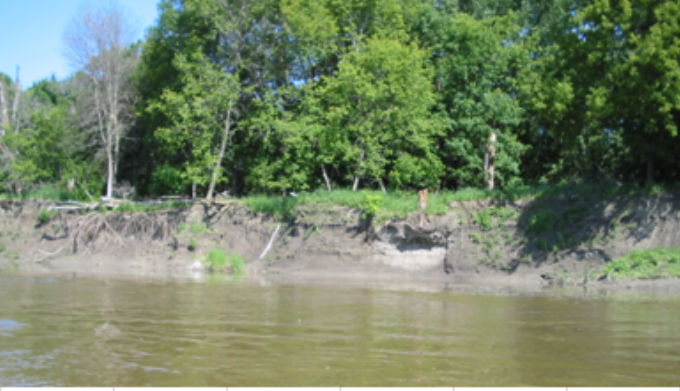
Streambank Erosion Severity Index		Site 56					
Site Description	Cutbank along bend in Red Lake River SE of Fisher						
Site visits on	6/8/2007 10:59		lat/long:	N47 47.241 W96 46.552			
OBSERVATION		SCORE

Fast	2						
Slow	1	x					
<b>Total Points for site</b>		<b>35</b>	<b>Moderate</b>				
0-30	Minor	30-36	Moderate	>36	Severe		
Eroding despite the fact that the streambanks are wooded and buffered.

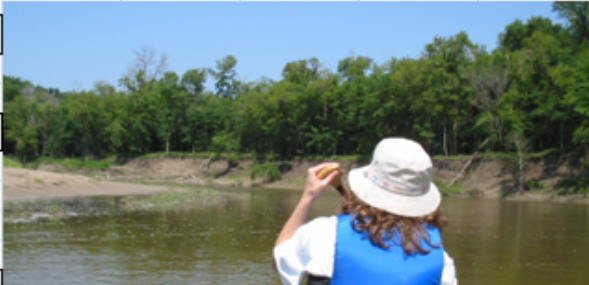
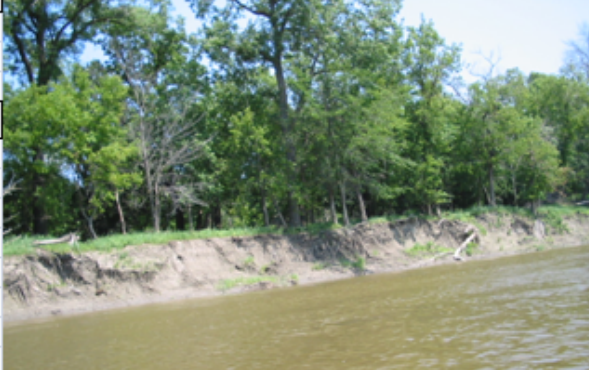
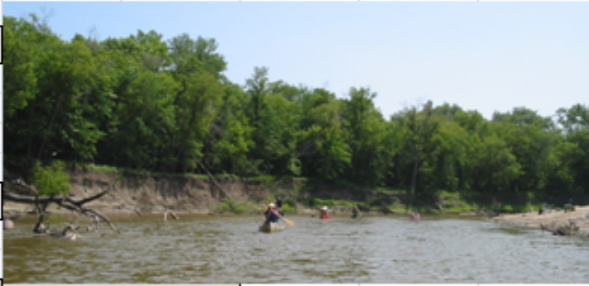
Streambank Erosion Severity Index		Sites 71-72					
Site Description	Cutbank on the Red Lake River south of Fisher						
Site visits on	6/8/2007 12:35		lat/long:	N47 47.376 W96 47.813			
OBSERVATION		SCORE

<b>Condition of bank</b>		<b>5</b>					
Toe and upper bank eroding	5	x					
Toe undercutting	3						
Toe stable, upper bank eroding	1						
<b>Problem Trend</b>		<b>5</b>					
Increasing	5	x					
Decreasing or stable	1						
<b>Side-slope of bank</b>		<b>5</b>					
Vertical, 1:1	5	x

2:1, 3:1	2						
4:1 or flatter	1						
<b>Length of eroded bank</b>		<b>5</b>					
More than 50 ft.	5	x					
20 to 50 ft.	3						
Less than 20 ft.	1						
<b>Depth of river</b>		<b>2</b>					
More than 3 ft.	2	x					
Less than 3 ft.	1						
<b>Soil type or texture</b>		<b>1</b>					
Sand	3						
Gravel	2						
Stratified	2						
Clay, loam	1	x					
<b>Vegetative Cover on bank slope</b>		<b>5</b>					
0-10%	5	x					
10-50%	3						
50-100%	1						
<b>Apparent cause of erosion</b>		<b>2</b>					
Light access traffic	1						
Obstruction in river	1						
Bank seepage	1						
Gullying by side channels	1						
Bend in river	2	x					
Wave action (impoundments)	2						
Road-stream crossing;	3						
Moderate access traffic	3						
Heavy access (foot, horse, etc.)	5						
<b>Mean height of eroded bank</b>		<b>3</b>					
More than 20 ft.	7						
10 to 20 ft.	5						
5 to 10 ft.	3	x					
Less than 5 ft.	1						
<b>Current</b>		<b>2</b>

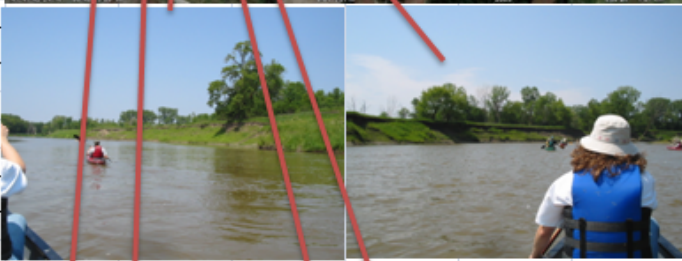
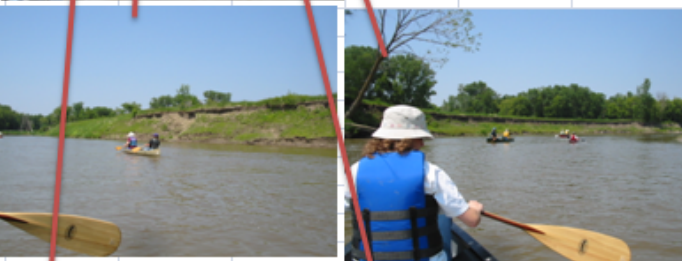
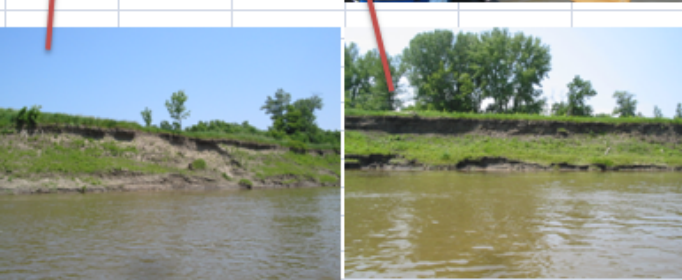
Streambank Erosion Severity Index		Sites 80-85	
Site Description	Very long stretch of eroding river bank south of Fisher		
Site visits on	6/8/2007 12:56	lat/long:	N47 47.769 W96 48.510
OBSERVATION		SCORE	
<b>Condition of bank</b>		<b>5</b>	
Toe and upper bank eroding	5	x	
Toe undercutting	3		
Toe stable, upper bank eroding	1		
<b>Problem Trend</b>		<b>5</b>	
Increasing	5	x	
Decreasing or stable	1		
<b>Side-slope of bank</b>		<b>5</b>	
Vertical, 1:1	5	x

2:1, 3:1	2		
4:1 or flatter	1		
<b>Length of eroded bank</b>		<b>5</b>	
More than 50 ft.	5	x	
20 to 50 ft.	3		
Less than 20 ft.	1		
<b>Depth of river</b>		<b>2</b>	
More than 3 ft.	2	x	
Less than 3 ft.	1		
<b>Soil type or texture</b>		<b>1</b>	
Sand	3		
Gravel	2		
Stratified	2		
Clay, loam	1	x	
<b>Vegetative Cover on bank slope</b>		<b>3</b>	
0-10%	5		
10-50%	3	x	
50-100%	1		
<b>Apparent cause of erosion</b>		<b>2</b>	
Light access traffic	1		
Obstruction in river	1		
Bank seepage	1		
Gullying by side channels	1		
Bend in river	2	x	
Wave action (impoundments)	2		
Road-stream crossing;	3		
Moderate access traffic	3		
Heavy access (foot, horse, etc.)	5		
<b>Mean height of eroded bank</b>		<b>5</b>	
More than 20 ft.	7		
10 to 20 ft.	5	x	
5 to 10 ft.	3		
Less than 5 ft.	1		
<b>Current</b>		<b>2</b>	
Fast	2		
Slow	1	x	
<b>Total Points for site</b>		<b>35</b>	<b>Moderate</b>
0-30	Minor	30-36	Moderate
		>36	Severe
The eroded areas in this group alone occur across a .5 mile length of stream. These sites combine with sites 86 through 94 to form a nearly continuous 1.3 mile stretch of river with eroding banks.

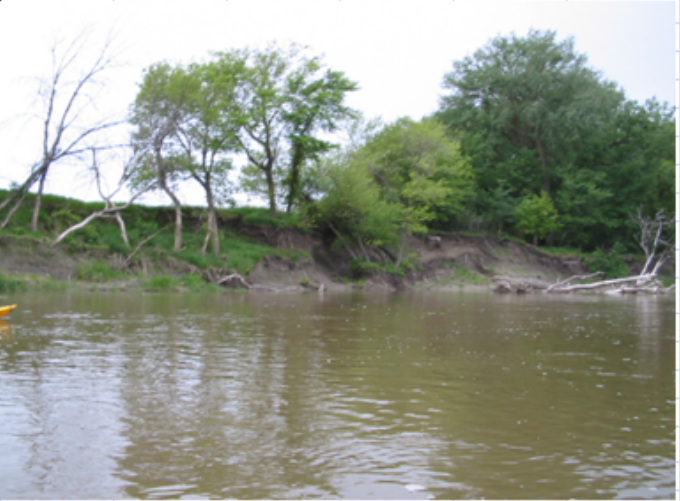
Streambank Erosion Severity Index		Site 111	
Site Description	Eroding bank along field S of Fisher Rest Stop		
Site visits on	6/9/2007 11:03	lat/long:	N47 49.693 W96 51.624
OBSERVATION		SCORE	
<b>Condition of bank</b>		<b>5</b>	
Toe and upper bank eroding	5	x	
Toe undercutting	3		
Toe stable, upper bank eroding	1		
<b>Problem Trend</b>		<b>5</b>	
Increasing	5	x	
Decreasing or stable	1		
<b>Side-slope of bank</b>		<b>5</b>	
Vertical, 1:1	5	x

2:1, 3:1	2		
4:1 or flatter	1		
<b>Length of eroded bank</b>		<b>5</b>	
More than 50 ft.	5	x	
20 to 50 ft.	3		
Less than 20 ft.	1		
<b>Depth of river</b>		<b>2</b>	
More than 3 ft.	2	x	
Less than 3 ft.	1		
<b>Soil type or texture</b>		<b>2</b>	
Sand	3		
Gravel	2		
Stratified	2	x	
Clay, loam	1		
<b>Vegetative Cover on bank slope</b>		<b>3</b>	
0-10%	5		
10-50%	3	x	
50-100%	1		
<b>Apparent cause of erosion</b>		<b>2</b>	
Light access traffic	1		
Obstruction in river	1		
Bank seepage	1		
Gully by side channels	1		
Bend in river	2	x	
Wave action (impoundments)	2		
Road-stream crossing;	3		
Moderate access traffic	3		
Heavy access (foot, horse, etc.)	5		
<b>Mean height of eroded bank</b>		<b>5</b>	
More than 20 ft.	7		
10 to 20 ft.	5	x	
5 to 10 ft.	3		
Less than 5 ft.	1		
<b>Current</b>		<b>1</b>	
Fast	2		
Slow	1	x	
<b>Total Points for site</b>		<b>35</b>	<b>Moderate</b>
0-30	Minor	30-36	Moderate
		>36	Severe
This spot is eroding the most where the plowed field is nearer to the river

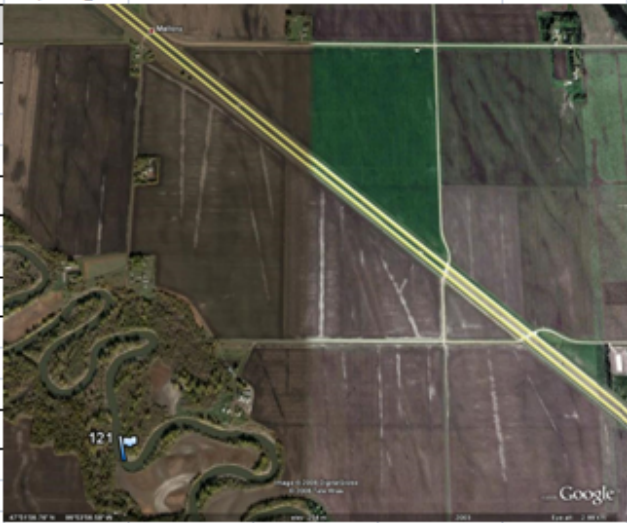
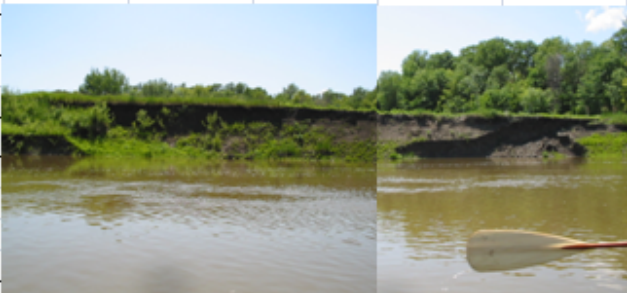
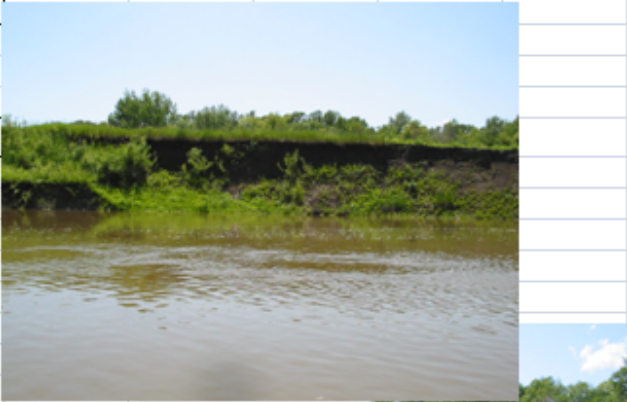
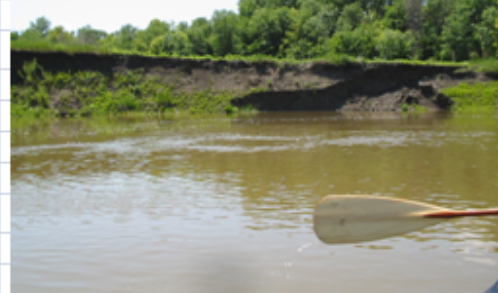
Streambank Erosion Severity Index			
Site Description	Washout along a field, outside of a bend, south of Mallory		
Site visits on	6/9/2007 13:40	lat/long:	N47 51.419 W96 54.672
OBSERVATION		SCORE	
<b>Condition of bank</b>		<b>5</b>	
Toe and upper bank eroding	5	x	
Toe undercutting	3		
Toe stable, upper bank eroding	1		
<b>Problem Trend</b>		<b>5</b>	
Increasing	5	x	
Decreasing or stable	1		
<b>Side-slope of bank</b>		<b>5</b>	
Vertical, 1:1	5	x

2:1, 3:1	2		
4:1 or flatter	1		
<b>Length of eroded bank</b>		<b>5</b>	
More than 50 ft.	5	x	
20 to 50 ft.	3		
Less than 20 ft.	1		
<b>Depth of river</b>		<b>2</b>	
More than 3 ft.	2	x	
Less than 3 ft.	1		
<b>Soil type or texture</b>		<b>2</b>	
Sand	3		
Gravel	2		
Stratified	2		
Clay, loam	1	x	
<b>Vegetative Cover on bank slope</b>		<b>3</b>	
0-10%	5		
10-50%	3	x	
50-100%	1		
<b>Apparent cause of erosion</b>		<b>2</b>	
Light access traffic	1		
Obstruction in river	1		
Bank seepage	1		
Gully by side channels	1		
Bend in river	2	x	
Wave action (impoundments)	2		
Road-stream crossing;	3		
Moderate access traffic	3		
Heavy access (foot, horse, etc.)	5		
<b>Mean height of eroded bank</b>		<b>5</b>	
More than 20 ft.	7		
10 to 20 ft.	5	x	
5 to 10 ft.	3		
Less than 5 ft.	1		
<b>Current</b>		<b>1</b>	
Fast	2		
Slow	1	x	
<b>Total Points for site</b>		<b>35</b>	<b>Moderate</b>
0-30	Minor	30-36	Moderate
		>36	Severe

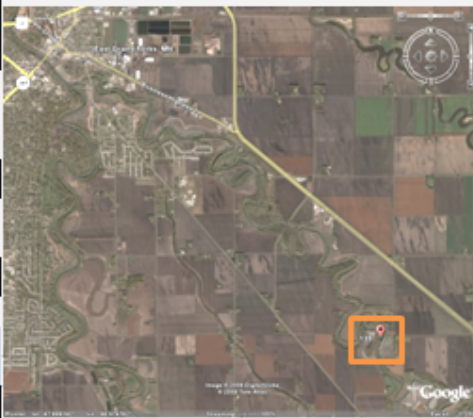
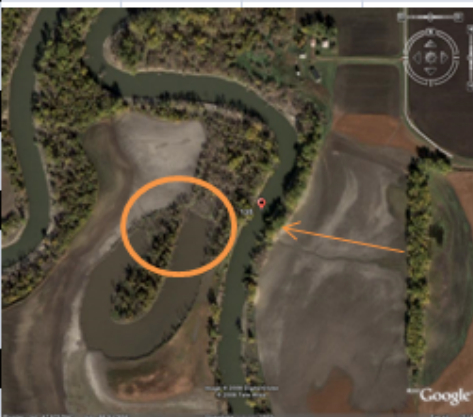
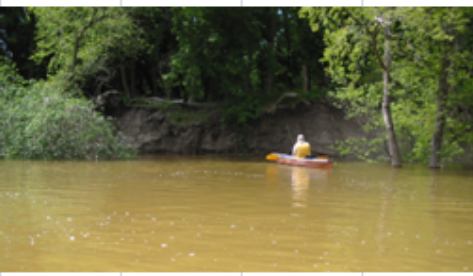
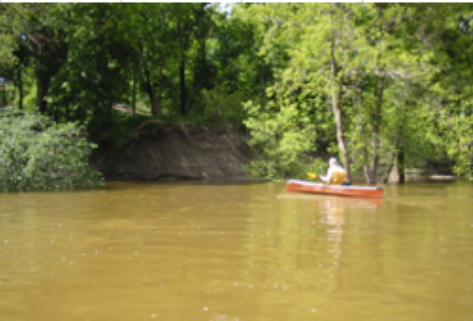
Streambank Erosion Severity Index						
Site Description	Bank sloughing between Fisher and EGF - point #135 on RLRR Tour					
Site visits on	6/9/2007 14:47		lat/long:	N47 52.548 W96 56.247		
OBSERVATION		SCORE

2:1, 3:1	2					
4:1 or flatter	1					
<b>Length of eroded bank</b>		<b>5</b>				
More than 50 ft.	5	x				
20 to 50 ft.	3					
Less than 20 ft.	1					
<b>Depth of river</b>		<b>2</b>				
More than 3 ft.	2	x				
Less than 3 ft.	1					
<b>Soil type or texture</b>		<b>1</b>				
Sand	3					
Gravel	2					
Stratified	2					
Clay, loam	1	x				
<b>Vegetative Cover on bank slope</b>		<b>5</b>				
0-10%	5	x				
10-50%	3					
50-100%	1					
<b>Apparent cause of erosion</b>		<b>1</b>				
Light access traffic	1					
Obstruction in river	1					
Bank seepage	1	x				
Gullying by side channels	1	x				
Bend in river	2					
Wave action (impoundments)	2					
Road-stream crossing;	3					
Moderate access traffic	3					
Heavy access (foot, horse, etc.)	5					
<b>Mean height of eroded bank</b>		<b>5</b>				
More than 20 ft.	7					
10 to 20 ft.	5	x				
5 to 10 ft.	3					
Less than 5 ft.	1					
<b>Current</b>		<b>1</b>				
Fast	2					
Slow	1	x				
<b>Total Points for site</b>		<b>35</b>	<b>Moderate</b>

0-30	Minor	30-36	Moderate	>36	Severe	
Erosion may be caused by combination of the force of field runoff from across the river and water saturated stream banks from and oxbow lake.

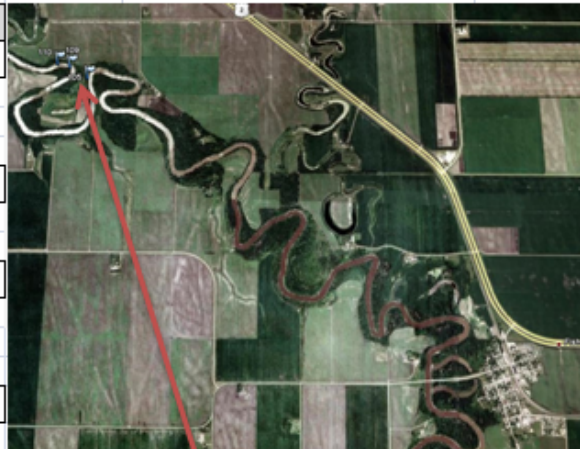
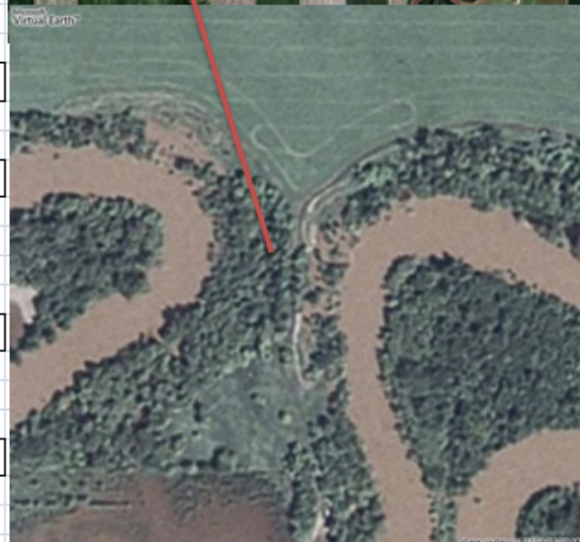
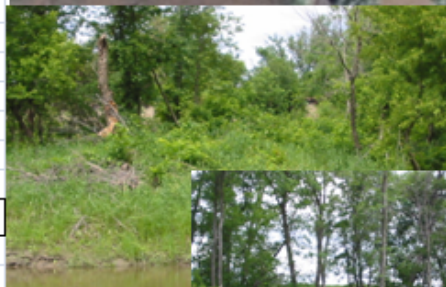
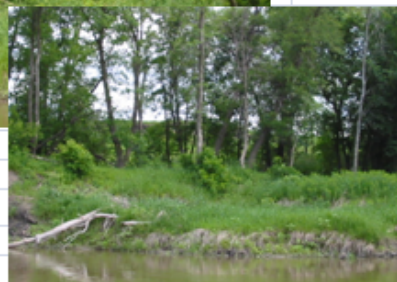
**Streambank Erosion Severity Index Sites 105, 109, 110**

OBSERVATION		SCORE
<b>Condition of bank</b>		<b>5</b>
Toe and upper bank eroding	5	X
Toe undercutting	3	
Toe stable, upper bank eroding	1	
<b>Problem Trend</b>		<b>5</b>
Increasing	5	x
Decreasing or stable	1	
<b>Side-slope of bank</b>		<b>5</b>
Vertical, 1:1	5	x

2:1, 3:1	2	
4:1 or flatter	1	
<b>Length of eroded bank</b>		<b>5</b>
More than 50 ft.	5	x
20 to 50 ft.	3	
Less than 20 ft.	1	
<b>Depth of river</b>		<b>2</b>
More than 3 ft.	2	x
Less than 3 ft.	1	
<b>Soil type or texture</b>		<b>1</b>
Sand	3	
Gravel	2	
Stratified	2	
Clay, loam	1	x
<b>Vegetative Cover on bank slope</b>		<b>1</b>
0-10%	5	
10-50%	3	
50-100%	1	x
<b>Apparent cause of erosion</b>		<b>2</b>
Light access traffic	1	
Obstruction in river	1	
Bank seepage	1	
Gullying by side channels	1	
Bend in river	2	x
Wave action (impoundments)	2	
Road-stream crossing;	3	
Moderate access traffic	3	
Heavy access (foot, horse, etc.)	5	
<b>Mean height of eroded bank</b>		<b>7</b>
More than 20 ft.	7	x
10 to 20 ft.	5	
5 to 10 ft.	3	
Less than 5 ft.	1	
<b>Current</b>		<b>1</b>
Fast	2	
Slow	1	x

<b>Total Points for site</b>		<b>34</b>	<b>Moderate</b>		
0-30	Minor	30-36	Moderate	>36	Severe

This site should be a priority over sites 108 and 106, which will be cut off from river flow if erosion and slumping continues here.

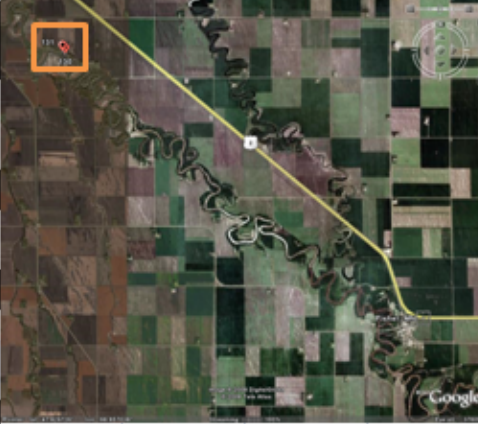
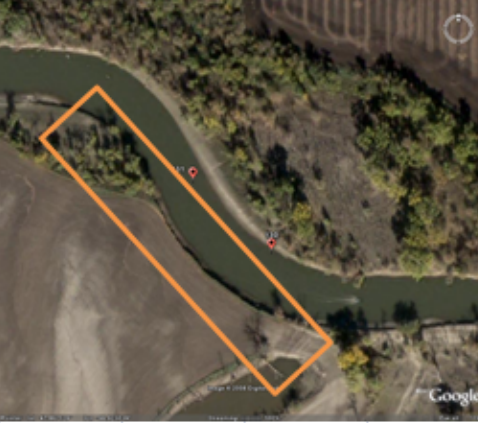
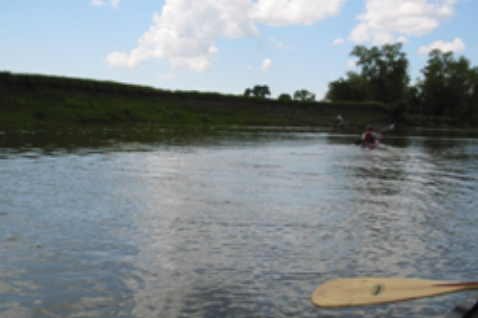
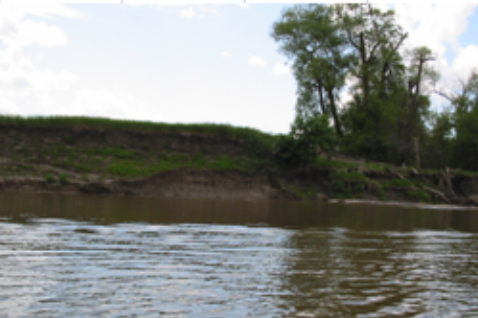
Streambank Erosion Severity Index					
Site Description		Long stretch of actively eroding cutbank along a field NW of Fisher			
Site visits on		6/9/2007 14:20	lat/long: N47 52.039 W96 55.419		
OBSERVATION		SCORE

<b>Condition of bank</b>		<b>5</b>			
Toe and upper bank eroding	5	x			
Toe undercutting	3				
Toe stable, upper bank eroding	1				
<b>Problem Trend</b>		<b>5</b>			
Increasing	5	x			
Decreasing or stable	1				
<b>Side-slope of bank</b>		<b>5</b>			
Vertical, 1:1	5	x

2:1, 3:1	2				
4:1 or flatter	1				
<b>Length of eroded bank</b>		<b>5</b>			
More than 50 ft.	5	x			
20 to 50 ft.	3				
Less than 20 ft.	1				
<b>Depth of river</b>		<b>2</b>			
More than 3 ft.	2	x			
Less than 3 ft.	1				
<b>Soil type or texture</b>		<b>1</b>			
Sand	3				
Gravel	2				
Stratified	2				
Clay, loam	1	x			
<b>Vegetative Cover on bank slope</b>		<b>3</b>			
0-10%	5				
10-50%	3	x			
50-100%	1				
<b>Apparent cause of erosion</b>		<b>2</b>			
Light access traffic	1				
Obstruction in river	1				
Bank seepage	1	x			
Gully by side channels	1				
Bend in river	2	x			
Wave action (impoundments)	2				
Road-stream crossing;	3				
Moderate access traffic	3				
Heavy access (foot, horse, etc.)	5				
<b>Mean height of eroded bank</b>		<b>5</b>			
More than 20 ft.	7				
10 to 20 ft.	5	x			
5 to 10 ft.	3				
Less than 5 ft.	1				
<b>Current</b>		<b>1</b>			
Fast	2				
Slow	1	x			
<b>Total Points for site</b>		<b>34</b>		<b>Moderate</b>

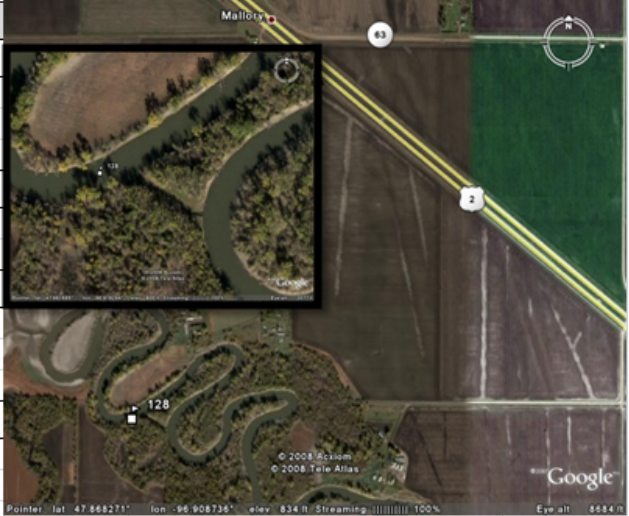
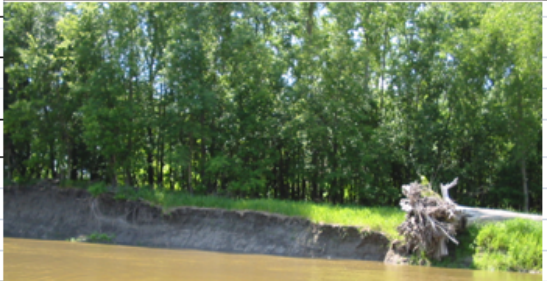
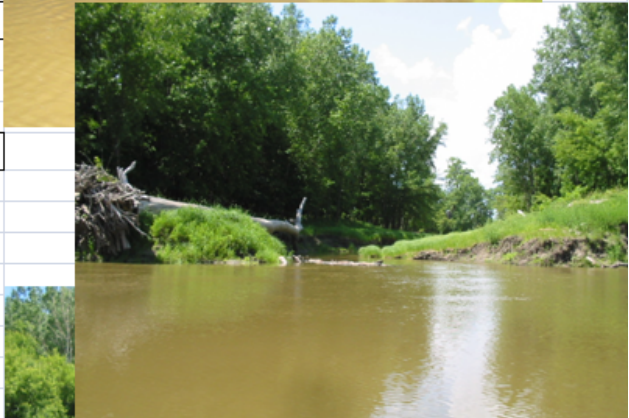
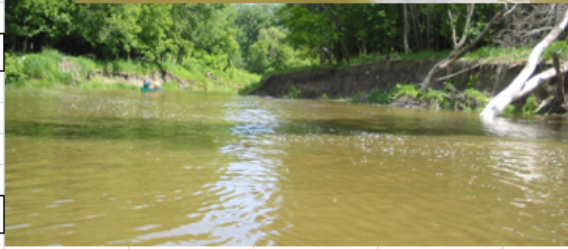
OBSERVATION		SCORE
<b>Condition of bank</b>		<b>3</b>
Toe and upper bank eroding	5	
Toe undercutting	3	x
Toe stable, upper bank eroding	1	
<b>Problem Trend</b>		<b>5</b>
Increasing	5	x
Decreasing or stable	1	
<b>Side-slope of bank</b>		<b>5</b>
Vertical, 1:1	5	x

2:1, 3:1	2	
4:1 or flatter	1	
<b>Length of eroded bank</b>		<b>5</b>
More than 50 ft.	5	x
20 to 50 ft.	3	
Less than 20 ft.	1	
<b>Depth of river</b>		<b>2</b>
More than 3 ft.	2	x
Less than 3 ft.	1	
<b>Soil type or texture</b>		<b>1</b>
Sand	3	
Gravel	2	
Stratified	2	
Clay, loam	1	x
<b>Vegetative Cover on bank slope</b>		<b>5</b>
0-10%	5	x
10-50%	3	
50-100%	1	
<b>Apparent cause of erosion</b>		<b>2</b>
Light access traffic	1	
Obstruction in river	1	
Bank seepage	1	
Gullyng by side channels	1	
Bend in river	2	x
Wave action (impoundments)	2	
Road-stream crossing;	3	
Moderate access traffic	3	
Heavy access (foot, horse, etc.)	5	
<b>Mean height of eroded bank</b>		<b>5</b>
More than 20 ft.	7	
10 to 20 ft.	5	x
5 to 10 ft.	3	
Less than 5 ft.	1	
<b>Current</b>		<b>1</b>
Fast	2	
Slow	1	x

<b>Total Points for site</b>		<b>34</b>	<b>Moderate</b>
0-30	Minor	30-36	Moderate
		>36	Severe

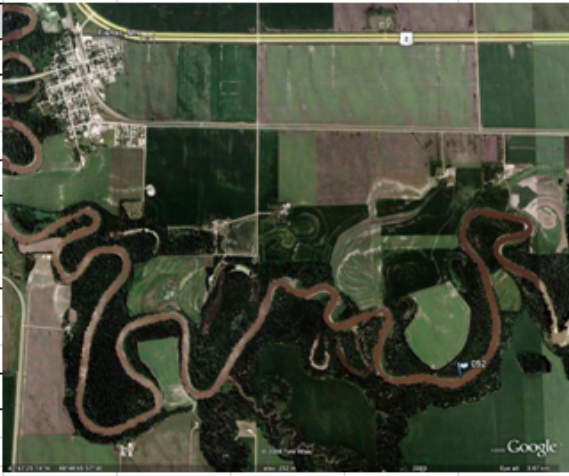
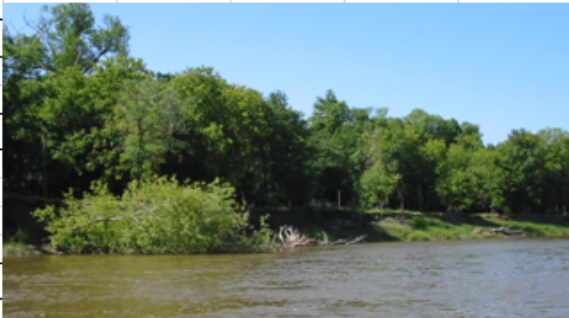
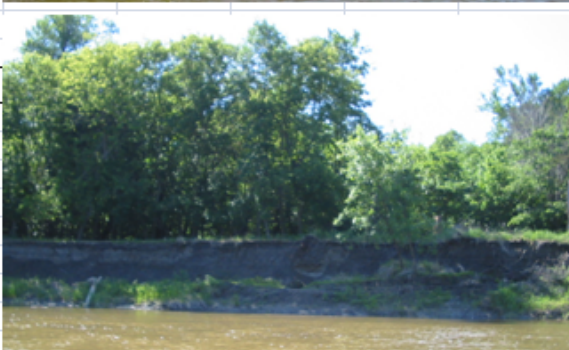
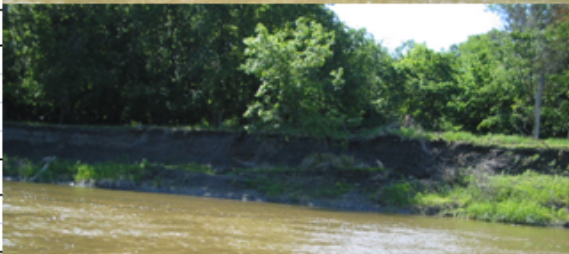
Streambank Erosion Severity Index		Site 52					
Site Description		Cutbank along bend in Red Lake River SE of Fisher					
Site visits on		6/8/2007 10:43		lat/long:		N47 46.912 W96 45.800	
OBSERVATION		SCORE

<b>Condition of bank</b>		<b>5</b>					
Toe and upper bank eroding	5	x					
Toe undercutting	3						
Toe stable, upper bank eroding	1						
<b>Problem Trend</b>		<b>5</b>					
Increasing	5	x					
Decreasing or stable	1						
<b>Side-slope of bank</b>		<b>5</b>					
Vertical, 1:1	5	x

2:1, 3:1	2						
4:1 or flatter	1						
<b>Length of eroded bank</b>		<b>5</b>					
More than 50 ft.	5	x					
20 to 50 ft.	3						
Less than 20 ft.	1						
<b>Depth of river</b>		<b>2</b>					
More than 3 ft.	2	x					
Less than 3 ft.	1						
<b>Soil type or texture</b>		<b>1</b>					
Sand	3						
Gravel	2						
Stratified	2						
Clay, loam	1	x					
<b>Vegetative Cover on bank slope</b>		<b>3</b>					
0-10%	5						
10-50%	3	x					
50-100%	1						
<b>Apparent cause of erosion</b>		<b>2</b>					
Light access traffic	1						
Obstruction in river	1						
Bank seepage	1						
Gully by side channels	1						
Bend in river	2	x					
Wave action (impoundments)	2						
Road-stream crossing; grade/shoulder	3						
Moderate access traffic	3						
Heavy access (foot, horse, etc.) traffic	5						
<b>Mean height of eroded bank</b>		<b>3</b>					
More than 20 ft.	7						
10 to 20 ft.	5						
5 to 10 ft.	3	x					
Less than 5 ft.	1						
<b>Current</b>		<b>2</b>

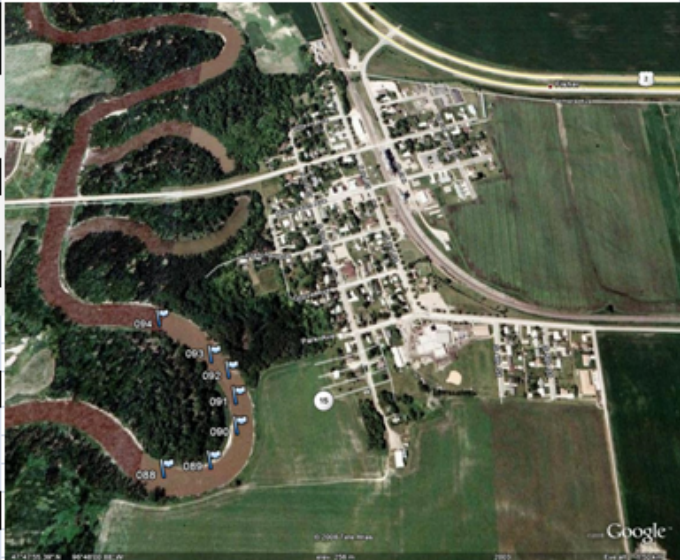
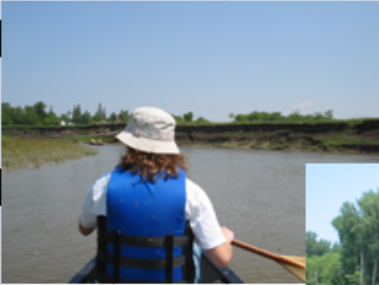
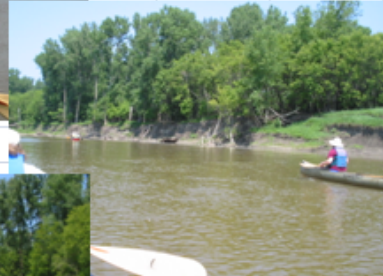
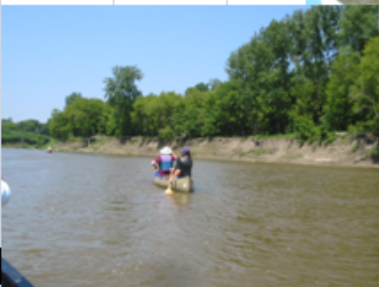
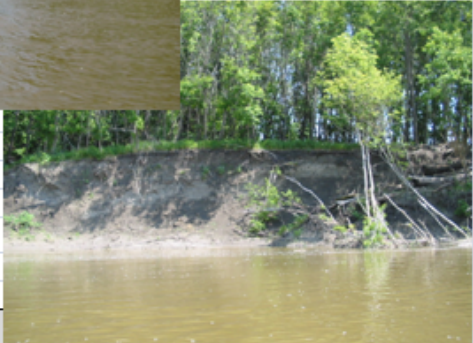
2:1, 3:1	2		
4:1 or flatter	1		
<b>Length of eroded bank</b>		<b>5</b>	
More than 50 ft.	5	x	
20 to 50 ft.	3		
Less than 20 ft.	1		
<b>Depth of river</b>		<b>2</b>	
More than 3 ft.	2	x	
Less than 3 ft.	1		
<b>Soil type or texture</b>		<b>1</b>	
Sand	3		
Gravel	2		
Stratified	2		
Clay, loam	1	x	
<b>Vegetative Cover on bank slope</b>		<b>5</b>	
0-10%	5	x	
10-50%	3		
50-100%	1		
<b>Apparent cause of erosion</b>		<b>2</b>	
Light access traffic	1		
Obstruction in river	1		
Bank seepage	1		
Gullyng by side channels	1		
Bend in river	2	x	
Wave action (impoundments)	2		
Road-stream crossing;	3		
Moderate access traffic	3		
Heavy access (foot, horse, etc.)	5		
<b>Mean height of eroded bank</b>		<b>5</b>	
More than 20 ft.	7		
10 to 20 ft.	5	x	
5 to 10 ft.	3		
Less than 5 ft.	1		
<b>Current</b>		<b>2</b>	
Fast	2		
Slow	1	x	
<b>Total Points for site</b>		<b>33</b>	
0-30	Minor	30-36	Moderate
		>36	Severe
