# Red Lake River Erosion Site and Assessment Catalog

## Threatening Infrastructure or homes

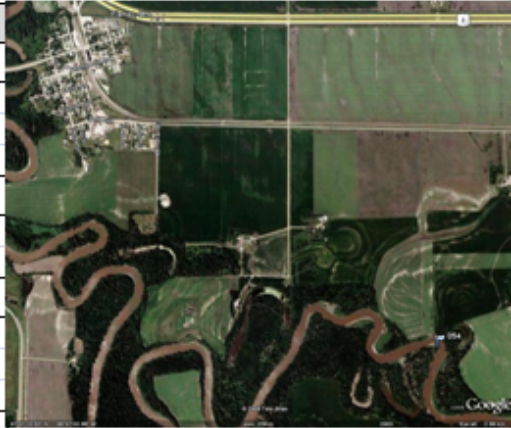
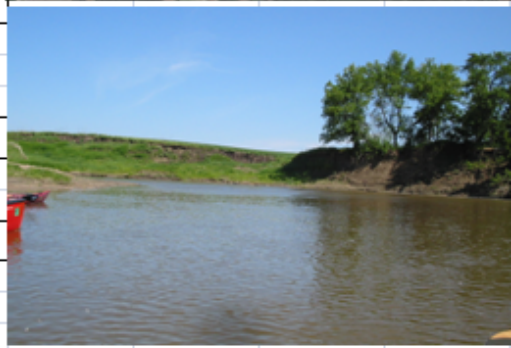
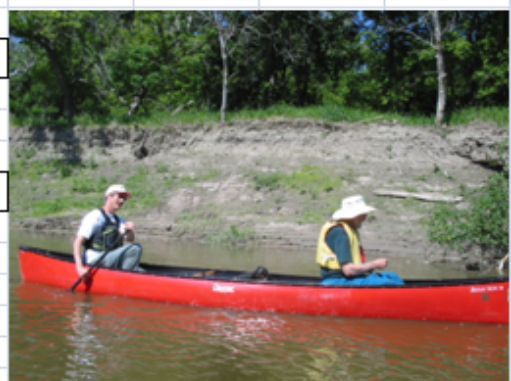
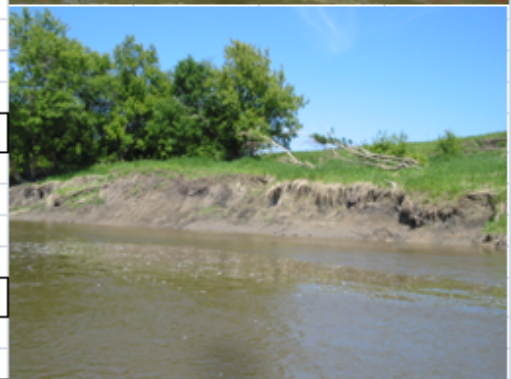
2:1, 3:1		2			
4:1 or flatter		1			
<b>Length of eroded bank</b>			<b>5</b>		
More than 50 ft.		5	x		
20 to 50 ft.		3			
Less than 20 ft.		1			
<b>Depth of river</b>			<b>2</b>		
More than 3 ft.		2	x		
Less than 3 ft.		1			
<b>Soil type or texture</b>			<b>1</b>		
Sand		3			
Gravel		2			
Stratified		2			
Clay, loam		1	x		
<b>Vegetative Cover on bank slope</b>			<b>3</b>		
0-10%		5			
10-50%		3	x		
50-100%		1			
<b>Apparent cause of erosion</b>			<b>2</b>		
Light access traffic		1			
Obstruction in river		1			
Bank seepage		1			
Gullying by side channels		1			
Bend in river		2	x		
Wave action (impoundments)		2			
Road-stream crossing; grade/shoulder		3			
Moderate access traffic		3			
Heavy access (foot, horse, etc.) traffic		5			
<b>Mean height of eroded bank</b>			<b>3</b>		
More than 20 ft.		7			
10 to 20 ft.		5			
5 to 10 ft.		3	x		
Less than 5 ft.		1			
<b>Current</b>			<b>1</b>		
Fast		2			
Slow		1	x		
<b>Total Points for site</b>			<b>32</b>

<b>Moderate</b>		
0-30	Minor	30-36	Moderate	>36	Severe

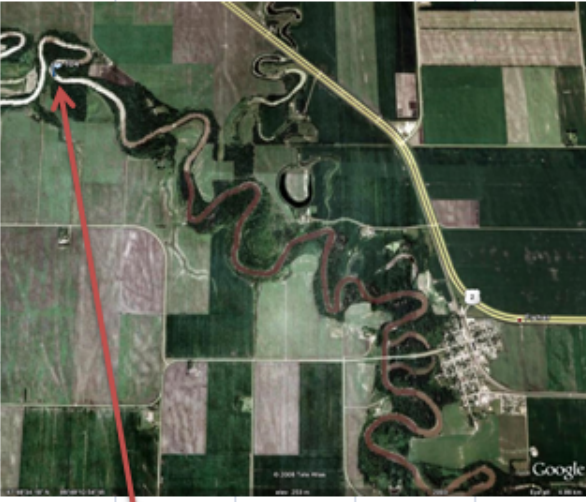
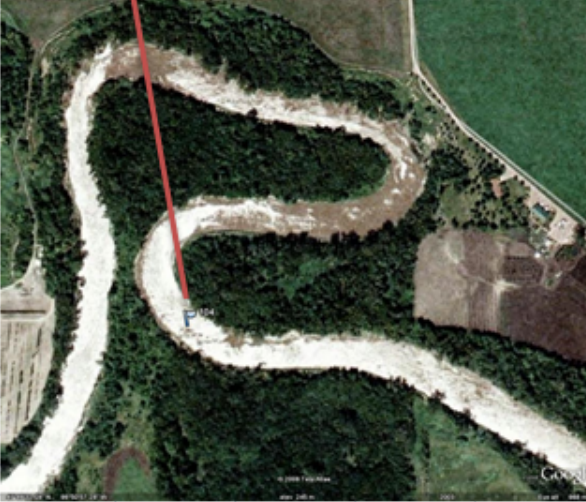
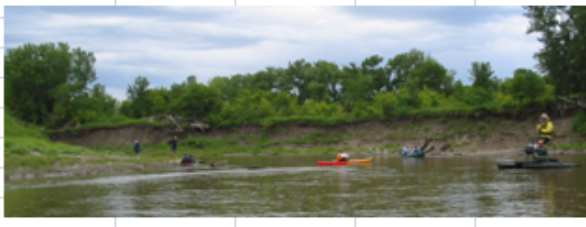
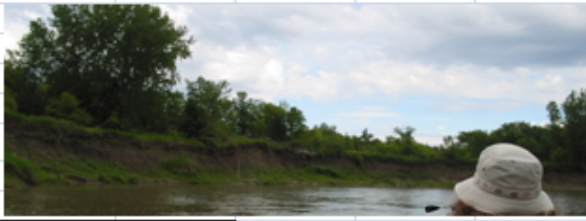
Streambank Erosion Severity Index		Site 104					
Site Description		Eroding cutbank along bend in river NW of Fisher					
Site visits on		6/9/2007 10:24		lat/long:		N47 49.475 W96 51.083	
OBSERVATION		SCORE

<b>Condition of bank</b>		<b>5</b>					
Toe and upper bank eroding	5	x					
Toe undercutting	3						
Toe stable, upper bank eroding	1						
<b>Problem Trend</b>		<b>5</b>					
Increasing	5	x					
Decreasing or stable	1						
<b>Side-slope of bank</b>		<b>5</b>					
Vertical, 1:1	5	x

2:1, 3:1	2						
4:1 or flatter	1						
<b>Length of eroded bank</b>		<b>5</b>					
More than 50 ft.	5	x					
20 to 50 ft.	3						
Less than 20 ft.	1						
<b>Depth of river</b>		<b>2</b>					
More than 3 ft.	2	x					
Less than 3 ft.	1						
<b>Soil type or texture</b>		<b>1</b>					
Sand	3						
Gravel	2						
Stratified	2						
Clay, loam	1	x					
<b>Vegetative Cover on bank slope</b>		<b>1</b>					
0-10%	5						
10-50%	3						
50-100%	1	x					
<b>Apparent cause of erosion</b>		<b>2</b>					
Light access traffic	1						
Obstruction in river	1						
Bank seepage	1						
Gullyng by side channels	1						
Bend in river	2	x					
Wave action (impoundments)	2						
Road-stream crossing;	3						
Moderate access traffic	3						
Heavy access (foot, horse, etc.)	5						
<b>Mean height of eroded bank</b>		<b>5</b>					
More than 20 ft.	7						
10 to 20 ft.	5	x					
5 to 10 ft.	3						
Less than 5 ft.	1						
<b>Current</b>		<b>1</b>

Fast	2						
Slow	1	x					
<b>Total Points for site</b>		<b>32</b>		<b>Moderate</b>			
0-30	Minor	30-36	Moderate	>36	Severe		
Continued erosion at this site will eventually cut across and cut off a bend in the river to form an oxbow lake.

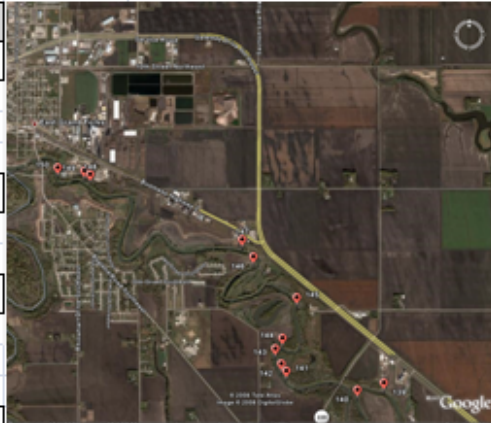
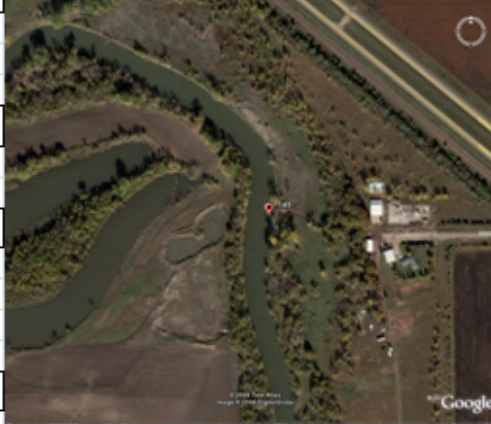
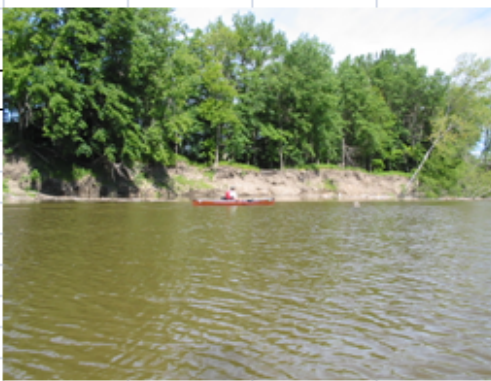
Streambank Erosion Severity Index						
Site Description						
Site visits on 6/10/2007 11:02			lat/long:	N47 54.347 W96 58.211		
OBSERVATION		SCORE

<b>Condition of bank</b>		<b>5</b>				
Toe and upper bank eroding	5	x				
Toe undercutting	3					
Toe stable, upper bank eroding	1					
<b>Problem Trend</b>		<b>5</b>				
Increasing	5	x				
Decreasing or stable	1					
<b>Side-slope of bank</b>		<b>5</b>				
Vertical, 1:1	5	x

2:1, 3:1	2					
4:1 or flatter	1					
<b>Length of eroded bank</b>		<b>3</b>				
More than 50 ft.	5					
20 to 50 ft.	3	x				
Less than 20 ft.	1					
<b>Depth of river</b>		<b>2</b>				
More than 3 ft.	2	x				
Less than 3 ft.	1					
<b>Soil type or texture</b>		<b>1</b>				
Sand	3					
Gravel	2					
Stratified	2					
Clay, loam	1	x				
<b>Vegetative Cover on bank slope</b>		<b>3</b>				
0-10%	5					
10-50%	3	x				
50-100%	1					
<b>Apparent cause of erosion</b>		<b>2</b>				
Light access traffic	1					
Obstruction in river	1					
Bank seepage	1	x				
Gully by side channels	1					
Bend in river	2	x				
Wave action (impoundments)	2					
Road-stream crossing;	3					
Moderate access traffic	3					
Heavy access (foot, horse, etc.)	5					
<b>Mean height of eroded bank</b>		<b>5</b>				
More than 20 ft.	7					
10 to 20 ft.	5	x				
5 to 10 ft.	3					
Less than 5 ft.	1					
<b>Current</b>		<b>1</b>				
Fast	2					
Slow	1	x				
<b>Total Points for site</b>		<b>32</b>	<b>Moderate</b>

The force of water coming into the river from a ditch on the opposite bank and water pool behind the bank may be factors

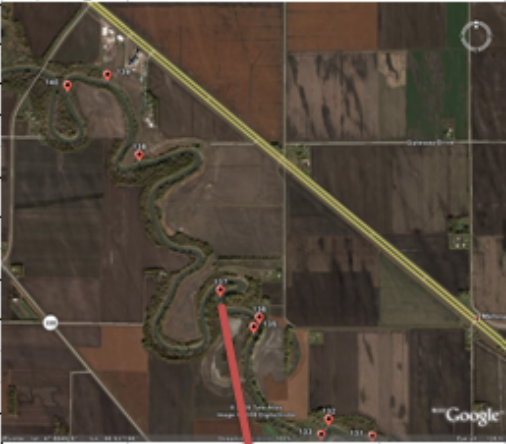
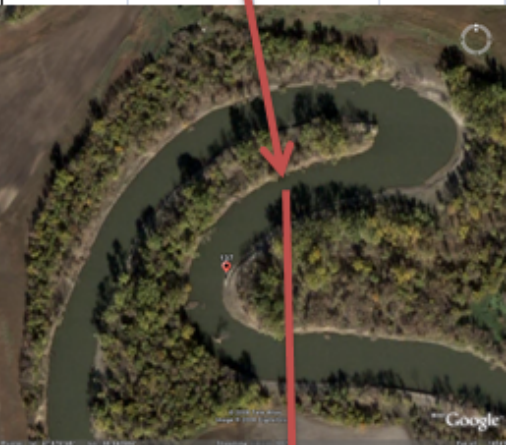
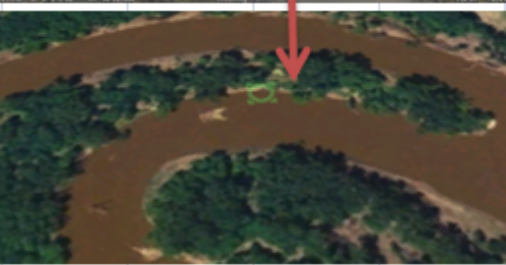
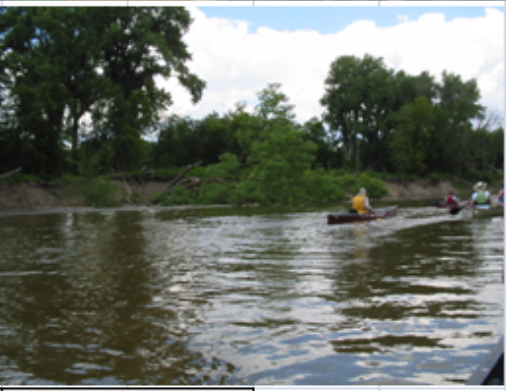
Streambank Erosion Severity Index							
Site Description							
Site visits on		6/9/2007 14:53		lat/long: N47 52.721 W96 56.482			
OBSERVATION			SCORE

<b>Condition of bank</b>			<b>3</b>				
Toe and upper bank eroding	5						
Toe undercutting	3	x					
Toe stable, upper bank eroding	1						
<b>Problem Trend</b>			<b>5</b>				
Increasing	5	x					
Decreasing or stable	1						
<b>Side-slope of bank</b>			<b>5</b>				
Vertical, 1:1	5	x

2:1, 3:1	2						
4:1 or flatter	1						
<b>Length of eroded bank</b>			<b>5</b>				
More than 50 ft.	5	x					
20 to 50 ft.	3						
Less than 20 ft.	1						
<b>Depth of river</b>			<b>2</b>				
More than 3 ft.	2	x					
Less than 3 ft.	1						
<b>Soil type or texture</b>			<b>1</b>				
Sand	3						
Gravel	2						
Stratified	2						
Clay, loam	1	x					
<b>Vegetative Cover on bank slope</b>			<b>5</b>				
0-10%	5	x					
10-50%	3						
50-100%	1						
<b>Apparent cause of erosion</b>			<b>2</b>				
Light access traffic	1						
Obstruction in river	1						
Bank seepage	1						
Gullying by side channels	1						
Bend in river	2	x					
Wave action (impoundments)	2						
Road-stream crossing;	3						
Moderate access traffic	3						
Heavy access (foot, horse, etc.)	5						
<b>Mean height of eroded bank</b>			<b>3</b>				
More than 20 ft.	7						
10 to 20 ft.	5						
5 to 10 ft.	3	x					
Less than 5 ft.	1						
<b>Current</b>			<b>1</b>

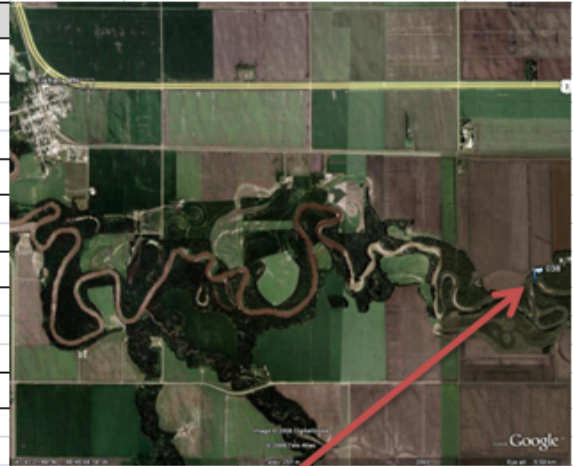
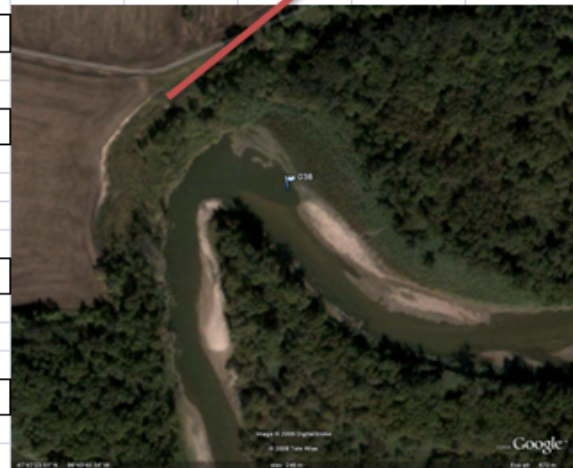
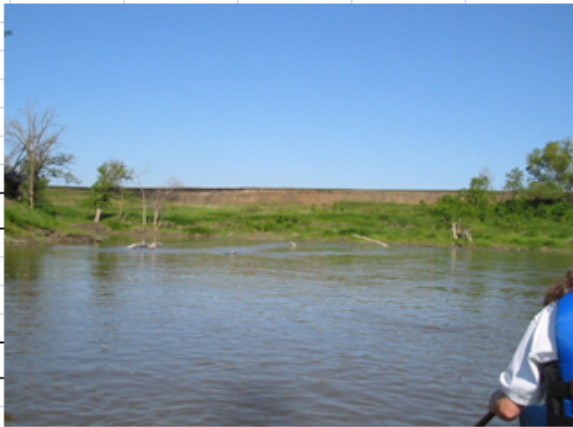
2:1, 3:1	2			
4:1 or flatter	1			
<b>Length of eroded bank</b>			<b>5</b>	
More than 50 ft.	5	x		
20 to 50 ft.	3			
Less than 20 ft.	1			
<b>Depth of river</b>			<b>2</b>	
More than 3 ft.	2	x		
Less than 3 ft.	1			
<b>Soil type or texture</b>			<b>1</b>	
Sand	3			
Gravel	2			
Stratified	2			
Clay, loam	1	x		
<b>Vegetative Cover on bank slope</b>			<b>1</b>	
0-10%	5			
10-50%	3			
50-100%	1	x		
<b>Apparent cause of erosion</b>			<b>2</b>	
Light access traffic	1			
Obstruction in river	1			
Bank seepage	1			
Gullying by side channels	1			
Bend in river	2	x		
Wave action (impoundments)	2			
Road-stream crossing; grade/shoulder	3			
Moderate access traffic	3			
Heavy access (foot, horse, etc.) traffic	5			
<b>Mean height of eroded bank</b>			<b>7</b>	
More than 20 ft.	7	x		
10 to 20 ft.	5			
5 to 10 ft.	3			
Less than 5 ft.	1			
<b>Current</b>			<b>2</b>	
Fast	2			
Slow	1	x		
<b>Total Points for site</b>			<b>31</b>	
			<b>Moderate</b>

0-30	Minor		30-36	Moderate
			>36	Severe

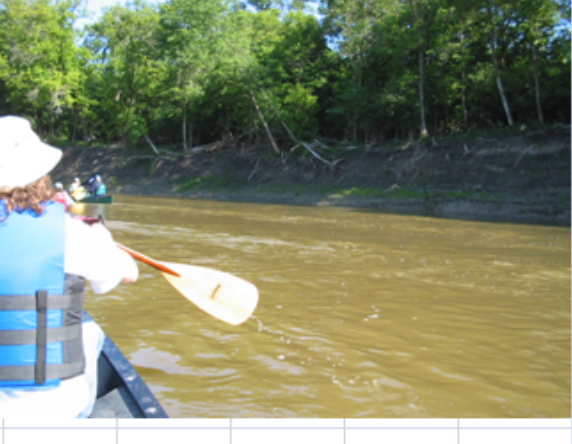
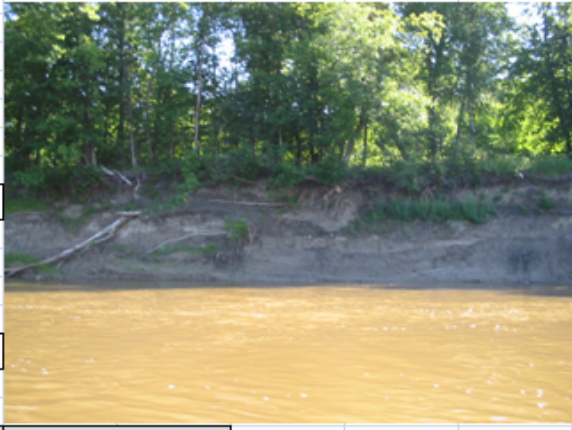
Streambank Erosion Severity Index		Site 42					
Site Description		Eroding streambank 2.8 miles east of Fisher					
Site visits on		6/8/2007 9:57		lat/long:		N47 47.114 W96 44.386	
OBSERVATION		SCORE

<b>Condition of bank</b>		<b>5</b>					
Toe and upper bank eroding		5	x

Toe undercutting		3					
Toe stable, upper bank eroding		1					
<b>Problem Trend</b>		<b>1</b>

Increasing		5					
Decreasing or stable		1	x				
<b>Side-slope of bank</b>		<b>5</b>

Vertical, 1:1		5	x

2:1, 3:1		2					
4:1 or flatter		1					
<b>Length of eroded bank</b>		<b>5</b>					
More than 50 ft.		5	x				
20 to 50 ft.		3					
Less than 20 ft.		1					
<b>Depth of river</b>		<b>2</b>					
More than 3 ft.		2	x				
Less than 3 ft.		1					
<b>Soil type or texture</b>		<b>1</b>					
Sand		3					
Gravel		2					
Stratified		2					
Clay, loam		1	x				
<b>Vegetative Cover on bank slope</b>		<b>5</b>					
0-10%		5	x				
10-50%		3					
50-100%		1					
<b>Apparent cause of erosion</b>		<b>2</b>					
Light access traffic		1					
Obstruction in river		1					
Bank seepage		1					
Gullying by side channels		1					
Bend in river		2	x				
Wave action (impoundments)		2					
Road-stream crossing; grade/shoulder		3					
Moderate access traffic		3					
Heavy access (foot, horse, etc.) traffic		5					
<b>Mean height of eroded bank</b>		<b>3</b>					
More than 20 ft.		7					
10 to 20 ft.		5					
5 to 10 ft.		3	x				
Less than 5 ft.		1

<b>Current</b>		<b>2</b>					
Fast		2					
Slow		1	x				
<b>Total Points for site</b>		<b>31</b>		<b>Moderate</b>			
0-30	Minor	30-36	Moderate	>36	Severe

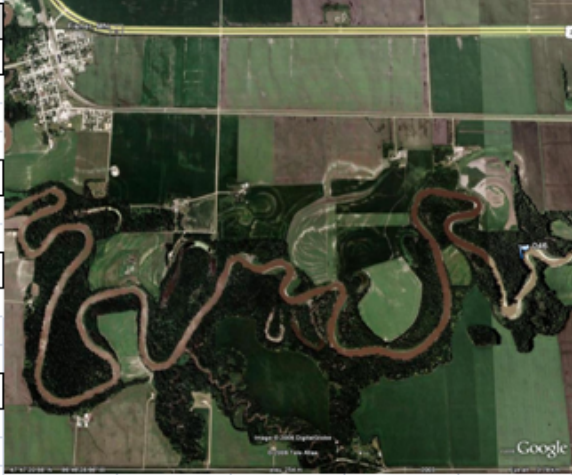
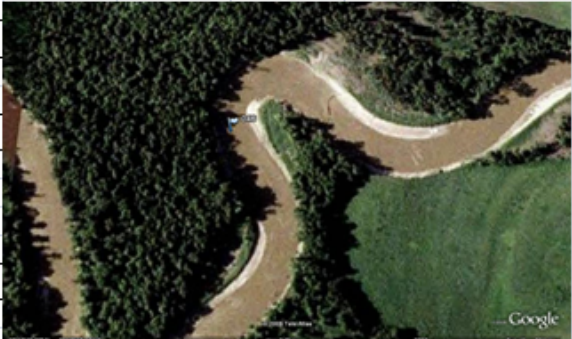
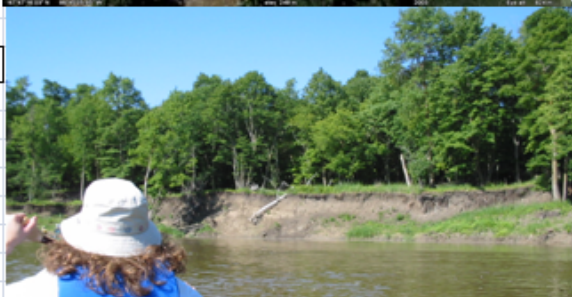
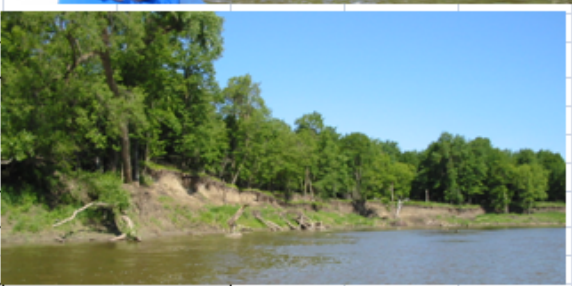
Streambank Erosion Severity Index		Site 46							
Site Description		Eroding cutbank 2.1 miles east of Fisher		lat/long:		N47 47.253 W96 45.151			
Site visits on		6/8/2007 10:16							
OBSERVATION			SCORE

<b>Condition of bank</b>			<b>5</b>						
Toe and upper bank eroding		5	x						
Toe undercutting		3							
Toe stable, upper bank eroding		1							
<b>Problem Trend</b>			<b>1</b>						
Increasing		5							
Decreasing or stable		1	x						
<b>Side-slope of bank</b>			<b>5</b>						
Vertical, 1:1		5	x

2:1, 3:1		2							
4:1 or flatter		1							
<b>Length of eroded bank</b>			<b>5</b>						
More than 50 ft.		5	x						
20 to 50 ft.		3							
Less than 20 ft.		1							
<b>Depth of river</b>			<b>2</b>						
More than 3 ft.		2	x						
Less than 3 ft.		1							
<b>Soil type or texture</b>			<b>1</b>						
Sand		3							
Gravel		2							
Stratified		2							
Clay, loam		1	x						
<b>Vegetative Cover on bank slope</b>			<b>3</b>						
0-10%		5							
10-50%		3	x						
50-100%		1							
<b>Apparent cause of erosion</b>			<b>2</b>						
Light access traffic		1							
Obstruction in river		1							
Bank seepage		1							
Gullying by side channels		1							
Bend in river		2	x						
Wave action (impoundments)		2							
Road-stream crossing; grade/shoulder		3							
Moderate access traffic		3							
Heavy access (foot, horse, etc.) traffic		5							
<b>Mean height of eroded bank</b>			<b>5</b>						
More than 20 ft.		7							
10 to 20 ft.		5	x

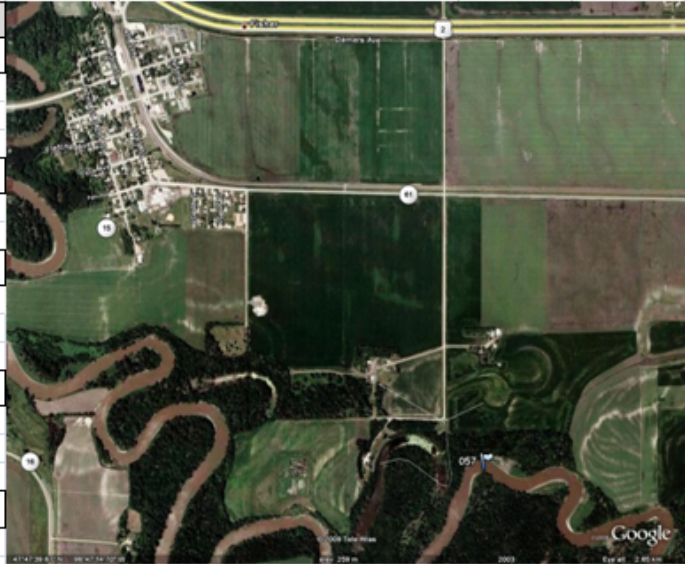
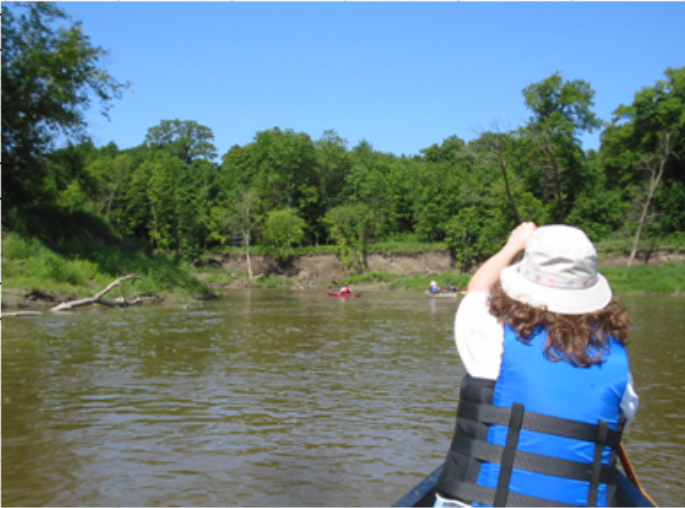
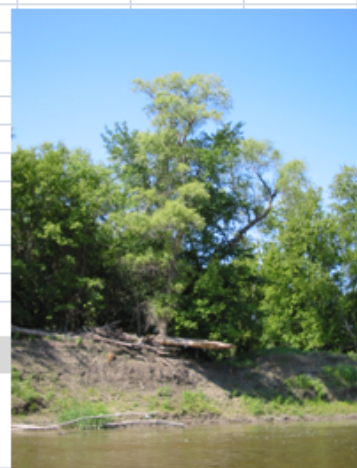
2:1, 3:1	2		
4:1 or flatter	1		
<b>Length of eroded bank</b>		<b>5</b>	
More than 50 ft.	5	x	
20 to 50 ft.	3		
Less than 20 ft.	1		
<b>Depth of river</b>		<b>2</b>	
More than 3 ft.	2	x	
Less than 3 ft.	1		
<b>Soil type or texture</b>		<b>1</b>	
Sand	3		
Gravel	2		
Stratified	2		
Clay, loam	1	x	
<b>Vegetative Cover on bank slope</b>		<b>3</b>	
0-10%	5		
10-50%	3	x	
50-100%	1		
<b>Apparent cause of erosion</b>		<b>2</b>	
Light access traffic	1		
Obstruction in river	1		
Bank seepage	1		
Gullyng by side channels	1		
Bend in river	2	x	
Wave action (impoundments)	2		
Road-stream crossing;	3		
Moderate access traffic	3		
Heavy access (foot, horse, etc.)	5		
<b>Mean height of eroded bank</b>		<b>5</b>	
More than 20 ft.	7		
10 to 20 ft.	5	x	
5 to 10 ft.	3		
Less than 5 ft.	1		
<b>Current</b>		<b>2</b>	
Fast	2		
Slow	1	x	
<b>Total Points for site</b>		<b>31</b>	
0-30	Minor	30-36	Moderate
		>36	Severe

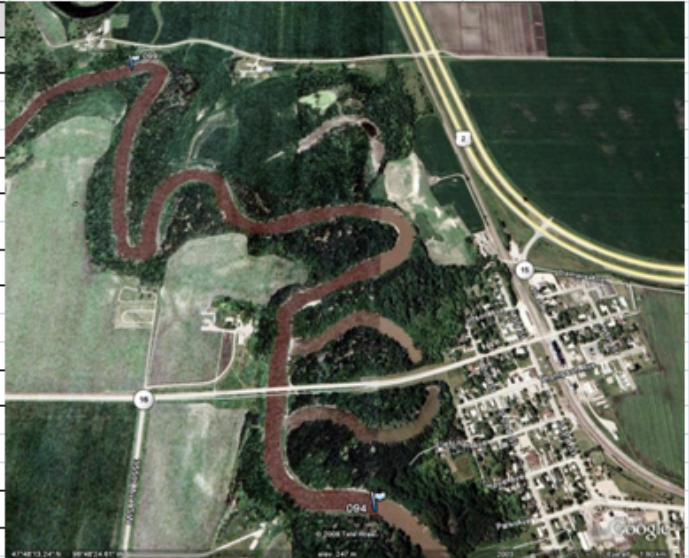
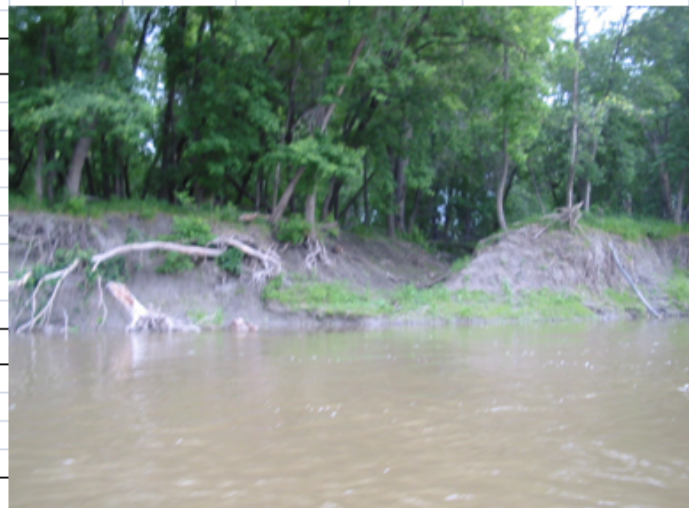
Streambank Erosion Severity Index		Site 96					
Site Description	Eroding bank at outlet of drainage (oxbow lake?) near Fisher						
Site visits on	6/9/2007 9:24	lat/long:					
OBSERVATION		SCORE					
<b>Condition of bank</b>		<b>5</b>					
Toe and upper bank eroding	5	x					
Toe undercutting	3						
Toe stable, upper bank eroding	1						
<b>Problem Trend</b>		<b>1</b>					
Increasing	5						
Decreasing or stable	1	x					
<b>Side-slope of bank</b>		<b>5</b>					
Vertical, 1:1	5	x

2:1, 3:1	2						
4:1 or flatter	1						
<b>Length of eroded bank</b>		<b>3</b>					
More than 50 ft.	5						
20 to 50 ft.	3	x					
Less than 20 ft.	1						
<b>Depth of river</b>		<b>2</b>					
More than 3 ft.	2	x					
Less than 3 ft.	1						
<b>Soil type or texture</b>		<b>1</b>					
Sand	3						
Gravel	2						
Stratified	2						
Clay, loam	1	x					
<b>Vegetative Cover on bank slope</b>		<b>3</b>					
0-10%	5						
10-50%	3	x					
50-100%	1						
<b>Apparent cause of erosion</b>		<b>2</b>					
Light access traffic	1						
Obstruction in river	1						
Bank seepage	1						
Gully by side channels	1	x					
Bend in river	2	x					
Wave action (impoundments)	2						
Road-stream crossing;	3						
Moderate access traffic	3						
Heavy access (foot, horse, etc.)	5						
<b>Mean height of eroded bank</b>		<b>7</b>					
More than 20 ft.	7	x					
10 to 20 ft.	5						
5 to 10 ft.	3						
Less than 5 ft.	1						
<b>Current</b>		<b>2</b>

Fast	2						
Slow	1	x					
<b>Total Points for site</b>		<b>31</b>	<b>Moderate</b>				
0-30	Minor	30-36	Moderate	>36	Severe		
GPS wasn't getting correct readings for sites 95-98

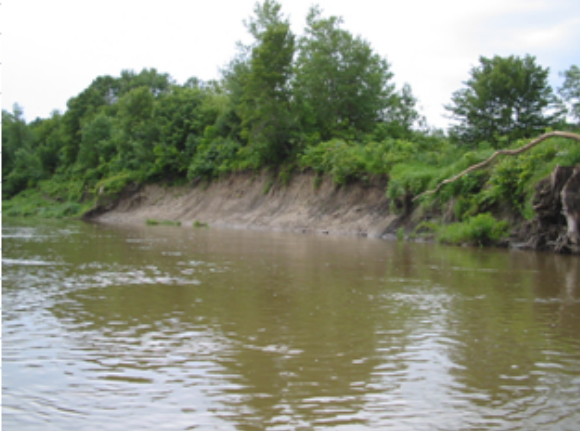
Streambank Erosion Severity Index		Site 101							
Site Description		Eroding bank NW of Fisher		lat/long:		N47 48.813 W96 49.803			
Site visits on		6/9/2007 9:56							
OBSERVATION		SCORE

<b>Condition of bank</b>		<b>5</b>							
Toe and upper bank eroding		5	x						
Toe undercutting		3							
Toe stable, upper bank eroding		1							
<b>Problem Trend</b>		<b>5</b>							
Increasing		5	x						
Decreasing or stable		1							
<b>Side-slope of bank</b>		<b>5</b>							
Vertical, 1:1		5	x

2:1, 3:1		2							
4:1 or flatter		1							
<b>Length of eroded bank</b>		<b>3</b>							
More than 50 ft.		5							
20 to 50 ft.		3	x						
Less than 20 ft.		1							
<b>Depth of river</b>		<b>2</b>							
More than 3 ft.		2	x						
Less than 3 ft.		1							
<b>Soil type or texture</b>		<b>1</b>							
Sand		3							
Gravel		2							
Stratified		2							
Clay, loam		1	x						
<b>Vegetative Cover on bank slope</b>		<b>5</b>							
0-10%		5	x						
10-50%		3							
50-100%		1							
<b>Apparent cause of erosion</b>		<b>1</b>							
Light access traffic		1	?						
Obstruction in river		1							
Bank seepage		1	?						
Gullying by side channels		1							
Bend in river		2							
Wave action (impoundments)		2							
Road-stream crossing;		3							
Moderate access traffic		3							
Heavy access (foot, horse, etc.)		5							
<b>Mean height of eroded bank</b>		<b>3</b>							
More than 20 ft.		7							
10 to 20 ft.		5							
5 to 10 ft.		3	x

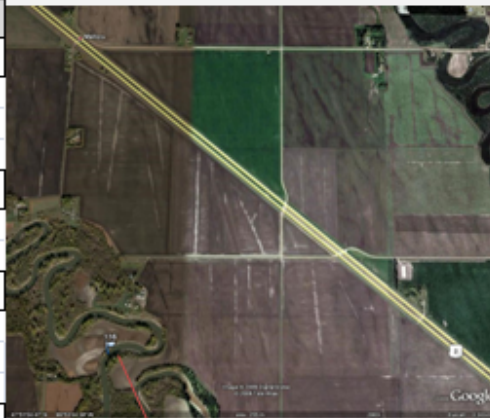
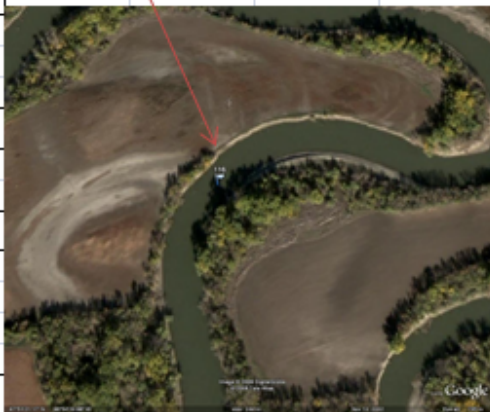
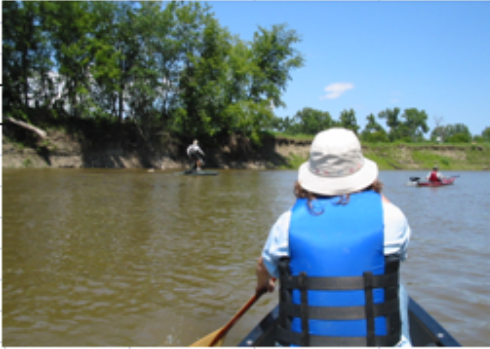
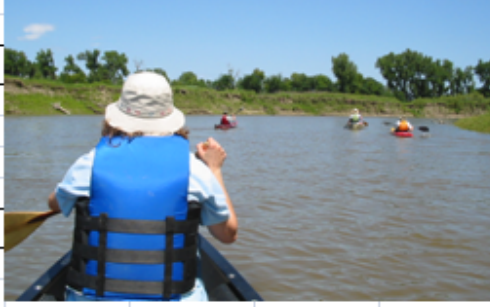
Streambank Erosion Severity Index			
Site Description	Long stretch of eroding bank along farmed river bank		
Site visits on	6/9/2007 13:27	lat/long:	N47 51.367 W96 54.379
OBSERVATION		SCORE	
<b>Condition of bank</b>		<b>5</b>	
Toe and upper bank eroding	5	x	
Toe undercutting	3		
Toe stable, upper bank eroding	1		
<b>Problem Trend</b>		<b>1</b>	
Increasing	5		
Decreasing or stable	1	x	
<b>Side-slope of bank</b>		<b>5</b>	
Vertical, 1:1	5	x

2:1, 3:1	2		
4:1 or flatter	1		
<b>Length of eroded bank</b>		<b>5</b>	
More than 50 ft.	5	x	
20 to 50 ft.	3		
Less than 20 ft.	1		
<b>Depth of river</b>		<b>2</b>	
More than 3 ft.	2	x	
Less than 3 ft.	1		
<b>Soil type or texture</b>		<b>1</b>	
Sand	3		
Gravel	2		
Stratified	2		
Clay, loam	1	x	
<b>Vegetative Cover on bank slope</b>		<b>3</b>	
0-10%	5		
10-50%	3	x	
50-100%	1		
<b>Apparent cause of erosion</b>		<b>2</b>	
Light access traffic	1		
Obstruction in river	1		
Bank seepage	1		
Gullying by side channels	1		
Bend in river	2	x	
Wave action (impoundments)	2		
Road-stream crossing;	3		
Moderate access traffic	3		
Heavy access (foot, horse, etc.)	5		
<b>Mean height of eroded bank</b>		<b>5</b>	
More than 20 ft.	7		
10 to 20 ft.	5	x	
5 to 10 ft.	3		
Less than 5 ft.	1		
<b>Current</b>		<b>1</b>	
Fast	2		
Slow	1	x	
<b>Total Points for site</b>		<b>30</b>	<b>Moderate</b>
0-30	Minor	30-36	Moderate
		>36	Severe

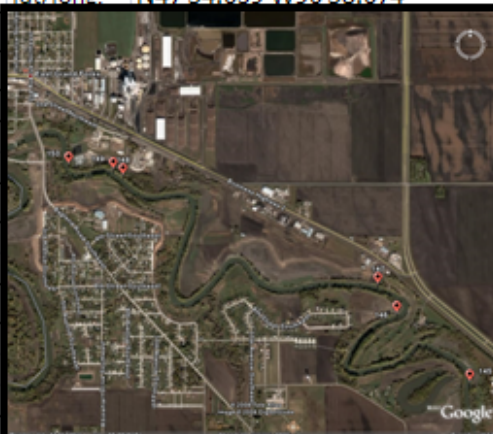
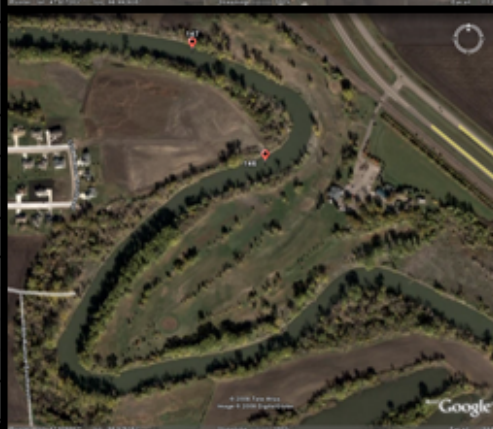
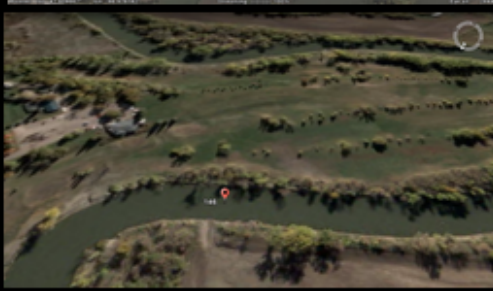
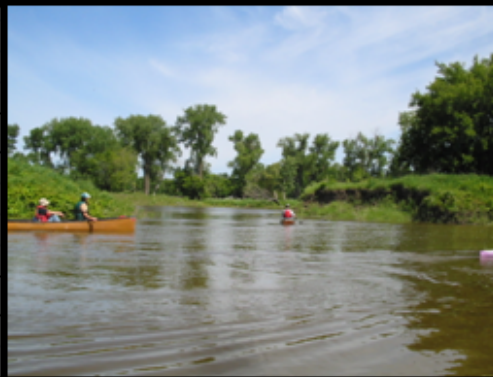
Streambank Erosion Severity Index			
Site Description	Erosion near the Riverbend Supper Club		
Site visits on	7/10/07	lat/long:	N47 54.639 W96 58.674
OBSERVATION		SCORE	
<b>Condition of bank</b>		<b>3</b>	
Toe and upper bank eroding	5		
Toe undercutting	3	x	
Toe stable, upper bank eroding	1		
<b>Problem Trend</b>		<b>5</b>	
Increasing	5	x	
Decreasing or stable	1		
<b>Side-slope of bank</b>		<b>5</b>	
Vertical, 1:1	5	x

2:1, 3:1	2		
4:1 or flatter	1		
<b>Length of eroded bank</b>		<b>3</b>	
More than 50 ft.	5		
20 to 50 ft.	3	x	
Less than 20 ft.	1		
<b>Depth of river</b>		<b>2</b>	
More than 3 ft.	2	x	
Less than 3 ft.	1		
<b>Soil type or texture</b>		<b>1</b>	
Sand	3		
Gravel	2		
Stratified	2		
Clay, loam	1	x	
<b>Vegetative Cover on bank slope</b>		<b>3</b>	
0-10%	5		
10-50%	3	x	
50-100%	1		
<b>Apparent cause of erosion</b>		<b>2</b>	
Light access traffic	1		
Obstruction in river	1		
Bank seepage	1		
Gullying by side channels	1		
Bend in river	2	x	
Wave action (impoundments)	2		
Road-stream crossing;	3		
Moderate access traffic	3		
Heavy access (foot, horse, etc.)	5		
<b>Mean height of eroded bank</b>		<b>5</b>	
More than 20 ft.	7		
10 to 20 ft.	5	x	
5 to 10 ft.	3		
Less than 5 ft.	1		
<b>Current</b>		<b>1</b>	
Fast	2		
Slow	1	x	
<b>Total Points for site</b>		<b>30</b>	
		<b>Moderate</b>	
0-30	Minor	30-36	Moderate
		>36	Severe

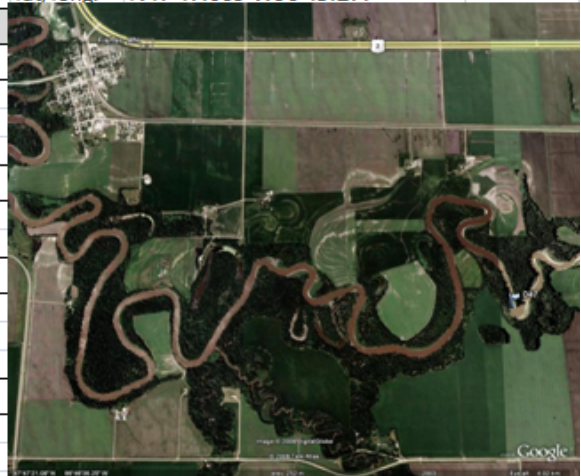
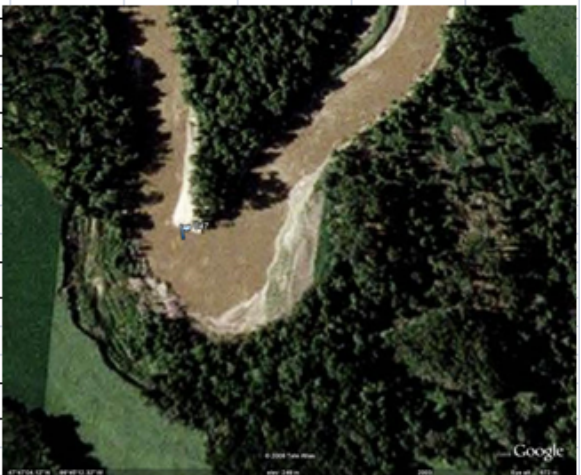
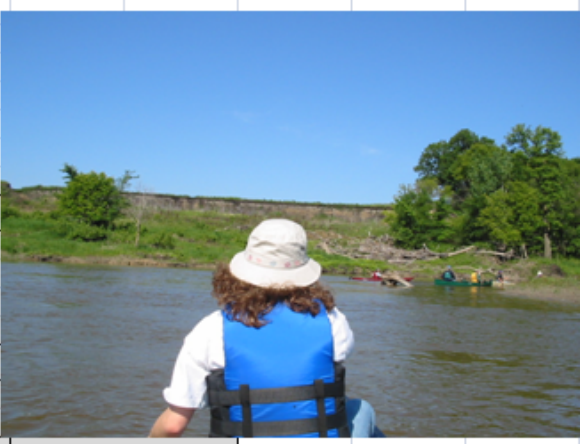
Streambank Erosion Severity Index		Site 47	
Site Description	Eroding cutbank 2 miles east of Fisher		
Site visits on	6/8/2007 10:20	lat/long:	N47 47.069 W96 45.277
OBSERVATION		SCORE	
<b>Condition of bank</b>		<b>3</b>	
Toe and upper bank eroding	5		
Toe undercutting	3	x	
Toe stable, upper bank eroding	1		
<b>Problem Trend</b>		<b>1</b>	
Increasing	5		
Decreasing or stable	1	x	
<b>Side-slope of bank</b>		<b>5</b>	
Vertical, 1:1	5	x

2:1, 3:1	2		
4:1 or flatter	1		
<b>Length of eroded bank</b>		<b>5</b>	
More than 50 ft.	5	x	
20 to 50 ft.	3		
Less than 20 ft.	1		
<b>Depth of river</b>		<b>2</b>	
More than 3 ft.	2	x	
Less than 3 ft.	1		
<b>Soil type or texture</b>		<b>1</b>	
Sand	3		
Gravel	2		
Stratified	2		
Clay, loam	1	x	
<b>Vegetative Cover on bank slope</b>		<b>1</b>	
0-10%	5		
10-50%	3		
50-100%	1	x	
<b>Apparent cause of erosion</b>		<b>2</b>	
Light access traffic	1		
Obstruction in river	1		
Bank seepage	1		
Gully by side channels	1		
Bend in river	2	x	
Wave action (impoundments)	2		
Road-stream crossing; grade/shoulder	3		
Moderate access traffic	3		
Heavy access (foot, horse, etc.) traffic	5		
<b>Mean height of eroded bank</b>		<b>7</b>	
More than 20 ft.	7	x	
10 to 20 ft.	5		
5 to 10 ft.	3		
Less than 5 ft.	1		
<b>Current</b>		<b>2</b>	
Fast	2		
Slow	1	x	
<b>Total Points for site</b>		<b>29</b>	
0-30	Minor	30-36	Moderate
		>36	Severe

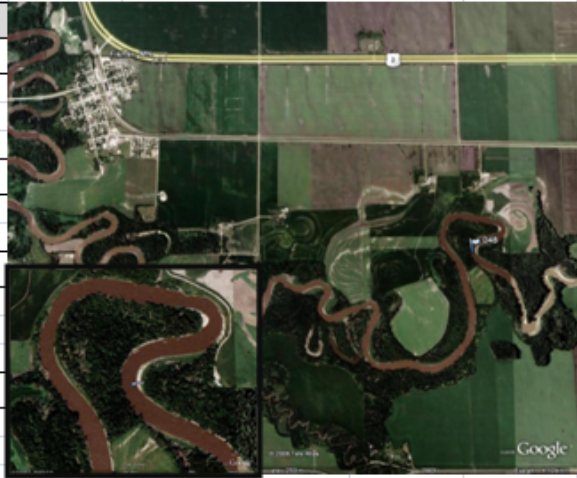
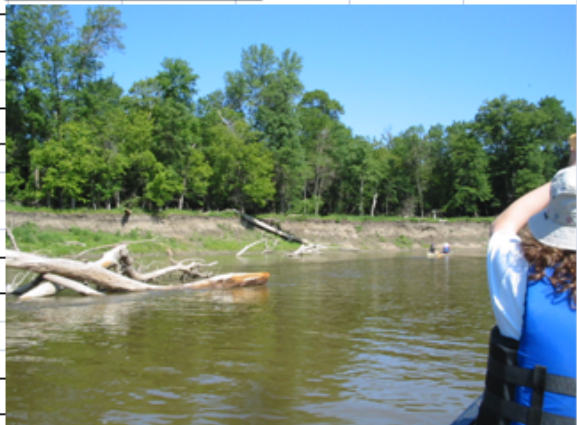
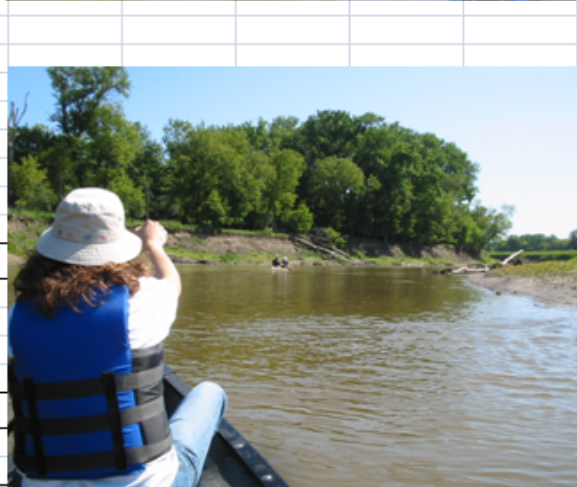
Streambank Erosion Severity Index			Site 48	
Site Description	Eroding cutbank 1.8 miles east of Fisher			
Site visits on	6/8/2007 10:25		lat/long:	N47 47.365 W96 45.573
OBSERVATION			SCORE	
<b>Condition of bank</b>			<b>5</b>	
Toe and upper bank eroding	5		x	
Toe undercutting	3			
Toe stable, upper bank eroding	1			
<b>Problem Trend</b>			<b>1</b>	
Increasing	5			
Decreasing or stable	1		x	
<b>Side-slope of bank</b>			<b>5</b>	
Vertical, 1:1	5		x

2:1, 3:1	2			
4:1 or flatter	1			
<b>Length of eroded bank</b>			<b>5</b>	
More than 50 ft.	5		x	
20 to 50 ft.	3			
Less than 20 ft.	1			
<b>Depth of river</b>			<b>2</b>	
More than 3 ft.	2		x	
Less than 3 ft.	1			
<b>Soil type or texture</b>			<b>1</b>	
Sand	3			
Gravel	2			
Stratified	2			
Clay, loam	1		x	
<b>Vegetative Cover on bank slope</b>			<b>3</b>	
0-10%	5			
10-50%	3		x	
50-100%	1			
<b>Apparent cause of erosion</b>			<b>2</b>	
Light access traffic	1			
Obstruction in river	1			
Bank seepage	1			
Gully by side channels	1			
Bend in river	2		x	
Wave action (impoundments)	2			
Road-stream crossing; grade/shoulder	3			
Moderate access traffic	3			
Heavy access (foot, horse, etc.) traffic	5			
<b>Mean height of eroded bank</b>			<b>3</b>	
More than 20 ft.	7			
10 to 20 ft.	5			
5 to 10 ft.	3		x	
Less than 5 ft.	1			
<b>Current</b>			<b>2</b>	
Fast	2			
Slow	1		x	
<b>Total Points for site</b>			<b>29</b>	
0-30	Minor	30-36	Moderate	>36

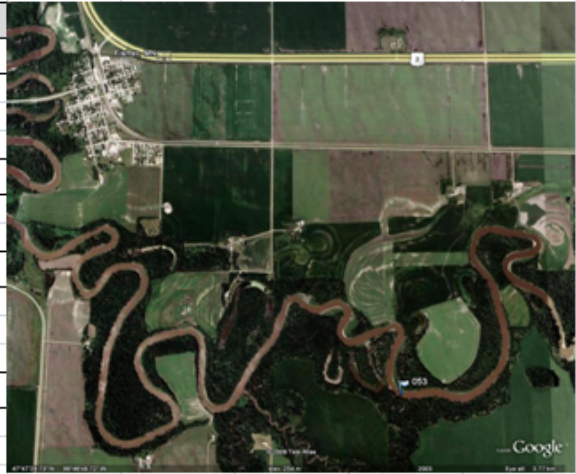
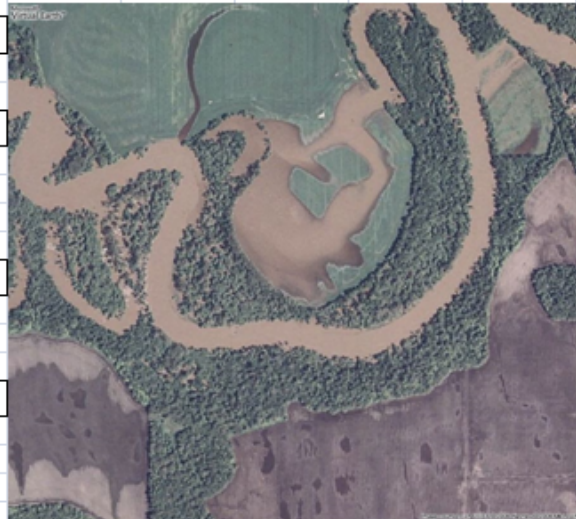
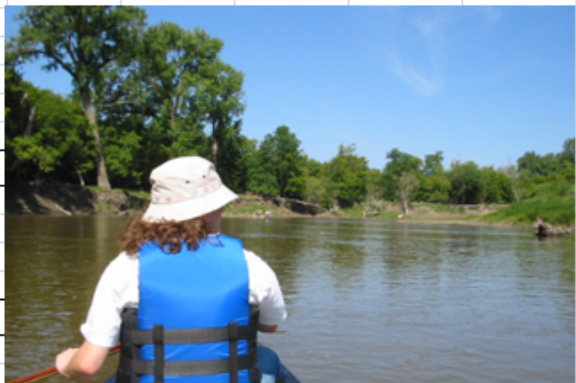
Streambank Erosion Severity Index		Site 53			
Site Description	Cutbank along bend in Red Lake River SE of Fisher				
Site visits on	6/8/2007 10:47		lat/long:	N47 46.898 W96 46.187	
OBSERVATION			SCORE		
<b>Condition of bank</b>			<b>5</b>		
Toe and upper bank eroding	5		x		
Toe undercutting	3				
Toe stable, upper bank eroding	1				
<b>Problem Trend</b>			<b>1</b>		
Increasing	5				
Decreasing or stable	1		x		
<b>Side-slope of bank</b>			<b>5</b>		
Vertical, 1:1	5		x

2:1, 3:1	2				
4:1 or flatter	1				
<b>Length of eroded bank</b>			<b>5</b>		
More than 50 ft.	5		x		
20 to 50 ft.	3				
Less than 20 ft.	1				
<b>Depth of river</b>			<b>2</b>		
More than 3 ft.	2		x		
Less than 3 ft.	1				
<b>Soil type or texture</b>			<b>1</b>		
Sand	3				
Gravel	2				
Stratified	2				
Clay, loam	1		x		
<b>Vegetative Cover on bank slope</b>			<b>3</b>		
0-10%	5				
10-50%	3		x		
50-100%	1				
<b>Apparent cause of erosion</b>			<b>2</b>		
Light access traffic	1				
Obstruction in river	1				
Bank seepage	1				
Gully by side channels	1				
Bend in river	2		x		
Wave action (impoundments)	2				
Road-stream crossing; grade/shoulder	3				
Moderate access traffic	3				
Heavy access (foot, horse, etc.) traffic	5				
<b>Mean height of eroded bank</b>			<b>3</b>		
More than 20 ft.	7				
10 to 20 ft.	5				
5 to 10 ft.	3		x		
Less than 5 ft.	1				
<b>Current</b>			<b>2</b>		
Fast	2				
Slow	1		x		
<b>Total Points for site</b>			<b>29</b>

<b>Minor</b>		
0-30	Minor	30-36	Moderate	>36	Severe
Eroding despite the fact that the streambanks are wooded and buffered. There is an oxbow lake on the upland side of this cutbank, which would add weight and moisture.

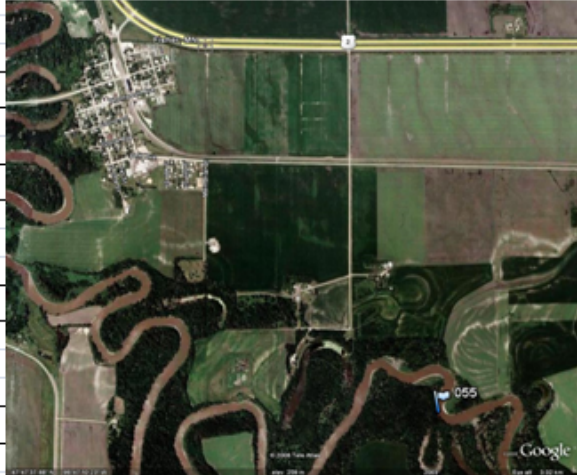
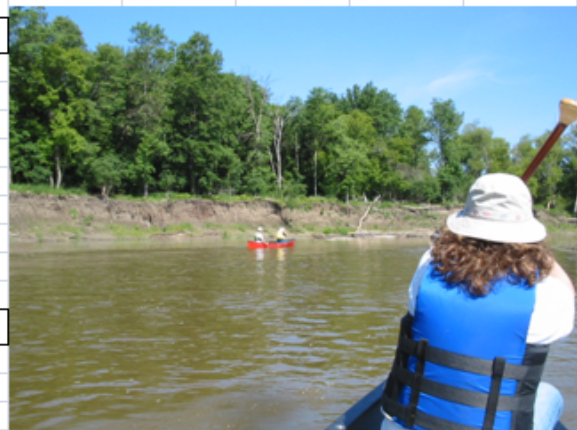
Streambank Erosion Severity Index		Site 55	
Site Description	Cutbank along bend in Red Lake River SE of Fisher		
Site visits on	6/8/2007 10:57	lat/long:	N47 47.112 W96 46.530
OBSERVATION		SCORE	
<b>Condition of bank</b>		<b>5</b>	
Toe and upper bank eroding	5	x	
Toe undercutting	3		
Toe stable, upper bank eroding	1		
<b>Problem Trend</b>		<b>1</b>	
Increasing	5		
Decreasing or stable	1	x	
<b>Side-slope of bank</b>		<b>5</b>	
Vertical, 1:1	5	x

2:1, 3:1	2		
4:1 or flatter	1		
<b>Length of eroded bank</b>		<b>5</b>	
More than 50 ft.	5	x	
20 to 50 ft.	3		
Less than 20 ft.	1		
<b>Depth of river</b>		<b>2</b>	
More than 3 ft.	2	x	
Less than 3 ft.	1		
<b>Soil type or texture</b>		<b>1</b>	
Sand	3		
Gravel	2		
Stratified	2		
Clay, loam	1	x	
<b>Vegetative Cover on bank slope</b>		<b>3</b>	
0-10%	5		
10-50%	3	x	
50-100%	1		
<b>Apparent cause of erosion</b>		<b>2</b>	
Light access traffic	1		
Obstruction in river	1		
Bank seepage	1		
Gullying by side channels	1		
Bend in river	2	x	
Wave action (impoundments)	2		
Road-stream crossing; grade/shoulder	3		
Moderate access traffic	3		
Heavy access (foot, horse, etc.) traffic	5		
<b>Mean height of eroded bank</b>		<b>3</b>	
More than 20 ft.	7		
10 to 20 ft.	5		
5 to 10 ft.	3	x	
Less than 5 ft.	1		
<b>Current</b>		<b>2</b>	
Fast	2		
Slow	1	x	
<b>Total Points for site</b>		<b>29</b>	<b>Minor</b>
0-30	Minor	30-36	Moderate
		>36	Severe

Eroding despite the fact that the streambanks are wooded and buffered.

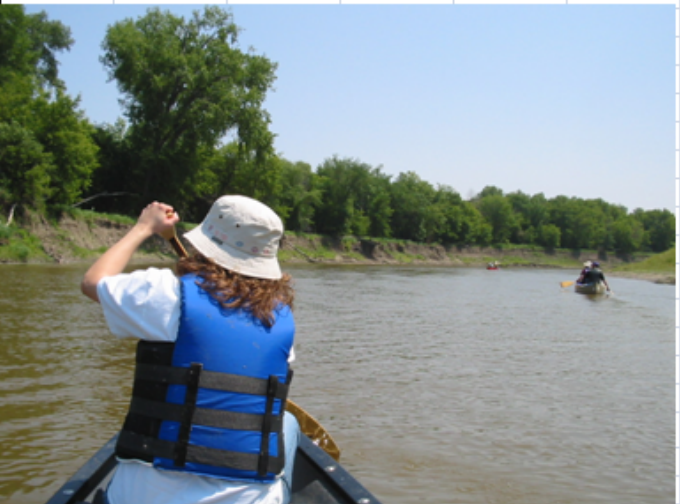
Streambank Erosion Severity Index		Site 86					
Site Description	Cutbank along bend in Red Lake Rier near Fisher						
Site visits on	6/8/2007 12:56	lat/long:	N47 47.769 W96 48.510				
OBSERVATION		SCORE

<b>Condition of bank</b>		<b>3</b>					
Toe and upper bank eroding	5						
Toe undercutting	3	x					
Toe stable, upper bank eroding	1						
<b>Problem Trend</b>		<b>1</b>					
Increasing	5						
Decreasing or stable	1	x					
<b>Side-slope of bank</b>		<b>5</b>					
Vertical, 1:1	5	x

2:1, 3:1	2						
4:1 or flatter	1						
<b>Length of eroded bank</b>		<b>5</b>					
More than 50 ft.	5	x					
20 to 50 ft.	3						
Less than 20 ft.	1						
<b>Depth of river</b>		<b>2</b>					
More than 3 ft.	2	x					
Less than 3 ft.	1						
<b>Soil type or texture</b>		<b>1</b>					
Sand	3						
Gravel	2						
Stratified	2						
Clay, loam	1	x					
<b>Vegetative Cover on bank slope</b>		<b>3</b>					
0-10%	5						
10-50%	3	x					
50-100%	1						
<b>Apparent cause of erosion</b>		<b>2</b>					
Light access traffic	1						
Obstruction in river	1						
Bank seepage	1						
Gullyng by side channels	1						
Bend in river	2	x					
Wave action (impoundments)	2						
Road-stream crossing;	3						
Moderate access traffic	3						
Heavy access (foot, horse, etc.)	5						
<b>Mean height of eroded bank</b>		<b>5</b>					
More than 20 ft.	7						
10 to 20 ft.	5	x					
5 to 10 ft.	3						
Less than 5 ft.	1						
<b>Current</b>		<b>2</b>

Fast	2						
Slow	1	x					
<b>Total Points for site</b>		<b>29</b>	<b>Minor</b>				
0-30	Minor	30-36	Moderate	>36	Severe

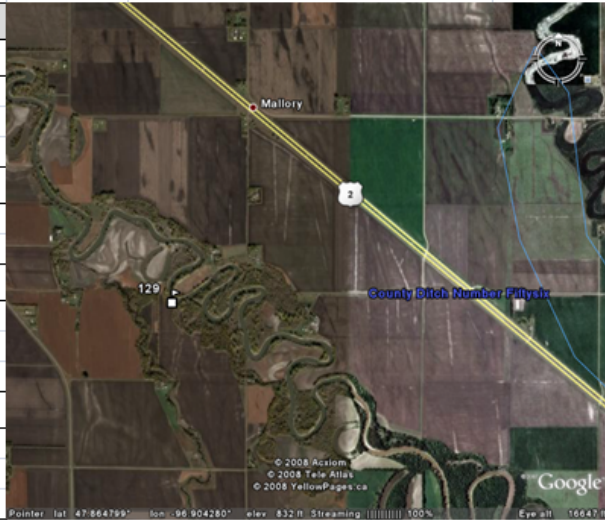
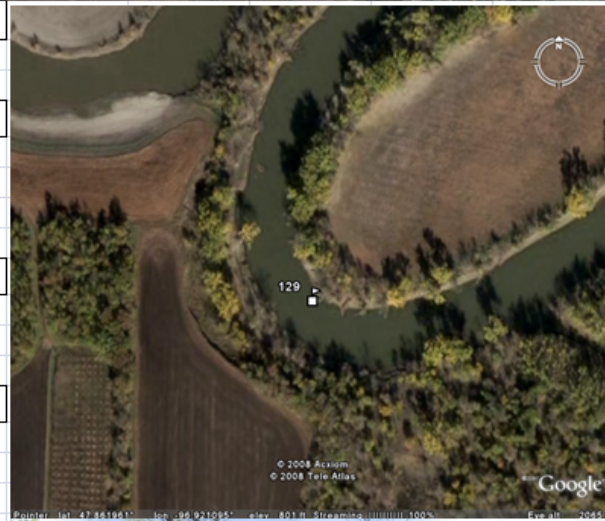
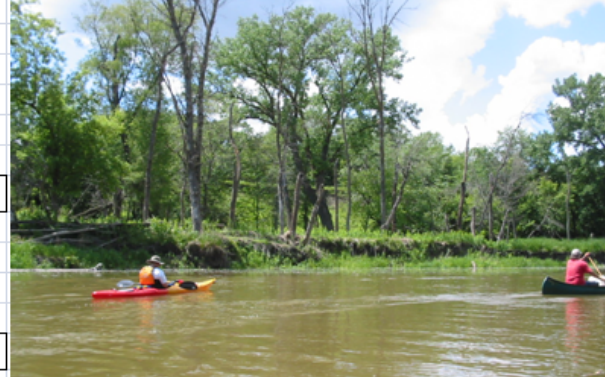
Streambank Erosion Severity Index			
Site Description	A large slump area on the south side of the river south of Mallory		
Site visits on	6/9/2007 14:09	lat/long:	N47 51.705 W96 55.265
OBSERVATION		SCORE	
<b>Condition of bank</b>		<b>1</b>	
Toe and upper bank eroding	5		
Toe undercutting	3		
Toe stable, upper bank eroding	1	x	
<b>Problem Trend</b>		<b>1</b>	
Increasing	5		
Decreasing or stable	1	x	
<b>Side-slope of bank</b>		<b>5</b>	
Vertical, 1:1	5	x

2:1, 3:1	2		
4:1 or flatter	1		
<b>Length of eroded bank</b>		<b>5</b>	
More than 50 ft.	5	x	
20 to 50 ft.	3		
Less than 20 ft.	1		
<b>Depth of river</b>		<b>2</b>	
More than 3 ft.	2	x	
Less than 3 ft.	1		
<b>Soil type or texture</b>		<b>1</b>	
Sand	3		
Gravel	2		
Stratified	2		
Clay, loam	1	x	
<b>Vegetative Cover on bank slope</b>		<b>3</b>	
0-10%	5		
10-50%	3	x	
50-100%	1		
<b>Apparent cause of erosion</b>		<b>2</b>	
Light access traffic	1		
Obstruction in river	1		
Bank seepage	1	x	
Gully by side channels	1		
Bend in river	2	x	
Wave action (impoundments)	2		
Road-stream crossing;	3		
Moderate access traffic	3		
Heavy access (foot, horse, etc.)	5		
<b>Mean height of eroded bank</b>		<b>7</b>	
More than 20 ft.	7	x	
10 to 20 ft.	5		
5 to 10 ft.	3		
Less than 5 ft.	1		
<b>Current</b>		<b>1</b>	
Fast	2		
Slow	1	x	
<b>Total Points for site</b>		<b>28</b>	
0-30	Minor	30-36	Moderate
		>36	Severe

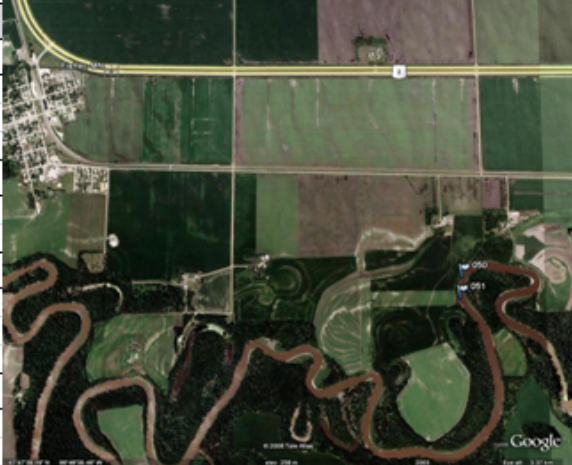
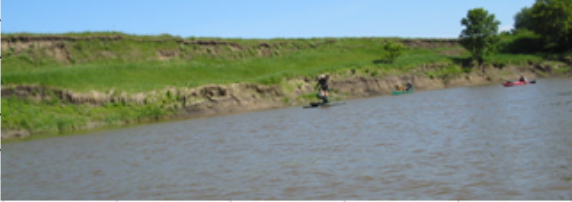
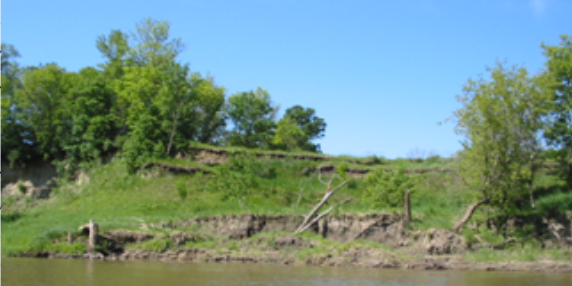
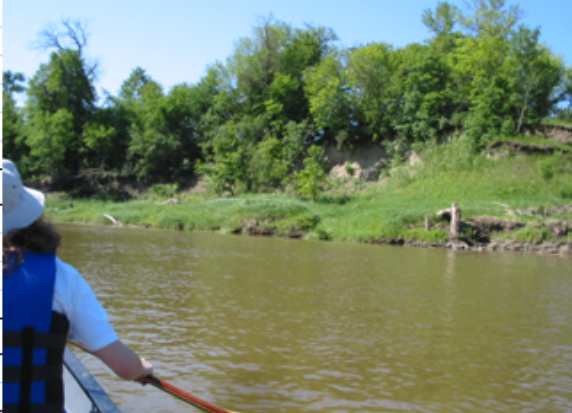
Streambank Erosion Severity Index		Sites 50-51					
Site Description	Relatively tall slumping streambank SE of Fisher						
Site visits on	6/8/2007 10:34			lat/long:	N47 47.406 W96 45.765		
OBSERVATION		SCORE

<b>Condition of bank</b>		<b>3</b>					
Toe and upper bank eroding	5						
Toe undercutting	3	x					
Toe stable, upper bank eroding	1						
<b>Problem Trend</b>		<b>1</b>					
Increasing	5						
Decreasing or stable	1	x					
<b>Side-slope of bank</b>		<b>5</b>					
Vertical, 1:1	5	x

2:1, 3:1	2						
4:1 or flatter	1						
<b>Length of eroded bank</b>		<b>5</b>					
More than 50 ft.	5	x					
20 to 50 ft.	3						
Less than 20 ft.	1						
<b>Depth of river</b>		<b>2</b>					
More than 3 ft.	2	x					
Less than 3 ft.	1						
<b>Soil type or texture</b>		<b>1</b>					
Sand	3						
Gravel	2						
Stratified	2						
Clay, loam	1	x					
<b>Vegetative Cover on bank slope</b>		<b>1</b>					
0-10%	5						
10-50%	3						
50-100%	1	x					
<b>Apparent cause of erosion</b>		<b>2</b>					
Light access traffic	1						
Obstruction in river	1						
Bank seepage	1						
Gully by side channels	1						
Bend in river	2	x					
Wave action (impoundments)	2						
Road-stream crossing; grade/shoulder	3						
Moderate access traffic	3						
Heavy access (foot, horse, etc.) traffic	5						
<b>Mean height of eroded bank</b>		<b>5</b>					
More than 20 ft.	7						
10 to 20 ft.	5	x					
5 to 10 ft.	3						
Less than 5 ft.	1						
<b>Current</b>		<b>2</b>

Fast	2						
Slow	1	x					
<b>Total Points for site</b>		<b>27</b>		<b>Minor</b>			
0-30	Minor	30-36	Moderate	>36	Severe

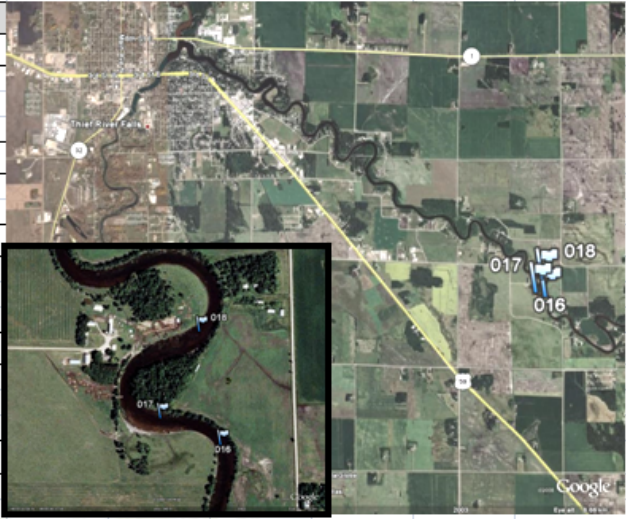
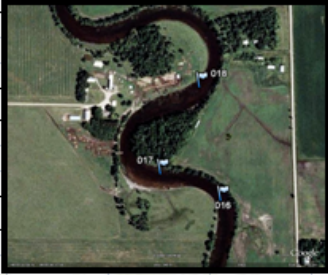
Streambank Erosion Severity Index		Site 16-18									
Site Description		Cattle operation 2 1/2 miles SE of Thief River Falls									
Site visits on		6/1/2007 11:19		lat/long:		N48 05.290 W96 05.665					
OBSERVATION		SCORE

<b>Condition of bank</b>		<b>1</b>									
Toe and upper bank eroding		5

Toe undercutting		3									
Toe stable, upper bank eroding		1								x	
<b>Problem Trend</b>		<b>5</b>

<b>Mean height of eroded bank</b>		<b>1</b>									
More than 20 ft.		7									
10 to 20 ft.		5									
5 to 10 ft.		3									
Less than 5 ft.		1		x							
<b>Current</b>		<b>2</b>									
Fast		2									
Slow		1		x							
<b>Total Points for site</b>		<b>26</b>		<b>Minor</b>							
0-30	Minor	30-36	Moderate	>36	Severe
