# Red Lake River Erosion Site and Assessment Catalog

## Threatening Infrastructure or homes

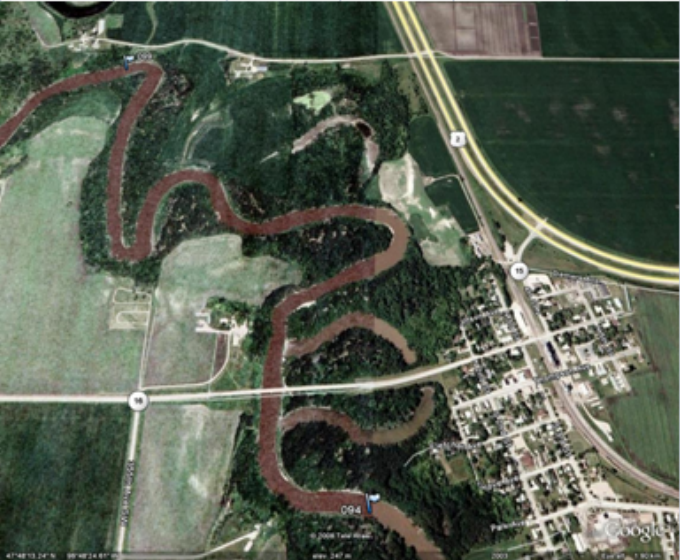
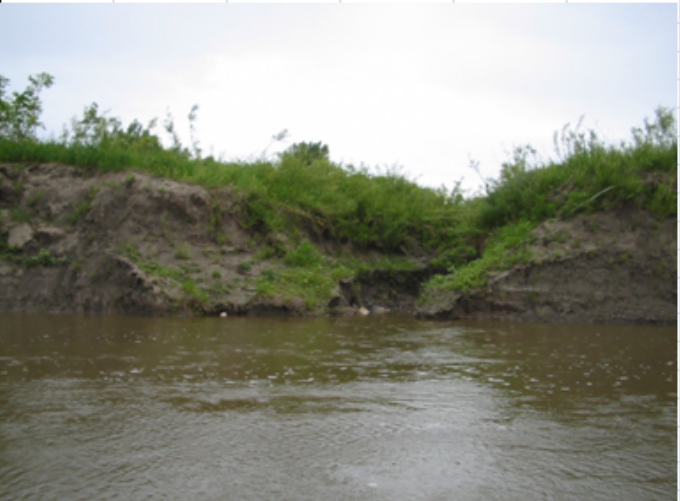
Streambank Erosion Severity Index		Site 98					
Site Description	Gullyng from drainage near Fisher and CSAH 15 Crossing						
Site visits on	6/9/2007 9:29	lat/long:					
OBSERVATION		SCORE

<b>Condition of bank</b>		<b>3</b>					
Toe and upper bank eroding	5						
Toe undercutting	3	x					
Toe stable, upper bank eroding	1						
<b>Problem Trend</b>		<b>5</b>					
Increasing	5	x					
Decreasing or stable	1						
<b>Side-slope of bank</b>		<b>5</b>					
Vertical, 1:1	5	x

2:1, 3:1	2						
4:1 or flatter	1						
<b>Length of eroded bank</b>		<b>1</b>					
More than 50 ft.	5						
20 to 50 ft.	3						
Less than 20 ft.	1	x					
<b>Depth of river</b>		<b>2</b>					
More than 3 ft.	2	x					
Less than 3 ft.	1						
<b>Soil type or texture</b>		<b>1</b>					
Sand	3						
Gravel	2						
Stratified	2						
Clay, loam	1	x					
<b>Vegetative Cover on bank slope</b>		<b>3</b>					
0-10%	5						
10-50%	3	x					
50-100%	1						
<b>Apparent cause of erosion</b>		<b>1</b>					
Light access traffic	1						
Obstruction in river	1						
Bank seepage	1						
Gullyng by side channels	1	x					
Bend in river	2						
Wave action (impoundments)	2						
Road-stream crossing;	3						
Moderate access traffic	3						
Heavy access (foot, horse, etc.)	5						
<b>Mean height of eroded bank</b>		<b>3</b>					
More than 20 ft.	7						
10 to 20 ft.	5						
5 to 10 ft.	3	x					
Less than 5 ft.	1						
<b>Current</b>		<b>2</b>

Fast	2						
Slow	1	x					
<b>Total Points for site</b>		<b>26</b>	<b>Minor</b>				
0-30	Minor	30-36	Moderate	>36	Severe		
GPS wasn't getting correct readings for sites 95-98

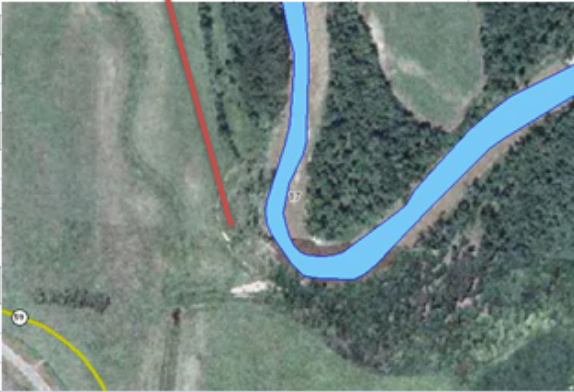
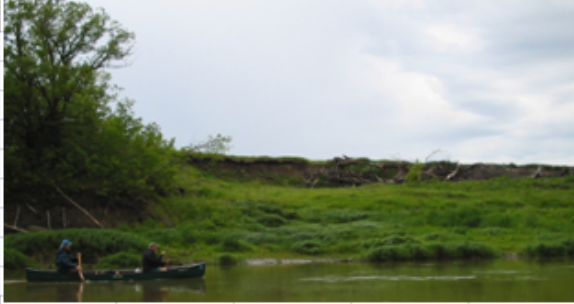
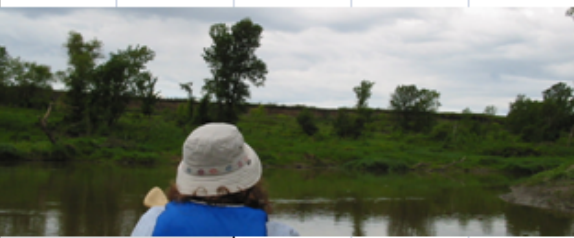
Streambank Erosion Severity Index		Site 102									
Site Description		Slumping streambank along a bend in the river NW of Fisher									
Site visits on		6/9/2007 9:58		lat/long:		N47 48.726 W96 49.943					
OBSERVATION		SCORE

<b>Condition of bank</b>		<b>1</b>									
Toe and upper bank eroding		5									
Toe undercutting		3									
Toe stable, upper bank eroding		1								x	
<b>Problem Trend</b>		<b>1</b>									
Increasing		5									
Decreasing or stable		1								x	
<b>Side-slope of bank</b>		<b>5</b>									
Vertical, 1:1		5								x

2:1, 3:1		2									
4:1 or flatter		1									
<b>Length of eroded bank</b>		<b>5</b>									
More than 50 ft.		5								x	
20 to 50 ft.		3									
Less than 20 ft.		1									
<b>Depth of river</b>		<b>2</b>									
More than 3 ft.		2								x	
Less than 3 ft.		1									
<b>Soil type or texture</b>		<b>1</b>									
Sand		3									
Gravel		2									
Stratified		2									
Clay, loam		1		x							
<b>Vegetative Cover on bank slope</b>		<b>1</b>									
0-10%		5									
10-50%		3									
50-100%		1		x							
<b>Apparent cause of erosion</b>		<b>2</b>									
Light access traffic		1									
Obstruction in river		1									
Bank seepage		1									
Gullying by side channels		1									
Bend in river		2		x							
Wave action (impoundments)		2									
Road-stream crossing;		3									
Moderate access traffic		3									
Heavy access (foot, horse, etc.)		5									
<b>Mean height of eroded bank</b>		<b>7</b>

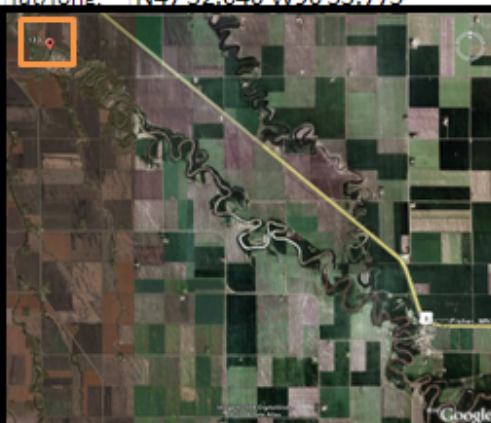
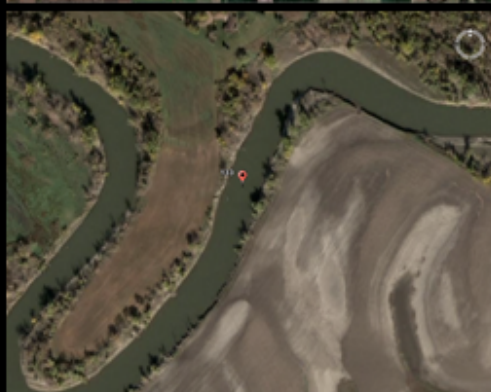
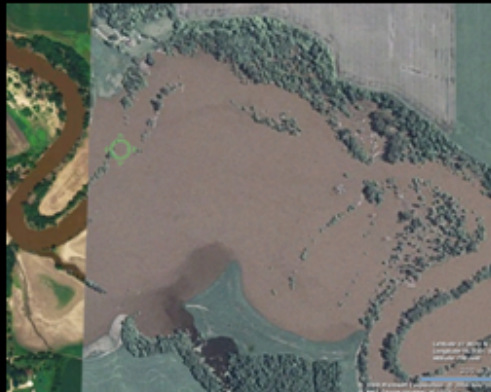
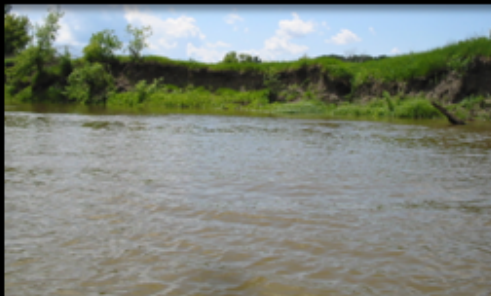
Streambank Erosion Severity Index							
Site Description	Sloughing bank along field between Fisher and East Grand						
Site visits on	6/9/2007 14:26	lat/long:	N47 52.046 W96 55.775				
OBSERVATION		SCORE

<b>Condition of bank</b>		<b>3</b>					
Toe and upper bank eroding	5						
Toe undercutting	3	x					
Toe stable, upper bank eroding	1						
<b>Problem Trend</b>		<b>1</b>					
Increasing	5						
Decreasing or stable	1	x					
<b>Side-slope of bank</b>		<b>5</b>					
Vertical, 1:1	5	x

2:1, 3:1	2						
4:1 or flatter	1						
<b>Length of eroded bank</b>		<b>5</b>					
More than 50 ft.	5	x					
20 to 50 ft.	3						
Less than 20 ft.	1						
<b>Depth of river</b>		<b>2</b>					
More than 3 ft.	2	x					
Less than 3 ft.	1						
<b>Soil type or texture</b>		<b>1</b>					
Sand	3						
Gravel	2						
Stratified	2						
Clay, loam	1	x					
<b>Vegetative Cover on bank slope</b>		<b>1</b>					
0-10%	5						
10-50%	3						
50-100%	1	x					
<b>Apparent cause of erosion</b>		<b>2</b>					
Light access traffic	1						
Obstruction in river	1						
Bank seepage	1						
Gullying by side channels	1						
Bend in river	2	x					
Wave action (impoundments)	2						
Road-stream crossing;	3						
Moderate access traffic	3						
Heavy access (foot, horse, etc.)	5						
<b>Mean height of eroded bank</b>		<b>5</b>					
More than 20 ft.	7						
10 to 20 ft.	5	x					
5 to 10 ft.	3						
Less than 5 ft.	1						
<b>Current</b>		<b>1</b>

Fast	2						
Slow	1	x					
<b>Total Points for site</b>		<b>26</b>		<b>Minor</b>			
0-30	Minor	30-36	Moderate	>36	Severe

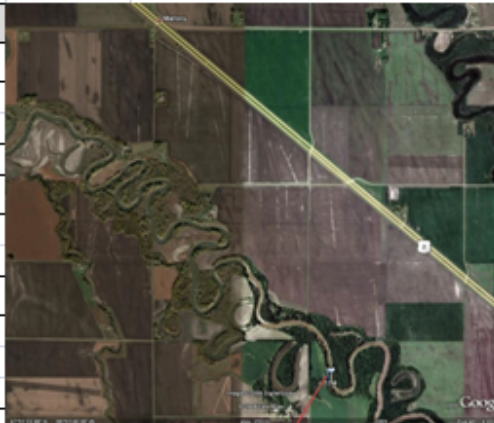
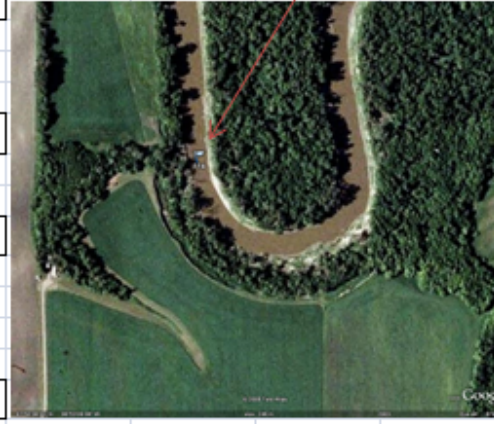
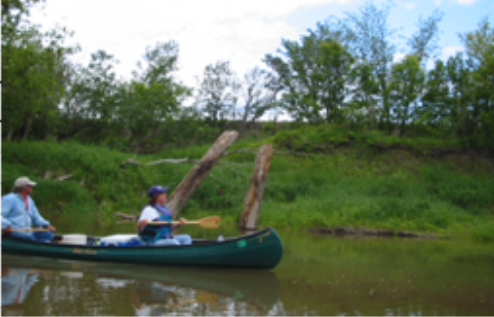
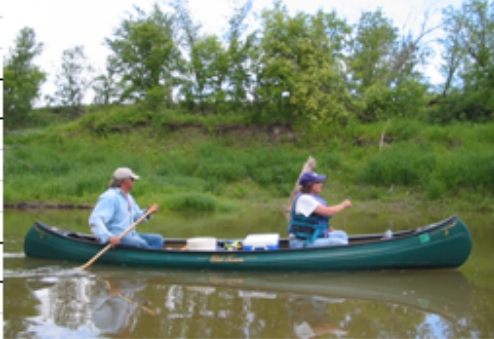
Streambank Erosion Severity Index		Site 114				
Site Description		Large slump with limited erosion along a bend in the river SE of Mallory				
Site visits on		6/9/2007 11:51		lat/long: N47 50.635 W96 53.242		
OBSERVATION		SCORE

<b>Condition of bank</b>		<b>0</b>				
Toe and upper bank eroding	5					
Toe undercutting	3					
Toe stable, upper bank eroding	1					
<b>Problem Trend</b>		<b>1</b>				
Increasing	5					
Decreasing or stable	1	x				
<b>Side-slope of bank</b>		<b>5</b>				
Vertical, 1:1	5	x

2:1, 3:1	2					
4:1 or flatter	1					
<b>Length of eroded bank</b>		<b>5</b>				
More than 50 ft.	5	x				
20 to 50 ft.	3					
Less than 20 ft.	1					
<b>Depth of river</b>		<b>2</b>				
More than 3 ft.	2	x				
Less than 3 ft.	1					
<b>Soil type or texture</b>		<b>1</b>				
Sand	3					
Gravel	2					
Stratified	2					
Clay, loam	1	x				
<b>Vegetative Cover on bank slope</b>		<b>1</b>				
0-10%	5					
10-50%	3					
50-100%	1	x				
<b>Apparent cause of erosion</b>		<b>2</b>				
Light access traffic	1					
Obstruction in river	1					
Bank seepage	1					
Gully by side channels	1					
Bend in river	2	x				
Wave action (impoundments)	2					
Road-stream crossing;	3					
Moderate access traffic	3					
Heavy access (foot, horse, etc.)	5					
<b>Mean height of eroded bank</b>		<b>7</b>				
More than 20 ft.	7	x				
10 to 20 ft.	5					
5 to 10 ft.	3					
Less than 5 ft.	1					
<b>Current</b>		<b>1</b>				
Fast	2					
Slow	1	x				
<b>Total Points for site</b>		<b>25</b>		<b>Minor</b>

0-30	Minor	30-36	Moderate	>36	Severe

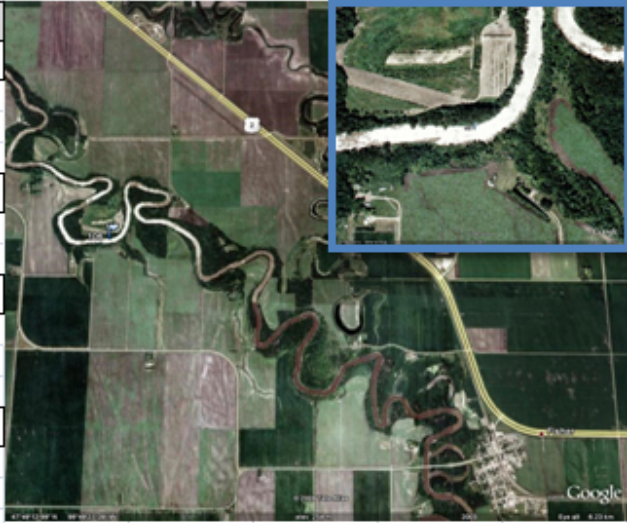
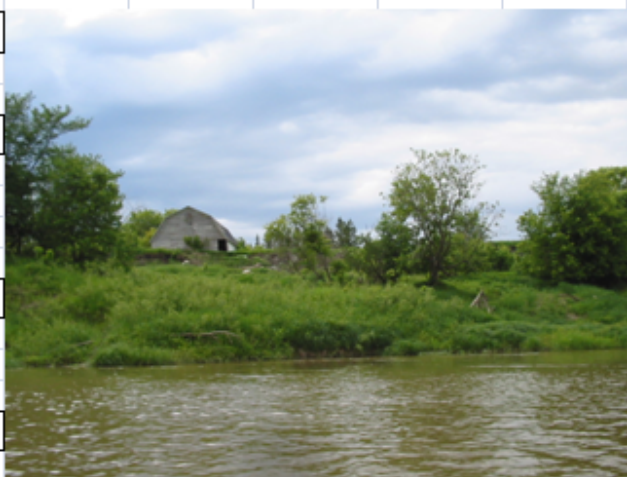
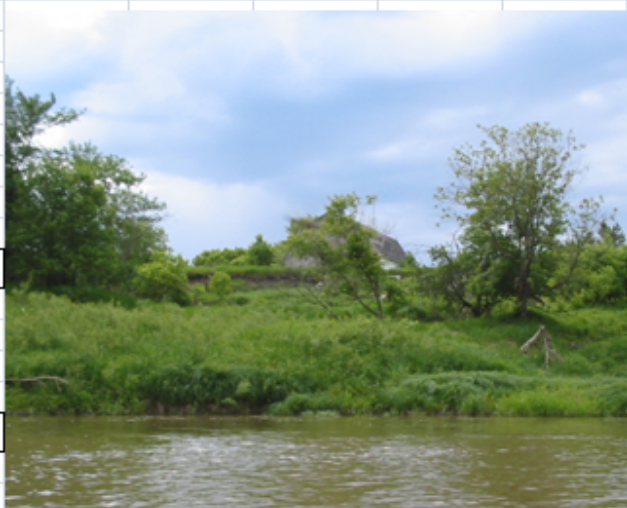
2:1, 3:1	2	x	
4:1 or flatter	1		
<b>Length of eroded bank</b>		<b>5</b>	
More than 50 ft.	5	x	
20 to 50 ft.	3		
Less than 20 ft.	1		
<b>Depth of river</b>		<b>2</b>	
More than 3 ft.	2	x	
Less than 3 ft.	1		
<b>Soil type or texture</b>		<b>1</b>	
Sand	3		
Gravel	2		
Stratified	2		
Clay, loam	1	x	
<b>Vegetative Cover on bank slope</b>		<b>1</b>	
0-10%	5		
10-50%	3		
50-100%	1	x	
<b>Apparent cause of erosion</b>		<b>2</b>	
Light access traffic	1		
Obstruction in river	1		
Bank seepage	1	x	
Gullying by side channels	1		
Bend in river	2	x	
Wave action (impoundments)	2		
Road-stream crossing;	3		
Moderate access traffic	3		
Heavy access (foot, horse, etc.)	5		
<b>Mean height of eroded bank</b>		<b>7</b>	
More than 20 ft.	7	x	
10 to 20 ft.	5		
5 to 10 ft.	3		
Less than 5 ft.	1		
<b>Current</b>		<b>1</b>	
Fast	2		
Slow	1	x	
<b>Total Points for site</b>		<b>25</b>	
		<b>Minor</b>	
0-30	Minor	30-36	Moderate
		>36	Severe
The slump is approaching some farm buildings

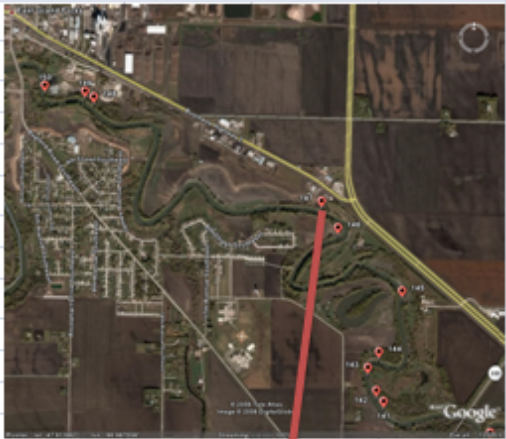
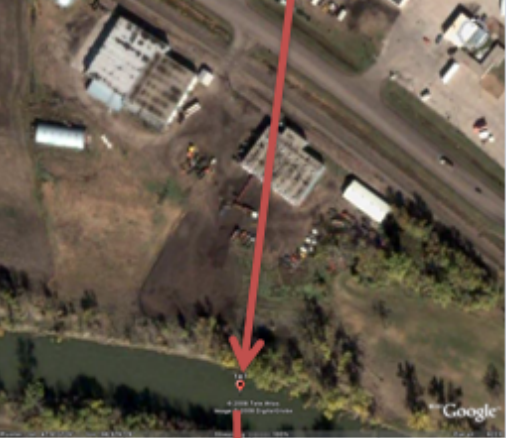
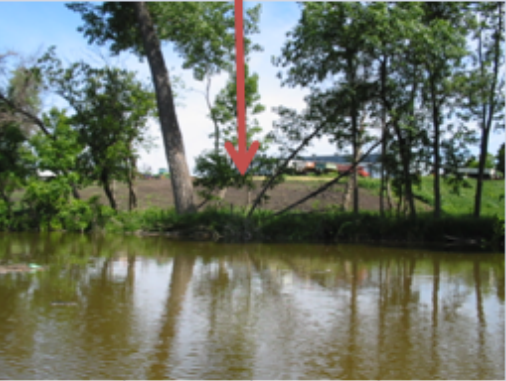
2:1, 3:1	2		
4:1 or flatter	1	1:1	
<b>Length of eroded bank</b>		<b>3</b>	
More than 50 ft.	5		
20 to 50 ft.	3	x	
Less than 20 ft.	1		
<b>Depth of river</b>		<b>2</b>	
More than 3 ft.	2	x	
Less than 3 ft.	1		
<b>Soil type or texture</b>		<b>1</b>	
Sand	3		
Gravel	2		
Stratified	2		
Clay, loam	1	x	
<b>Vegetative Cover on bank slope</b>		<b>5</b>	
0-10%	5	x	
10-50%	3		
50-100%	1		
<b>Apparent cause of erosion</b>		<b>5</b>	
Light access traffic	1		
Obstruction in river	1		
Bank seepage	1		
Gullyng by side channels	1		
Bend in river	2		
Wave action (impoundments)	2		
Road-stream crossing;	3		
Moderate access traffic	3		
Heavy access (foot, horse, etc.)	5	x	
<b>Mean height of eroded bank</b>		<b>3</b>	
More than 20 ft.	7		
10 to 20 ft.	5		
5 to 10 ft.	3	x	
Less than 5 ft.	1		
<b>Current</b>		<b>1</b>	
Fast	2		
Slow	1	x	
<b>Total Points for site</b>		<b>23</b>	<b>Minor</b>
0-30	Minor	30-36	Moderate
		>36	Severe

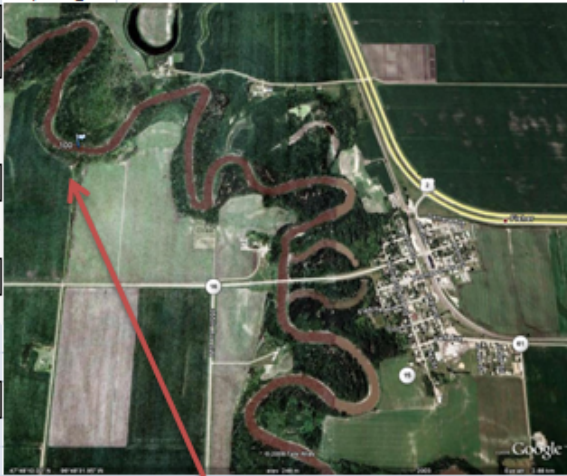
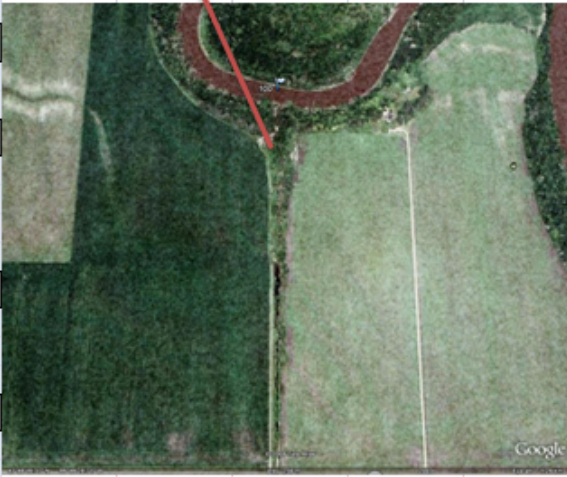
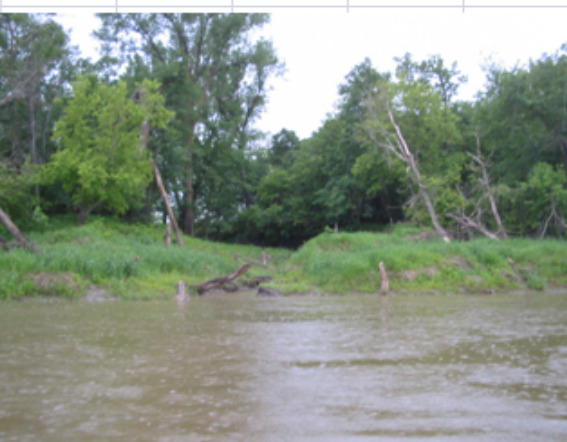
2:1, 3:1	2	x	
4:1 or flatter	1		
<b>Length of eroded bank</b>		<b>5</b>	
More than 50 ft.	5	x	
20 to 50 ft.	3		
Less than 20 ft.	1		
<b>Depth of river</b>		<b>1</b>	
More than 3 ft.	2		
Less than 3 ft.	1	x	
<b>Soil type or texture</b>		<b>1</b>	
Sand	3		
Gravel	2		
Stratified	2		
Clay, loam	1	x	
<b>Vegetative Cover on bank slope</b>		<b>1</b>	
0-10%	5		
10-50%	3		
50-100%	1	x	
<b>Apparent cause of erosion</b>		<b>1</b>	
Light access traffic	1		
Obstruction in river	1		
Bank seepage	1		
Gullying by side channels	1	x	
Bend in river	2		
Wave action (impoundments)	2		
Road-stream crossing;	3		
Moderate access traffic	3		
Heavy access (foot, horse, etc.)	5		
<b>Mean height of eroded bank</b>		<b>1</b>	
More than 20 ft.	7		
10 to 20 ft.	5		
5 to 10 ft.	3		
Less than 5 ft.	1	x	
<b>Current</b>		<b>2</b>	
Fast	2	x	
Slow	1		
<b>Total Points for site</b>		<b>20</b>	<b>Minor</b>
0-30	Minor	30-36	Moderate
		>36	Severe
Channel entering the river is eroding. Score is based on characteristics of the gully.
