**Ruffy Brook Stream Study
Clearwater County
2005**

**Submitted by Bill Evarts, Bemidji Area Fisheries
December 28, 2005**

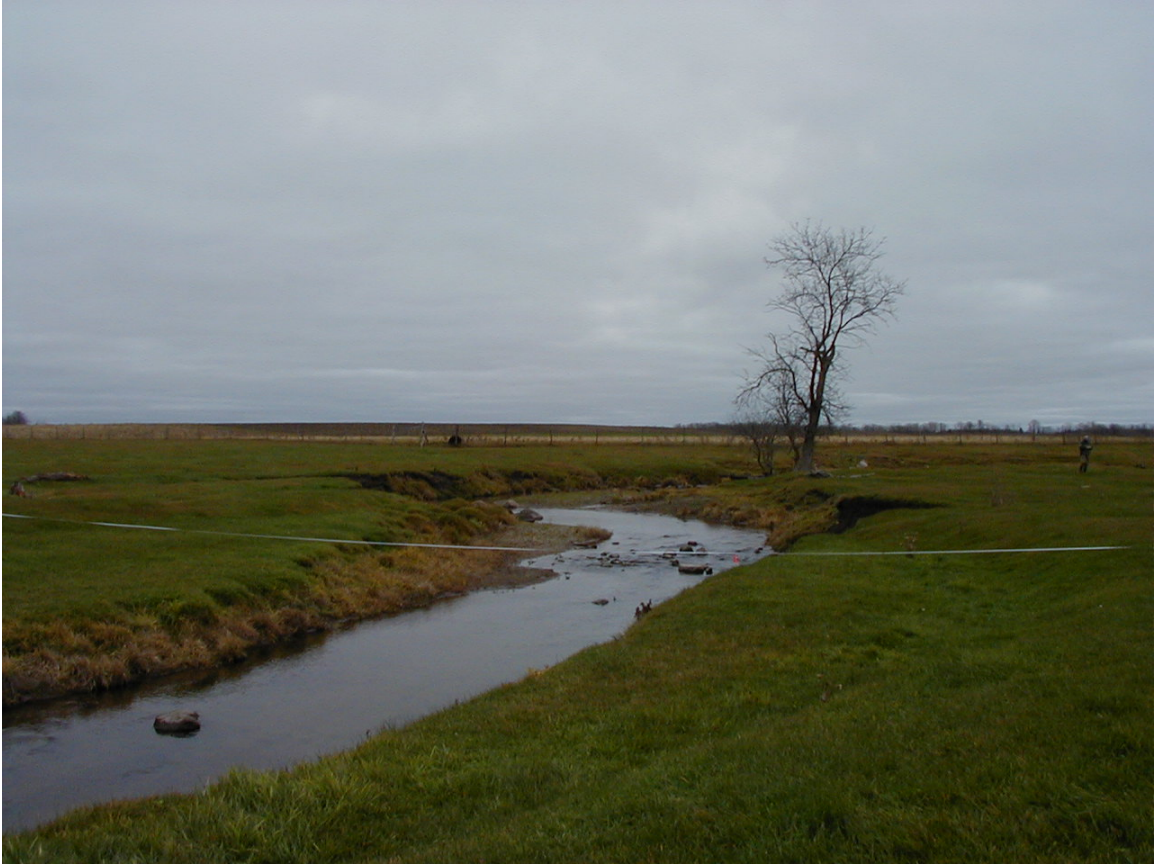
Due to a late start and restrictions on access to the intermediate and reference Rosgen sites, only the Rosgen survey of a pastured reach was completed (see Figure 1 and Rosgen Classification Summary attached). Mesohabitat and fish habitat results are presented in Tables 1 and 2. Fish habitat was measured following the definitions in the 2005 Minnesota Department of Natural Resources draft Fisheries Stream Survey Manual. Fish habitat is essentially absent from this reach. Much of the boulder cover is water too shallow to be utilized by larger fish. The pools are shallow with the substrate dominated by sand.

Figure 1. Pastured reach used for Rosgen Level II survey.

Complete the Rosgen and fish community surveys in 2006.
